EUROPEAN ENHANCED VEHICLE-SAFETY COMMITTEE

**EEVC Working Group 13 Report.
Head Contacts In Side Impact - An Accident Analysis
February 2001**

Head Contacts In Side Impact - An Accident Analysis

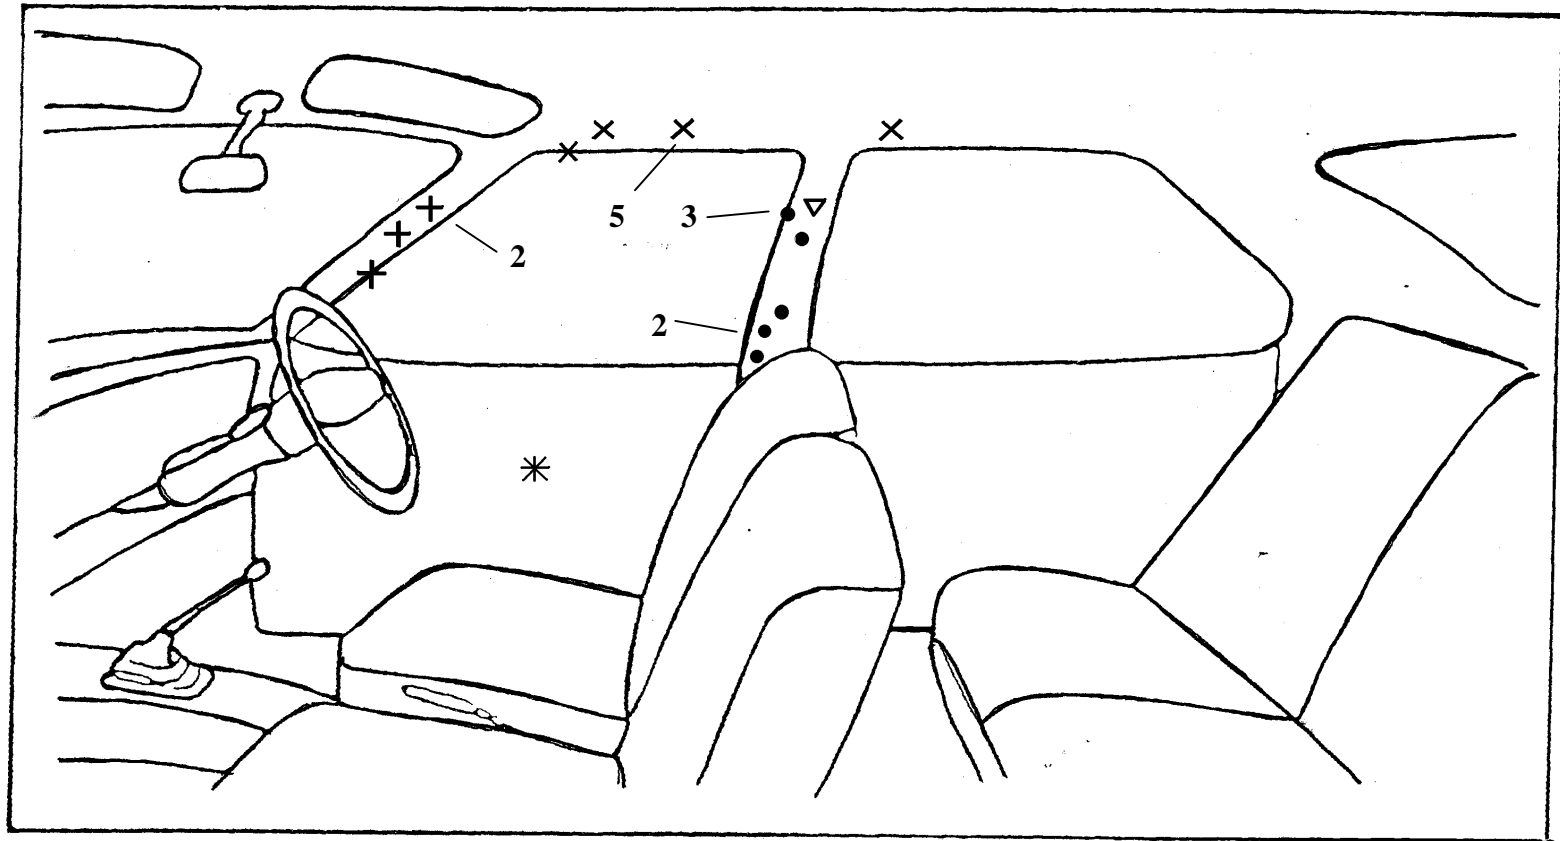
Figure 2 - Graphical Representation of Frequent Head Contact Regions, Front Seat, Restrained Struck Side Occupants - TRL Data

Key	Contact Region	Total in figure	Total no of contacts	Key	Contact Region	Total in figure	Total no of contacts	Key	Contact Region	Total in figure	Total no of contacts
●	B Pillar	8	13	▲	Header	0	0	▽	Upper Anchorage	1	1
+	A Pillar	4	6	#	Facia Top	0	1	■	Steering Wheel	0	3
	Side Other	1	8	O	Roof	0	0	◆	Head Restraint	0	1
	Side Roof Rail	8	8

Contacts on the vehicle structure for restrained struck side occupants are listed below, Table 3. The specific points of contact when known, are illustrated on Figures 2-5.

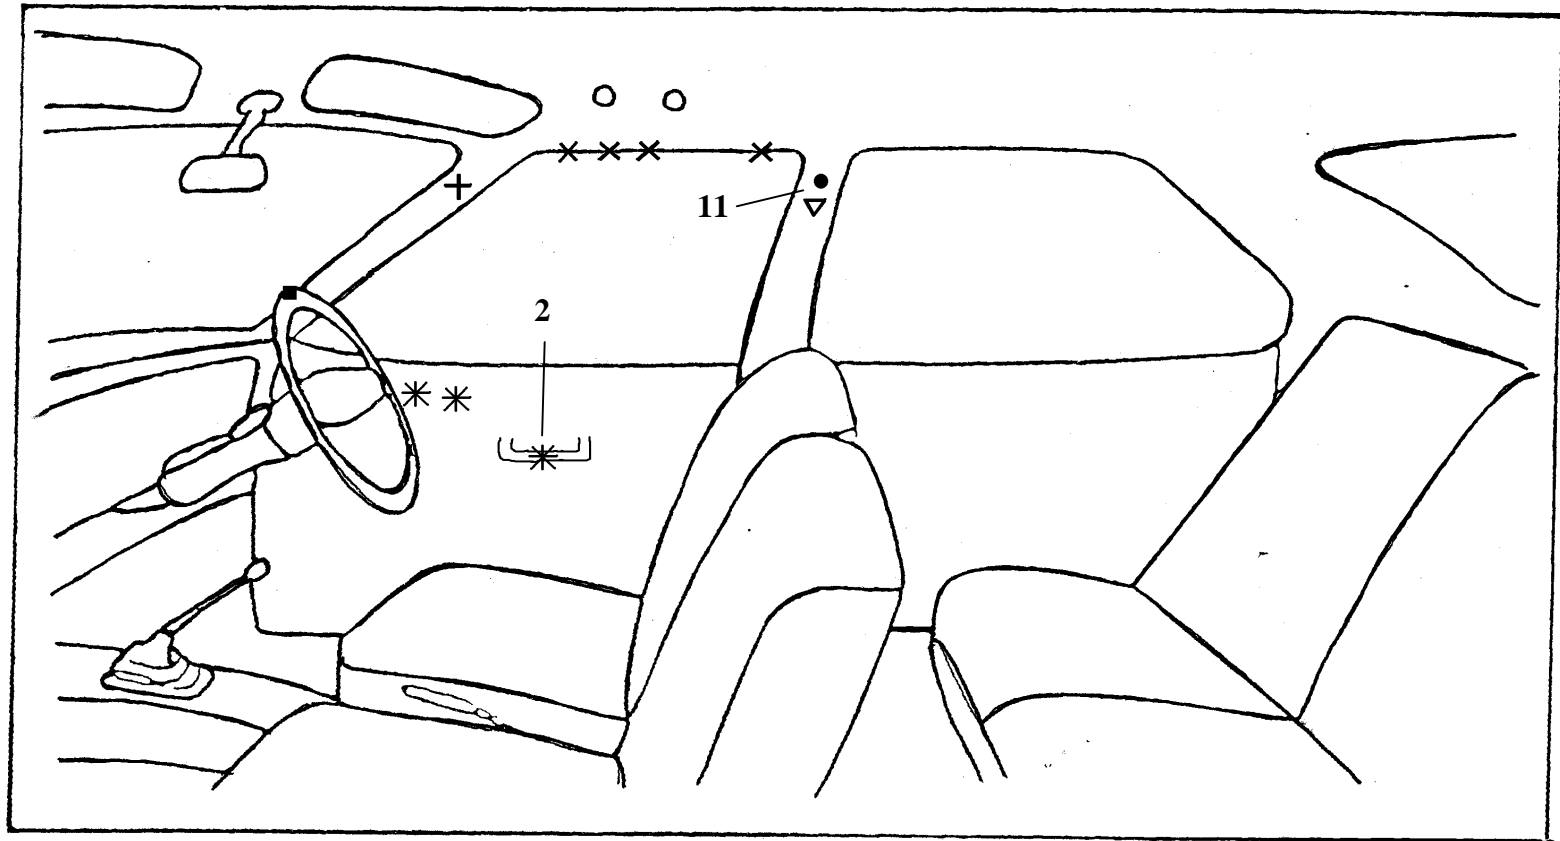
Figure 3 - Graphical Representation of Frequent Head Contact Regions, Front Seat, Restrained Struck Side Occupants - BAST Data

Key	Contact Region	Total in figure	Total no of contacts	Key	Contact Region	Total in figure	Total no of contacts	Key	Contact Region	Total in figure	Total no of contacts
●	B Pillar	11	11	▲	Header	0	0	▽	Upper Anchorage	1	1
+	A Pillar	1	1	#	Facia Top	0	1	■	Steering Wheel	1	1
	Side Other	4	4	O	Roof	2	2	◆	Head Restraint	0	0
	Side Roof Rail	4	4

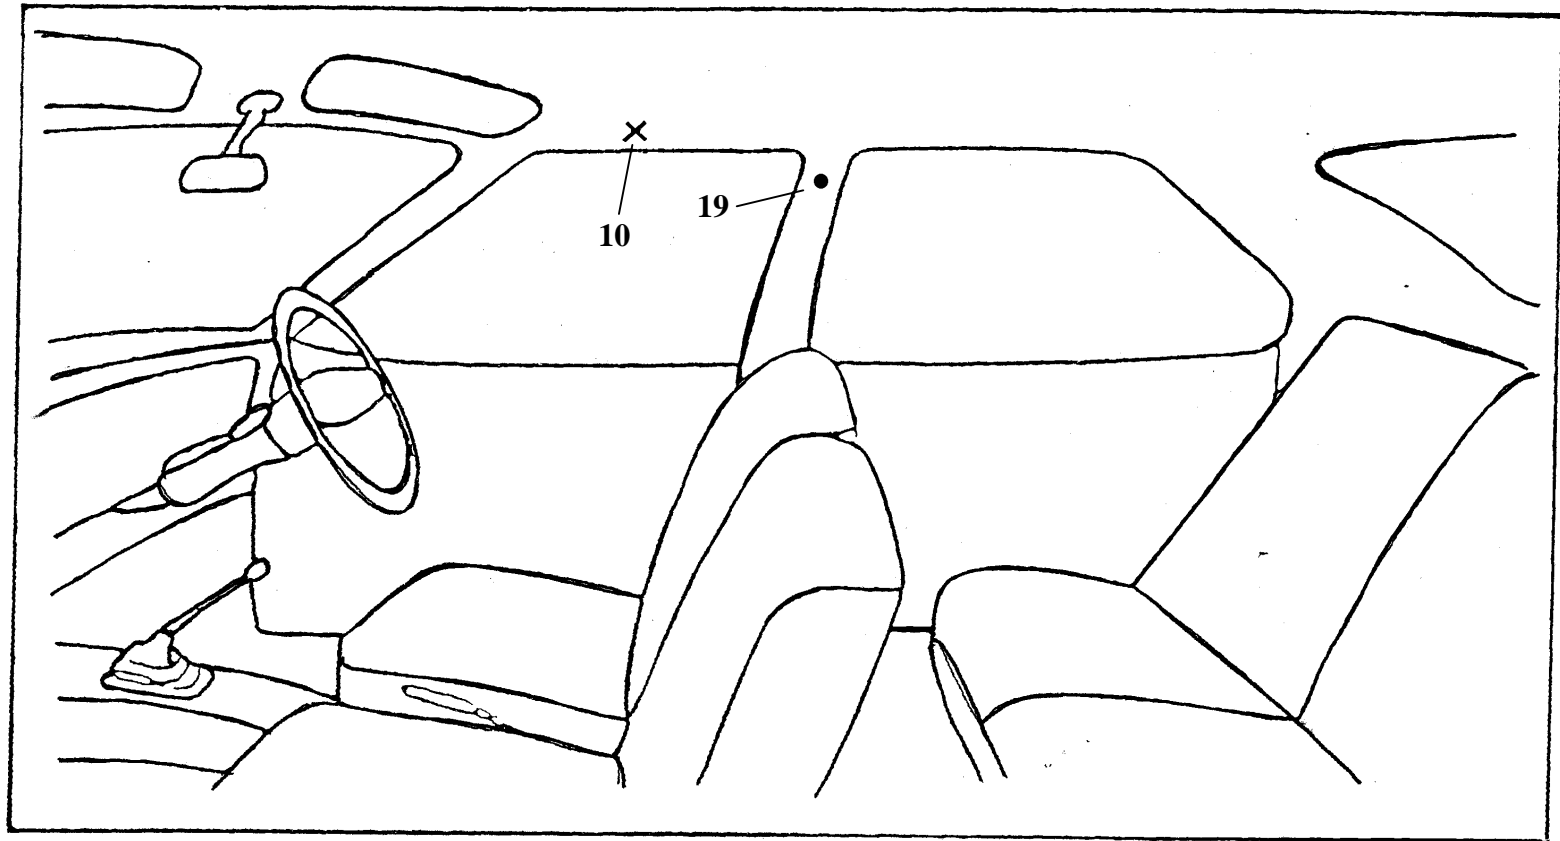
Figure 4 - Graphical Representation of Frequent Head Contact Regions, Front Seat, Restrained Struck Side Occupants - LAB Data

Key	Contact Region	Total in figure	Total no of contacts	Key	Contact Region	Total in figure	Total no of contacts	Key	Contact Region	Total in figure	Total no of contacts
●	B Pillar	19	19	▲	Header			▽	Upper Anchorage		
+	A Pillar	0	0	#	Facia Top			■	Steering Wheel		
	Side Other	0	0	O	Roof			◆	Head Restraint		
	Side Roof Rail	10	10

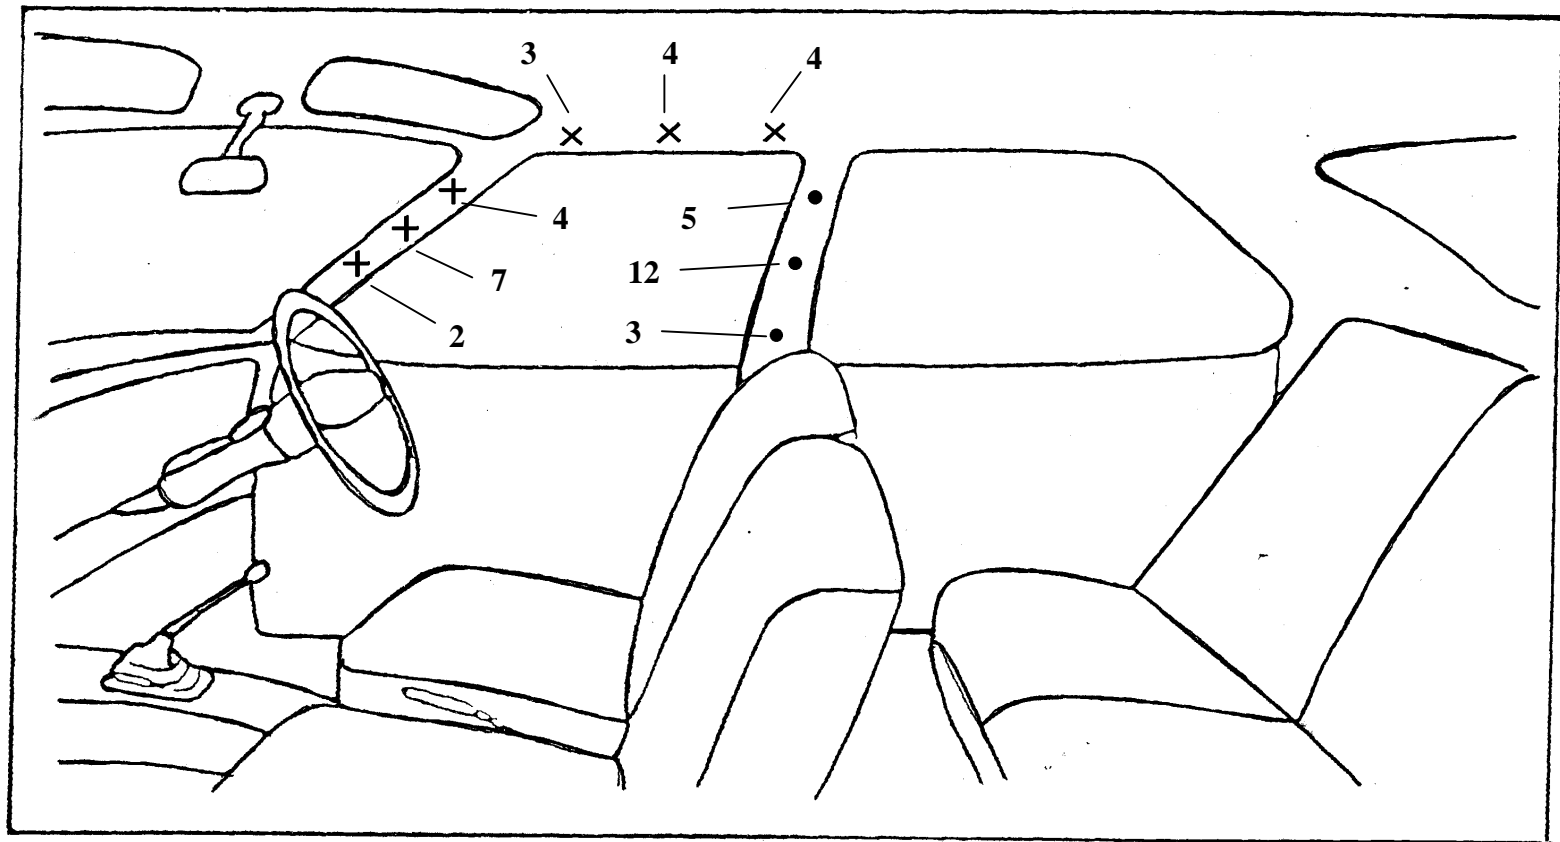
Figure 5 - Graphical Representation of Frequent Head Contact Regions, Front Seat, Restrained Struck Side Occupants - NHTSA Data

Key	Contact Region	Total in figure	Total no of contacts	Key	Contact Region	Total in figure	Total no of contacts	Key	Contact Region	Total in figure	Total no of contacts
●	B Pillar	20	39	▲	Header			▽	Upper Anchorage		
+	A Pillar	13	22	#	Facia Top			■	Steering Wheel		
	Side Other			O	Roof			◆	Head Restraint		
	Side Roof Rail	11	24

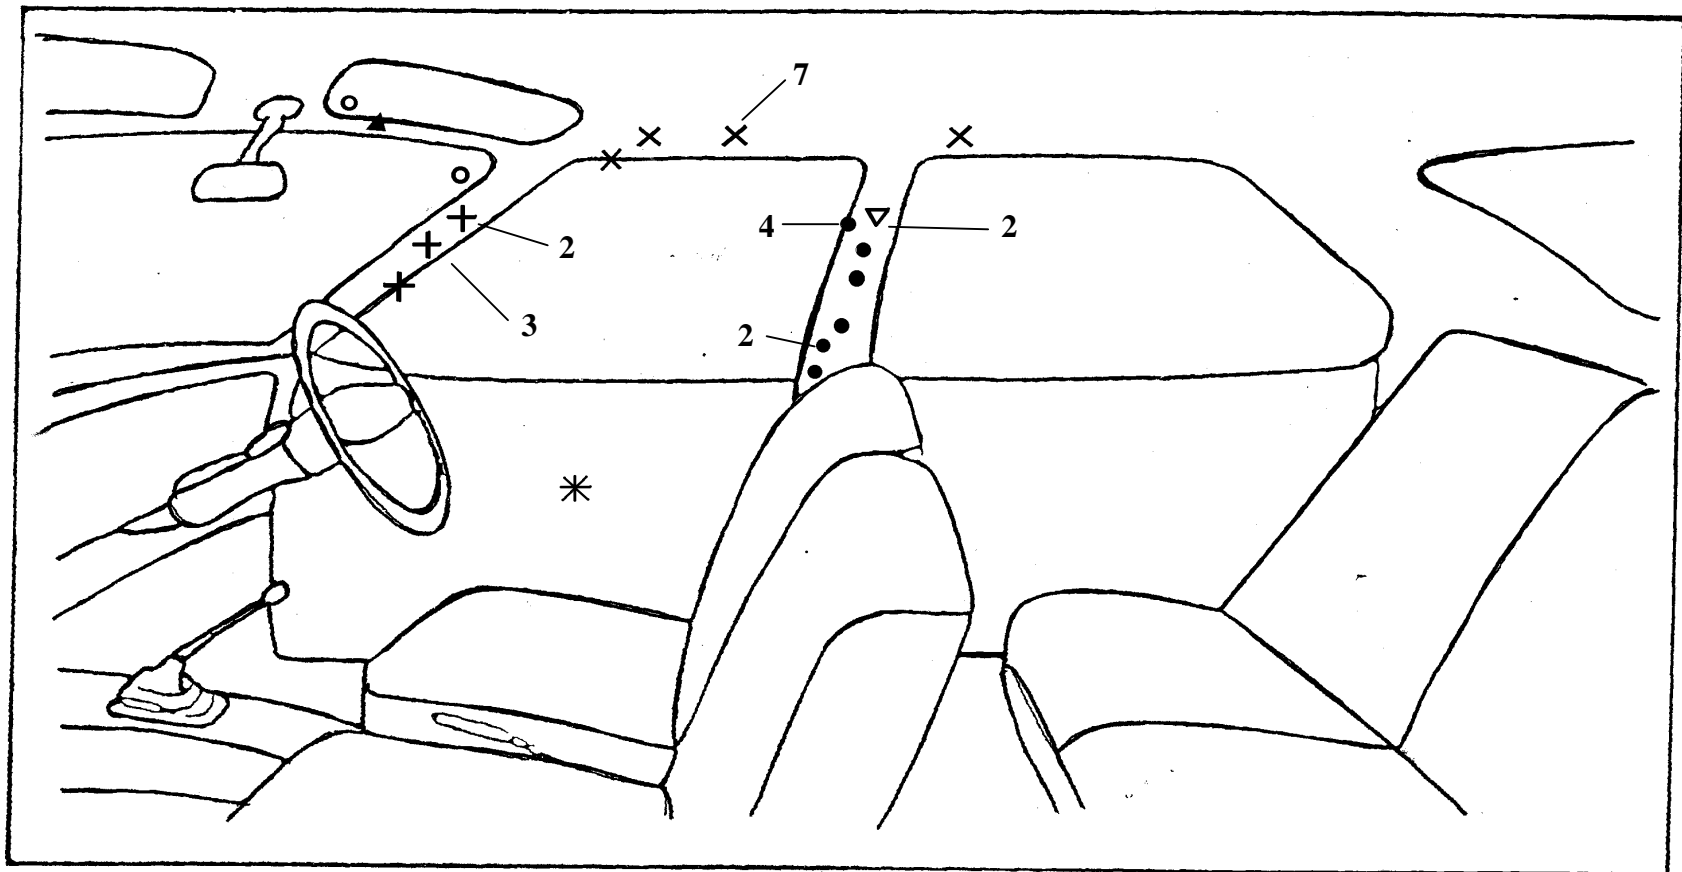
Figure 6 - Graphical Representation of Frequent Head Contact Regions, Front Seat, Struck Side Occupants - TRL Data

Key	Contact Region	Total in figure	Total no of contacts	Key	Contact Region	Total in figure	Total no of contacts	Key	Contact Region	Total in figure	Total no of contacts
●	B Pillar	10	18	▲	Header	1	1	▽	Upper Anchorage	2	2
+	A Pillar	6	9	#	Facia Top	1	0	■	Steering Wheel	0	3
	Side Other	1	5	O	Roof	2	2	◆	Head Restraint	0	2
	Side Roof Rail	10	12

Table 9 shows the results for all struck side occupants (restrained and unrestrained). The specific points of contact on the vehicle structure for struck side occupants, are shown on Figures 6-9

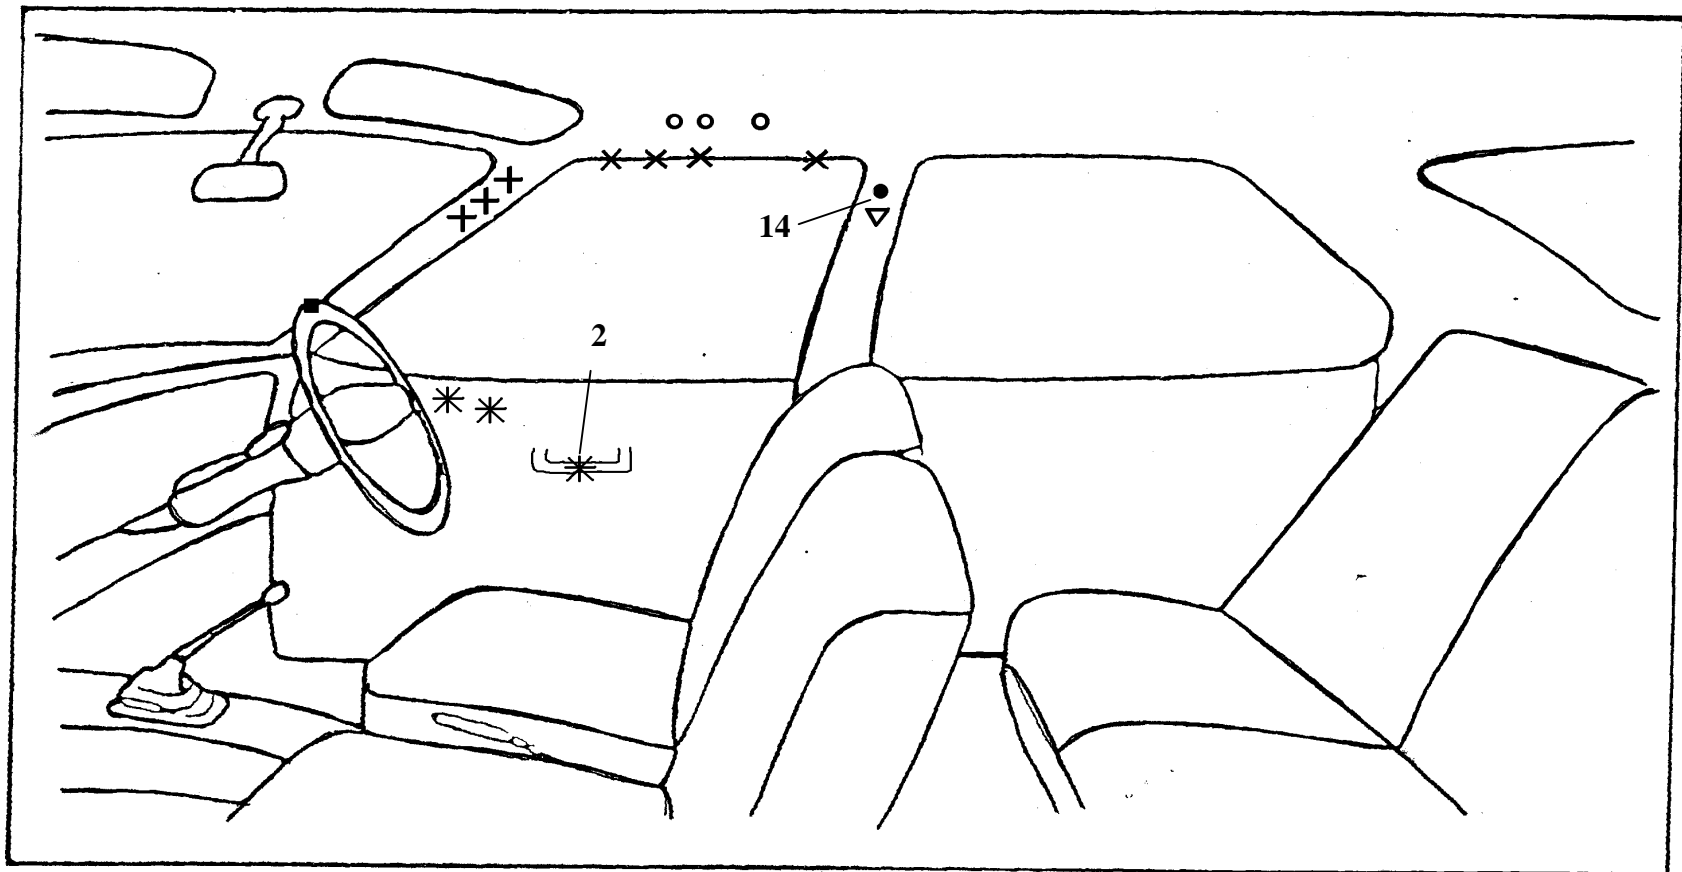
Figure 7 - Graphical Representation of Frequent Head Contact Regions, Front Seat, Struck Side Occupants - BAST Data

Key	Contact Region	Total in figure	Total no of contacts	Key	Contact Region	Total in figure	Total no of contacts	Key	Contact Region	Total in figure	Total no of contacts
●	B Pillar	14	14	▲	Header	0	0	▽	Upper Anchorage	1	1
+	A Pillar	3	3	#	Facia Top	0	0	■	Steering Wheel	1	1
	Side Other	4	4	○	Roof	3	3	◆	Head Restraint	0	0
	Side Roof Rail	4	4

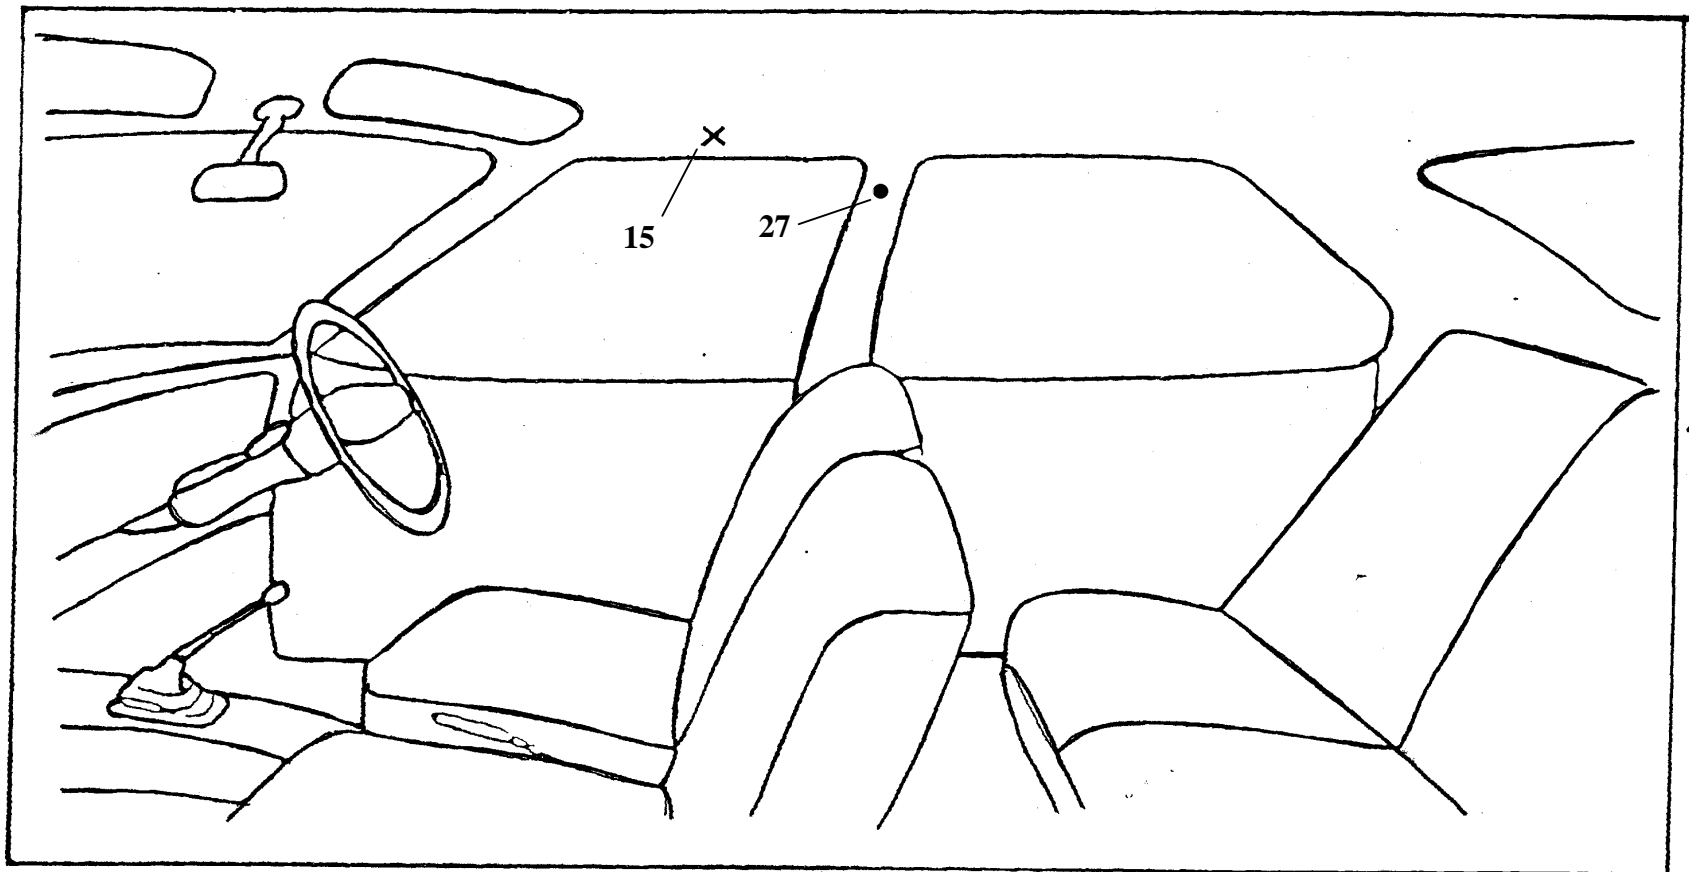
Figure 8 - Graphical Representation of Frequent Head Contact Regions, Front Seat, Struck Side Occupants - LAB Data

Key	Contact Region	Total in figure	Total no of contacts	Key	Contact Region	Total in figure	Total no of contacts	Key	Contact Region	Total in figure	Total no of contacts
●	B Pillar	127	27	▲	Header			∇	Upper Anchorage		
+	A Pillar	0	0	#	Facia Top			■	Steering Wheel		
	Side Other			O	Roof			◆	Head Restraint		
	Side Roof Rail	15	15

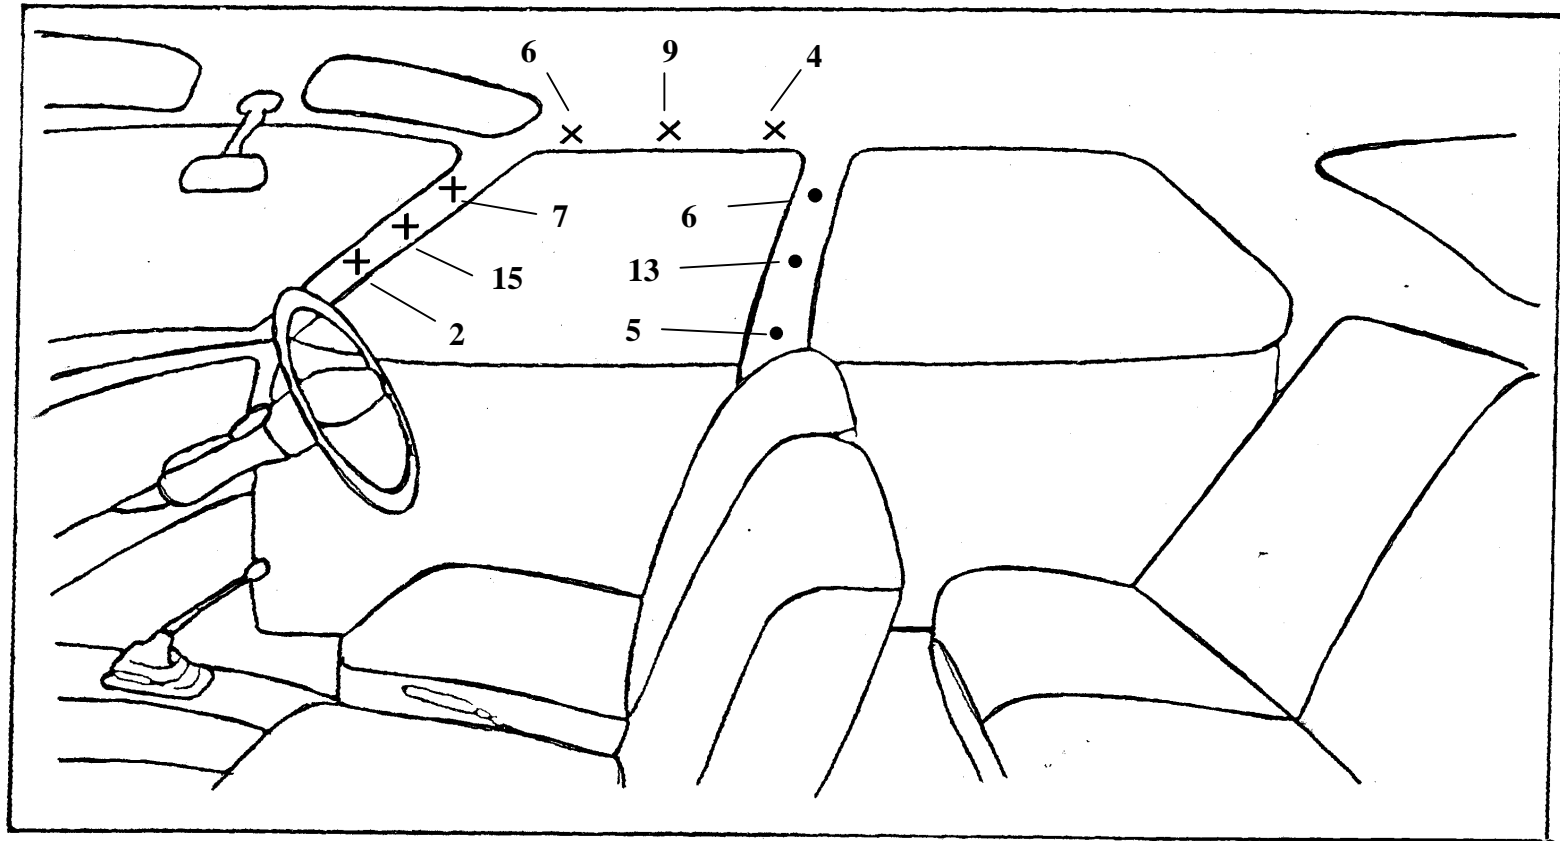
Figure 9 - Graphical Representation of Frequent Head Contact Regions, Front Seat, Struck Side Occupants - NHTSA Data

Key	Contact Region	Total in figure	Total no of contacts	Key	Contact Region	Total in figure	Total no of contacts	Key	Contact Region	Total in figure	Total no of contacts
●	B Pillar	24	56	▲	Header			▽	Upper Anchorage		
+	A Pillar	24	40	#	Facia Top			■	Steering Wheel		
	Side Other			O	Roof			◆	Head Restraint		
	Side Roof Rail	19	39

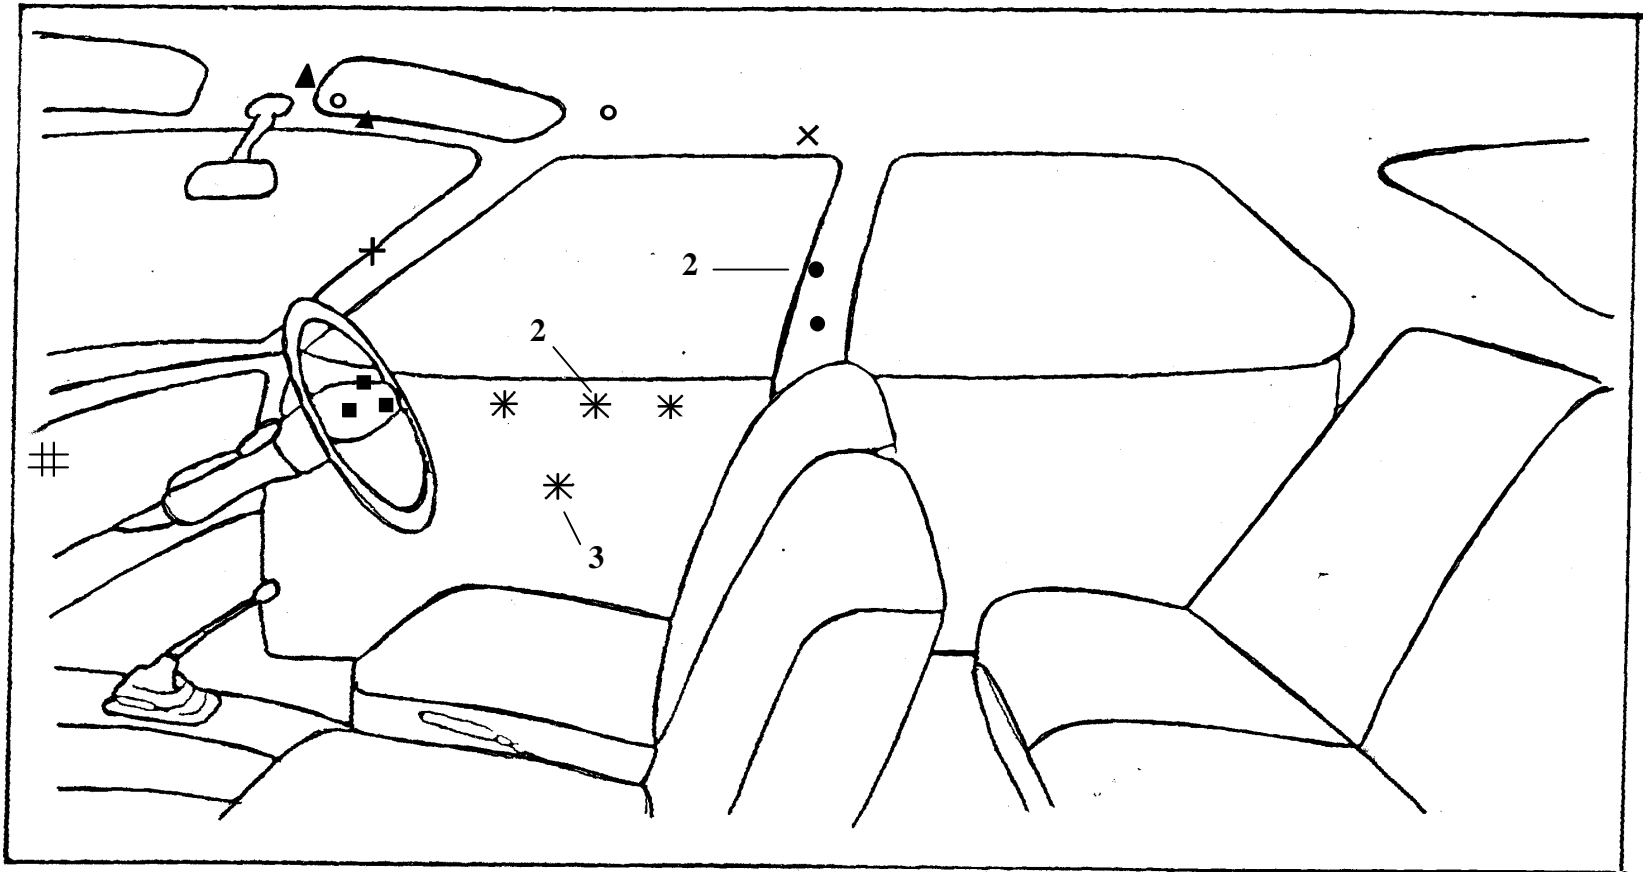
Figure 10: Graphical Representation of Frequent Head Contact Regions, Front Seat, Non-Struck Side Occupants - TRL Data

Key	Contact Region	Total in figure	Total no of contacts	Key	Contact Region	Total in figure	Total no of contacts	Key	Contact Region	Total in figure	Total no of contacts
●	B Pillar	3	6	▲	Header	2	2	∇	Upper Anchorage	0	0
+	A Pillar	1	2	#	Facia Top	1	2	■	Steering Wheel	3	7
	Side Other	1	3	O	Roof	2	3	◆	Head Restraint	0	3
	Side Roof Rail	1	3

Table 10 shows the results for all non-struck side occupants, (restrained and unrestrained). The specific points of contact on the vehicle structure for non-struck side occupants are shown on Figures 10-13.

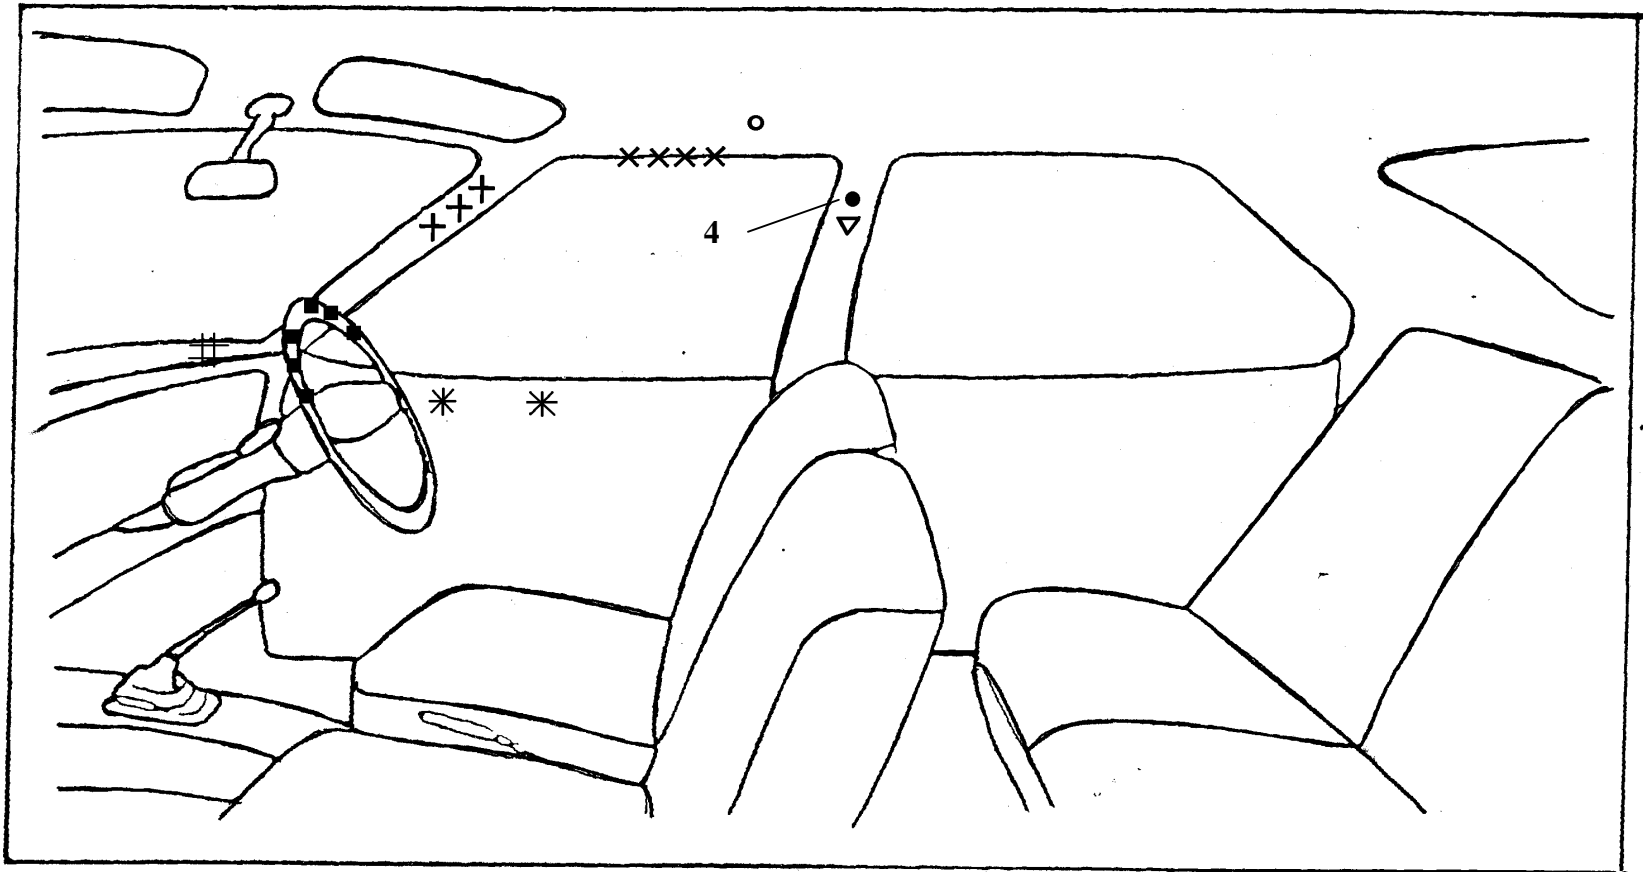
Figure 11: Graphical Representation of Frequent Head Contact Regions, Front Seat, Non-Struck Side Occupants - BAST Data

Key	Contact Region	Total in figure	Total no of contacts	Key	Contact Region	Total in figure	Total no of contacts	Key	Contact Region	Total in figure	Total no of contacts
●	B Pillar	4	4	▲	Header	0	0	▽	Upper Anchorage	1	1
+	A Pillar	3	3	#	Facia Top	1	1	■	Steering Wheel	6	6
	Side Other	2	2	O	Roof	1	1	◆	Head Restraint	0	2
	Side Roof Rail	4	4

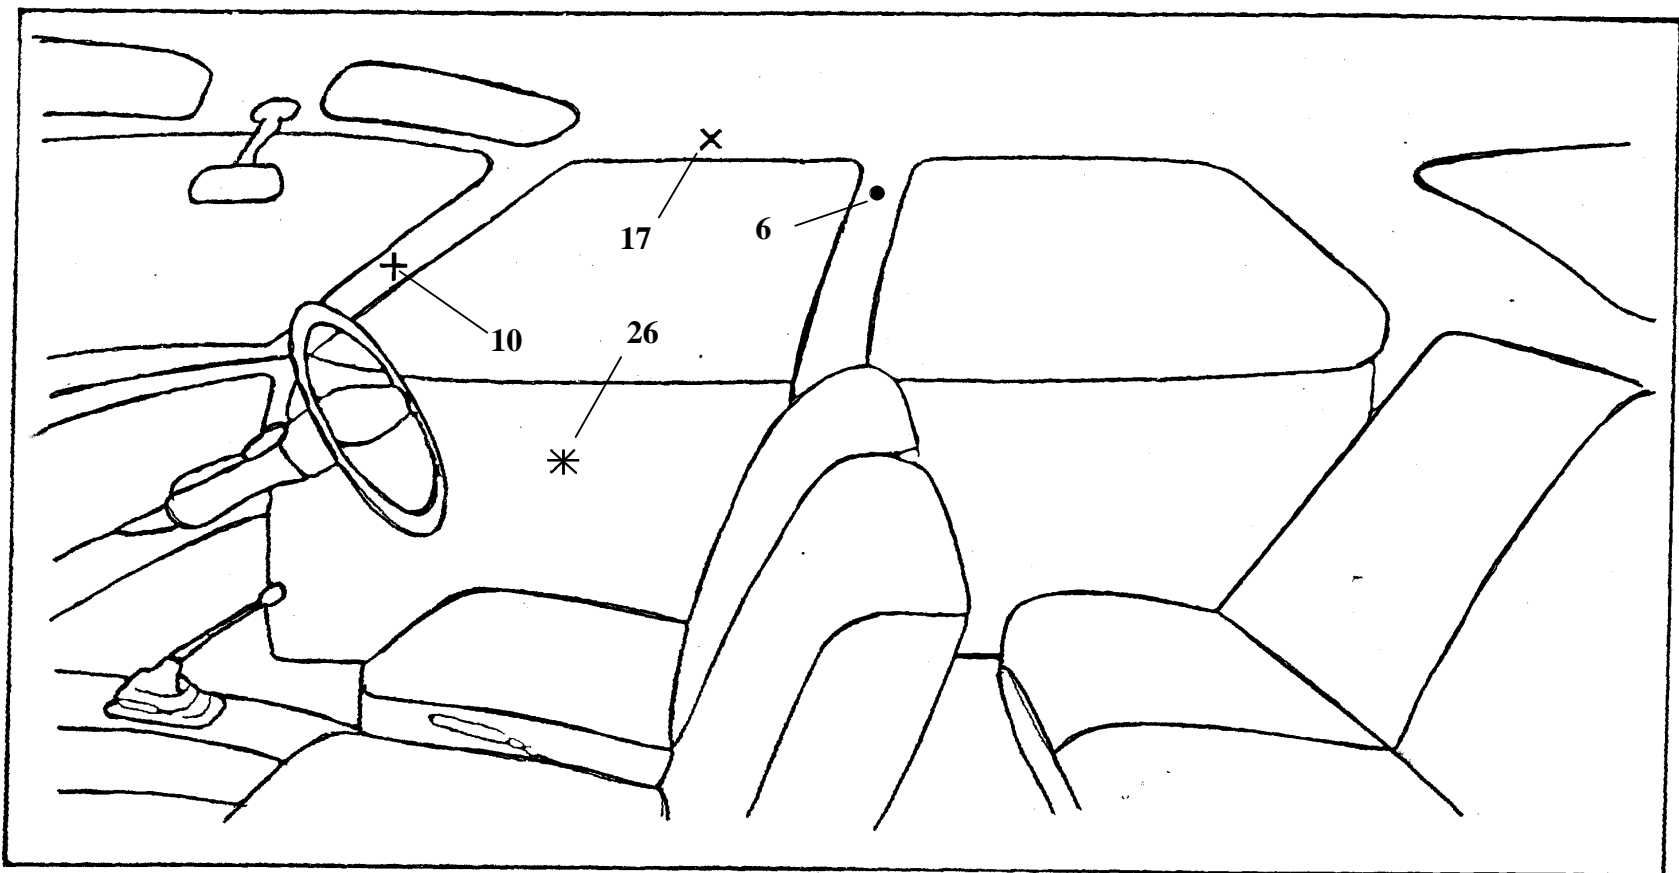
Figure 12 - Graphical Representation of Frequent Head Contact Regions, Front Seat, Non Struck Side Occupants - LAB Data

Key	Contact Region	Total in figure	Total no of contacts	Key	Contact Region	Total in figure	Total no of contacts	Key	Contact Region	Total in figure	Total no of contacts
●	B Pillar	127	27	▲	Header			∇	Upper Anchorage		
+	A Pillar	0	0	#	Facia Top			■	Steering Wheel		
	Side Other	26	26	O	Roof			◆	Head Restraint		
	Side Roof Rail	15	15

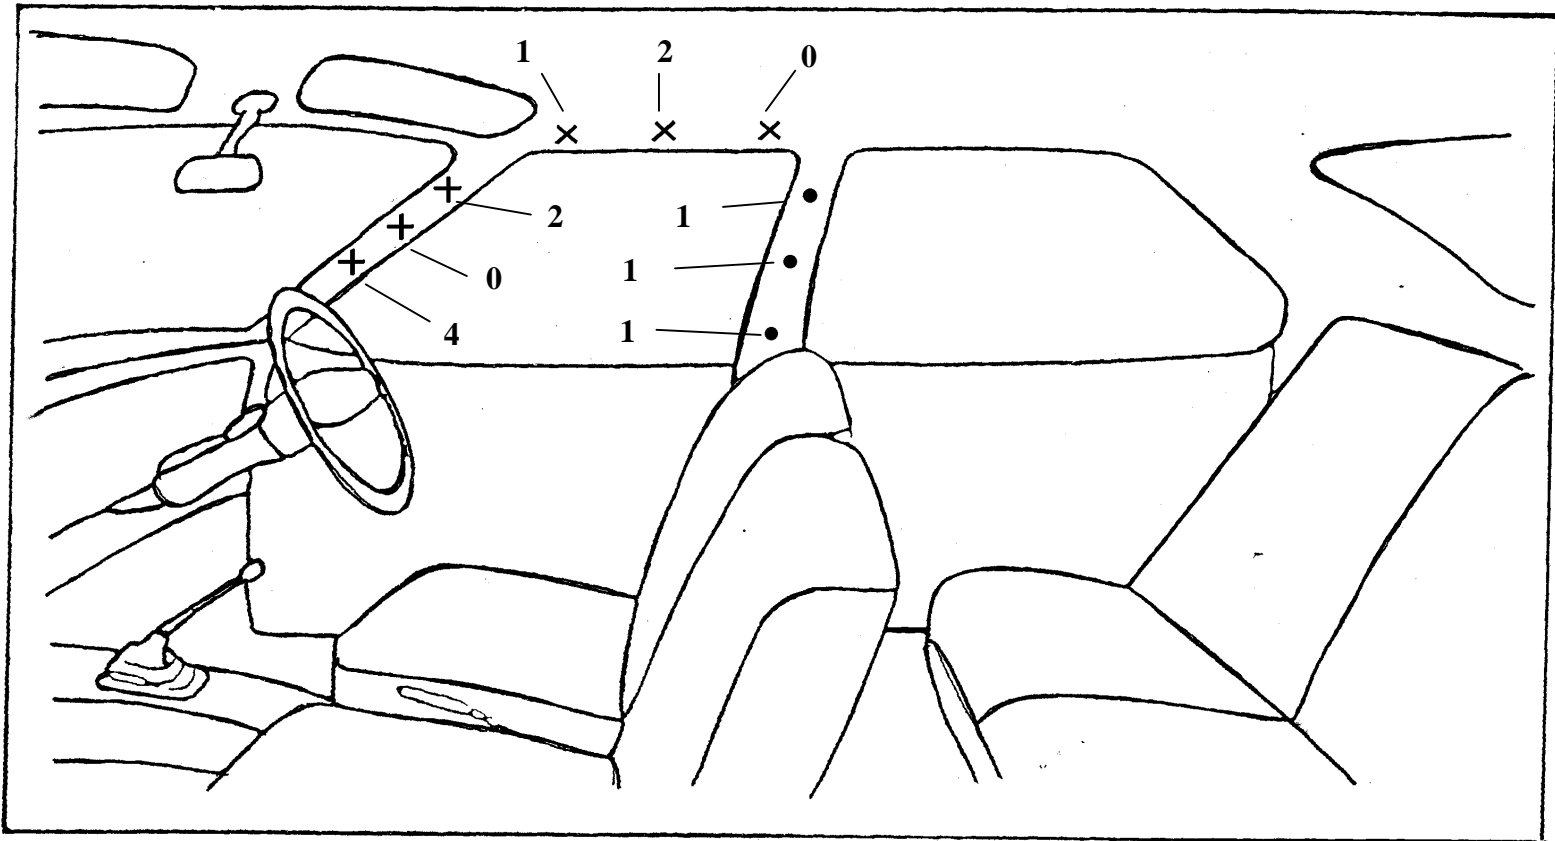
Figure 13 - Graphical Representation of Frequent Head Contact Regions, Front Seat, Struck Side Occupants - NHTSA Data

Key	Contact Region	Total in figure	Total no of contacts	Key	Contact Region	Total in figure	Total no of contacts	Key	Contact Region	Total in figure	Total no of contacts
●	B Pillar	3	8	▲	Header			∇	Upper Anchorage		
+	A Pillar	6	10	#	Facia Top			■	Steering Wheel		
	Side Other			O	Roof			◆	Head Restraint		
	Side Roof Rail	3	7

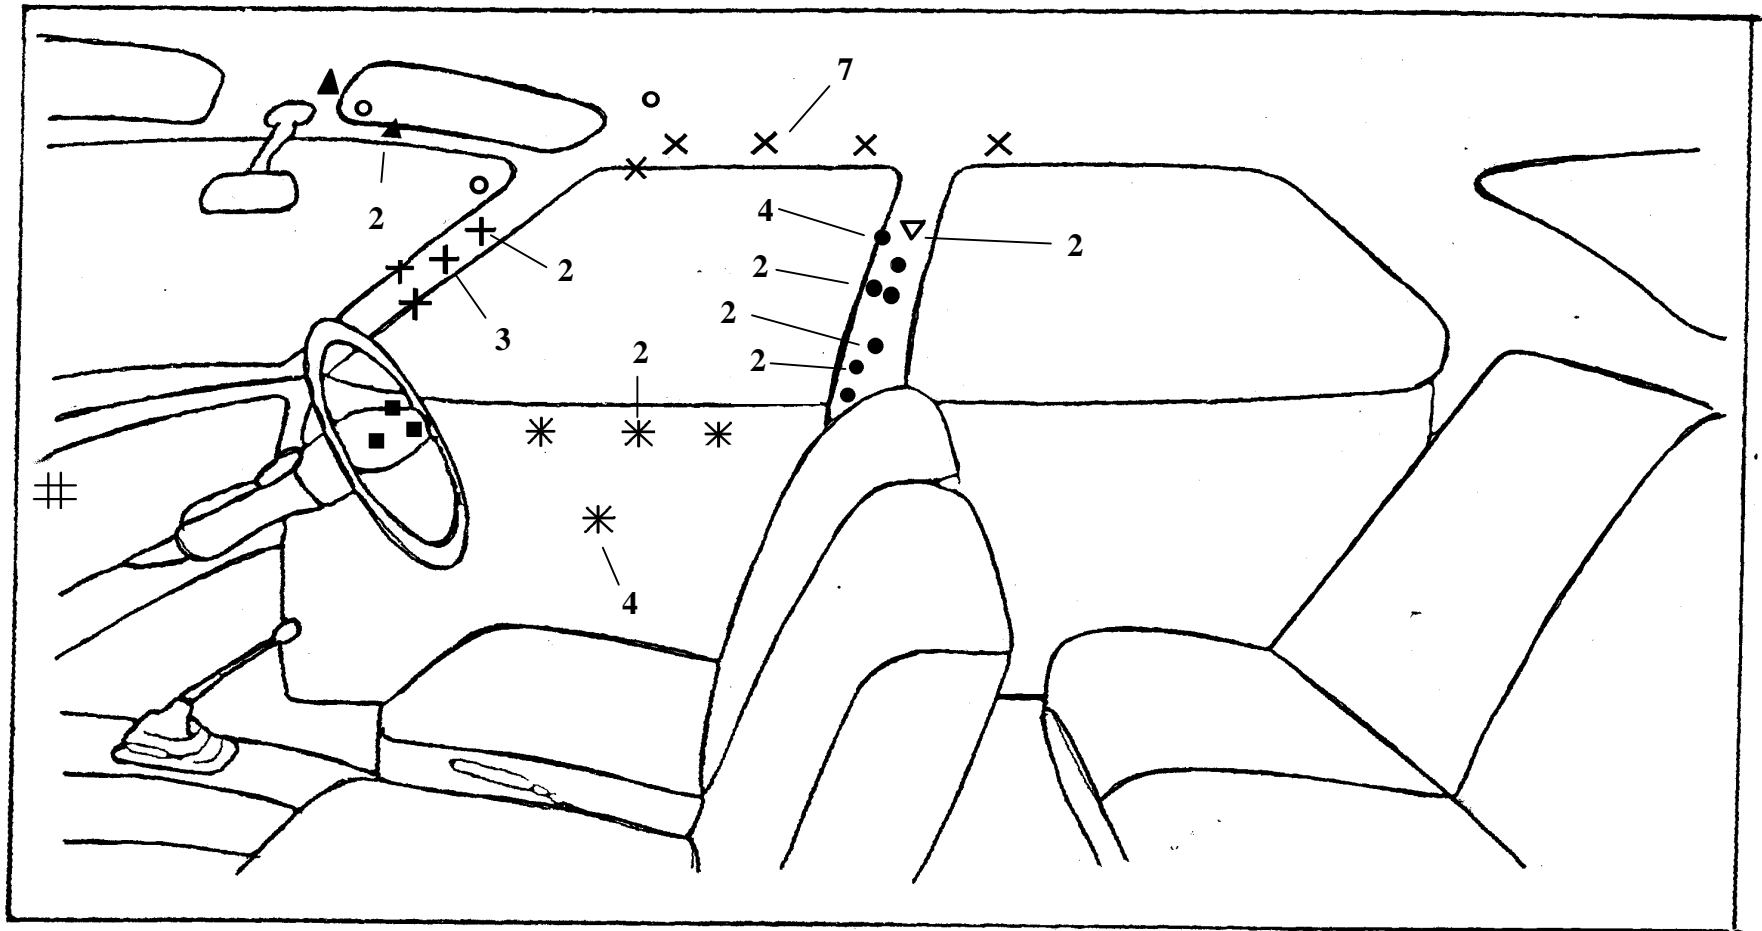
Figure 14 Graphical Representation of Frequent Head Contact Regions, All Front Seat Occupants - TRL Data

Key	Contact Region	Total in figure	Total no of contacts	Key	Contact Region	Total in figure	Total no of contacts	Key	Contact Region	Total in figure	Total no of contacts
●	B Pillar	13	24	▲	Header	3	3	▽	Upper Anchorage	2	2
+	A Pillar	7	11	#	Facia Top	1	3	■	Steering Wheel	3	10
	Side Other	8	16	O	Roof	3	6	◆	Head Restraint	0	5
	Side Roof Rail	11	15

Table 11 shows the combined results for all front seat occupants (restrained/unrestrained/unknown belt use, occupants on both the struck and non-struck sides). Figures 14-17 show head contact regions on the vehicle structure for all front seat occupants. Shaded areas denote contact site not recorded

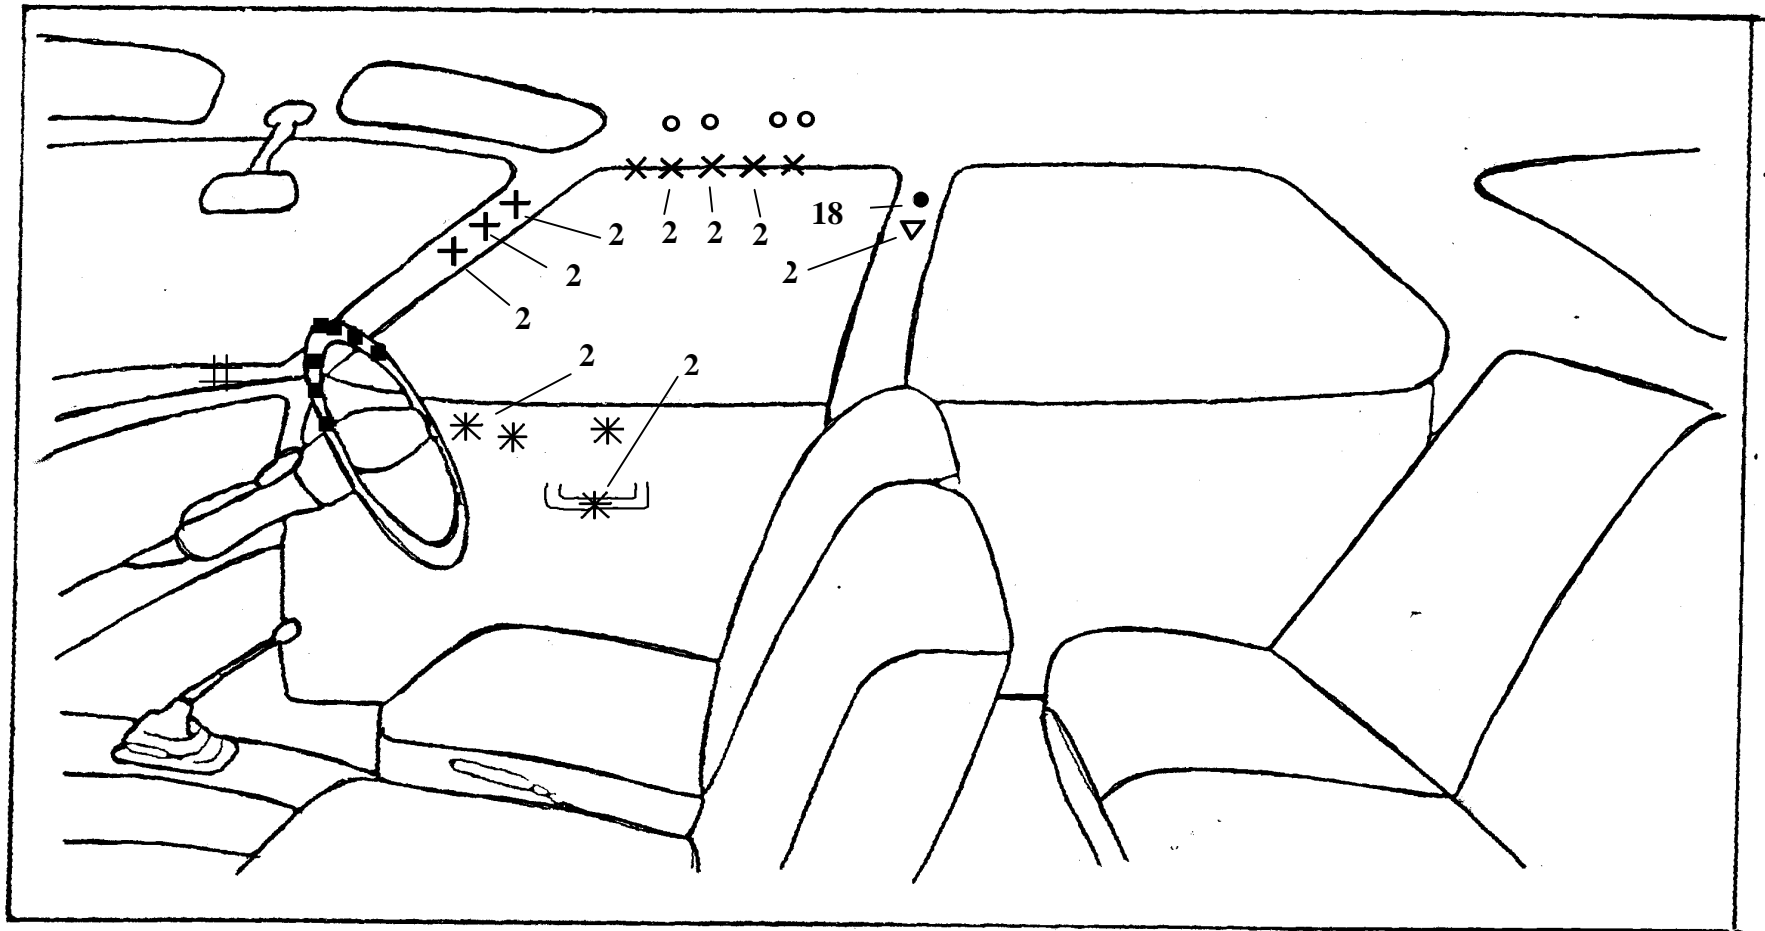
Figure 15 Graphical Representation of Frequent Head Contact Regions, All Front Seat Occupants - BAST Data

Key	Contact Region	Total in figure	Total no of contacts	Key	Contact Region	Total in figure	Total no of contacts	Key	Contact Region	Total in figure	Total no of contacts
●	B Pillar	18	18	▲	Header	0	0	▽	Upper Anchorage	2	2
+	A Pillar	6	6	#	Facia Top	0	0	■	Steering Wheel	1	7
	Side Other	8	16	O	Roof	4	4	◆	Head Restraint	0	2
	Side Roof Rail	8	8
