EUROPEAN ENHANCED VEHICLE-SAFETY COMMITTEE

**EEVC Working Group 13 Report.
Head Contacts In Side Impact - An Accident Analysis
February 2001**

Head Contacts In Side Impact - An Accident Analysis

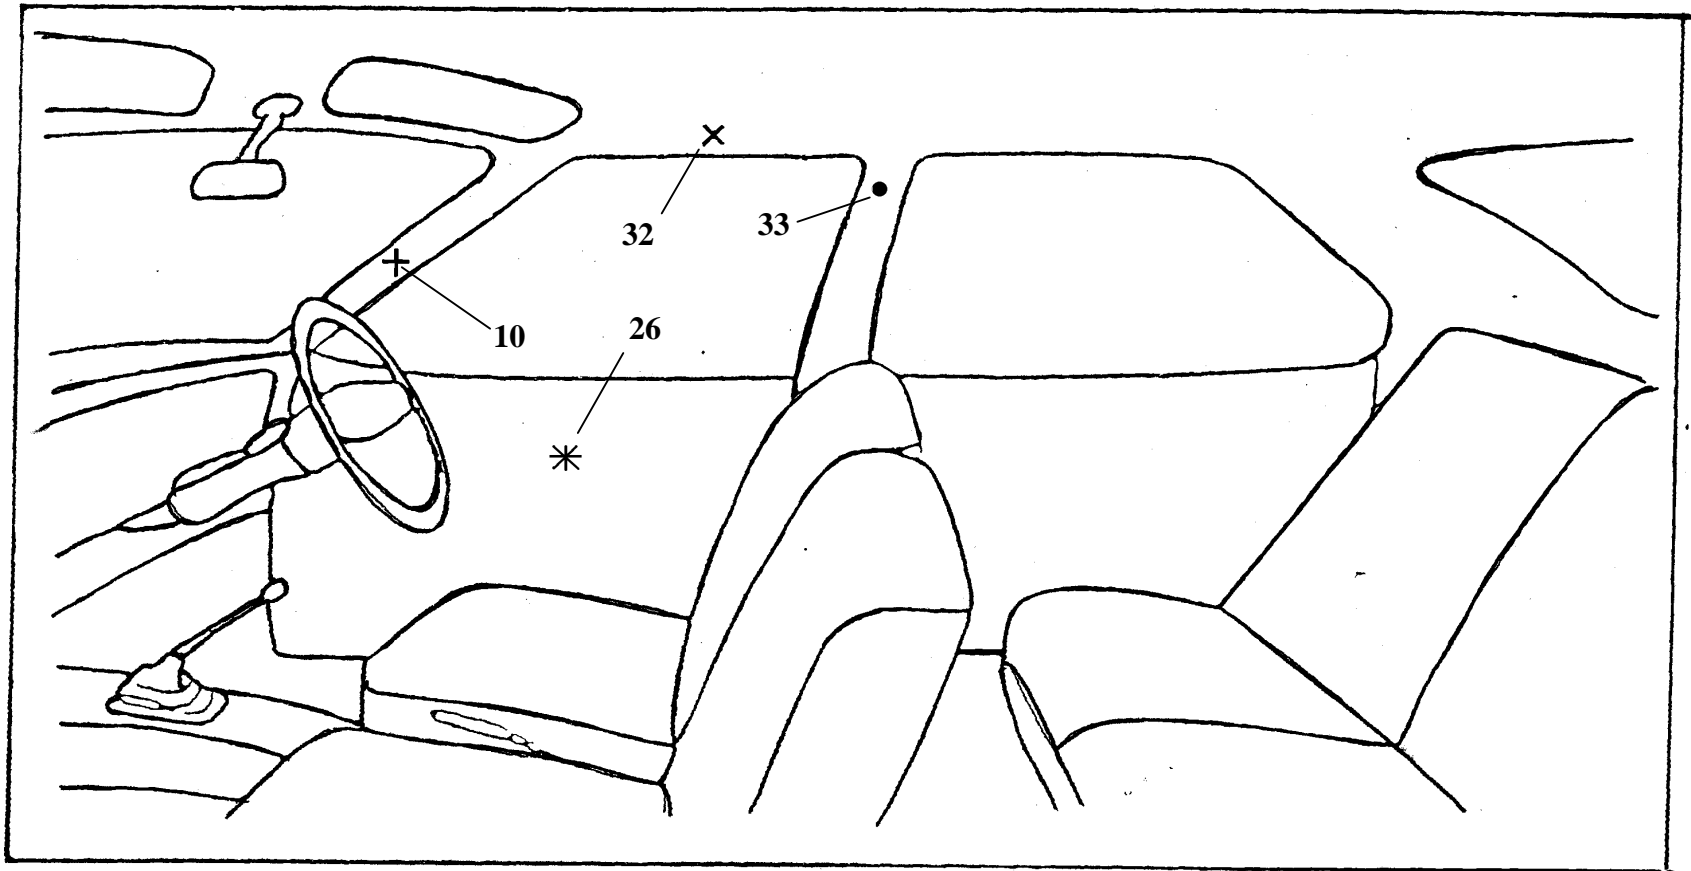
Figure 16 - Graphical Representation of Frequent Head Contact Regions, All Front Seat Occupants - LAB Data

Key	Contact Region	Total in figure	Total no of contacts	Key	Contact Region	Total in figure	Total no of contacts	Key	Contact Region	Total in figure	Total no of contacts
●	B Pillar	127	27	▲	Header			∇	Upper Anchorage		
+	A Pillar	0	0	#	Facia Top			■	Steering Wheel		
	Side Other	26	26	O	Roof			◆	Head Restraint		
	Side Roof Rail	15	15

Table 11 shows the combined results for all front seat occupants (restrained/unrestrained/unknown belt use, occupants on both the struck and non-struck sides). Figures 14-17 show head contact regions on the vehicle structure for all front seat occupants. Shaded areas denote contact site not recorded

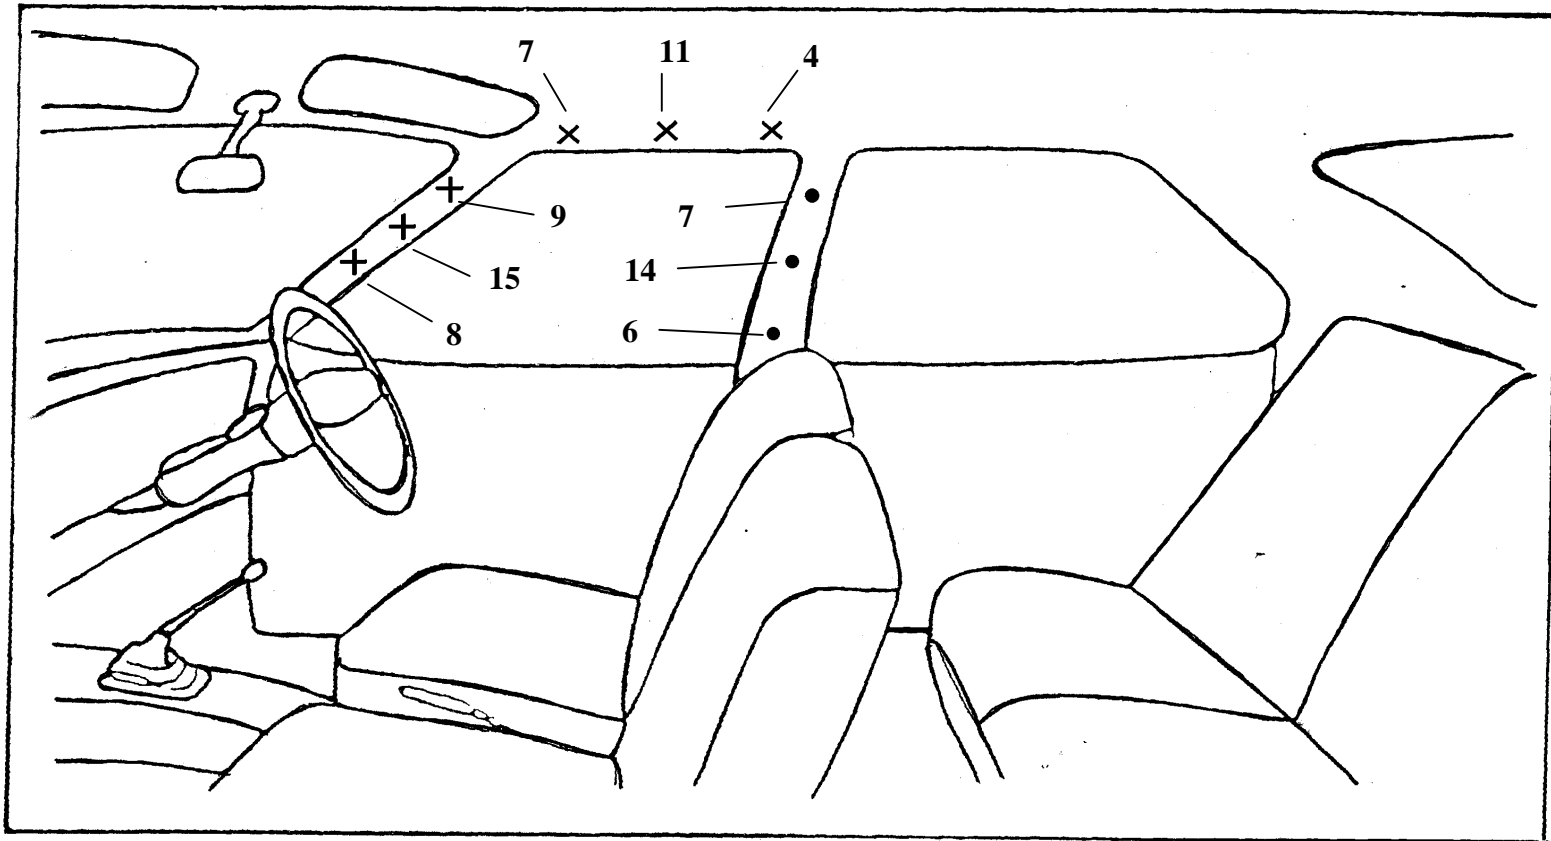
Figure 17 - Graphical Representation of Frequent Head Contact Regions, All Front Seat Occupants - NHTSA Data

Key	Contact Region	Total in figure	Total no of contacts	Key	Contact Region	Total in figure	Total no of contacts	Key	Contact Region	Total in figure	Total no of contacts
●	B Pillar	27	64	▲	Header			∇	Upper Anchorage		
+	A Pillar	32	50	#	Facia Top			■	Steering Wheel		
	Side Other			O	Roof			◆	Head Restraint		
	Side Roof Rail	22	46

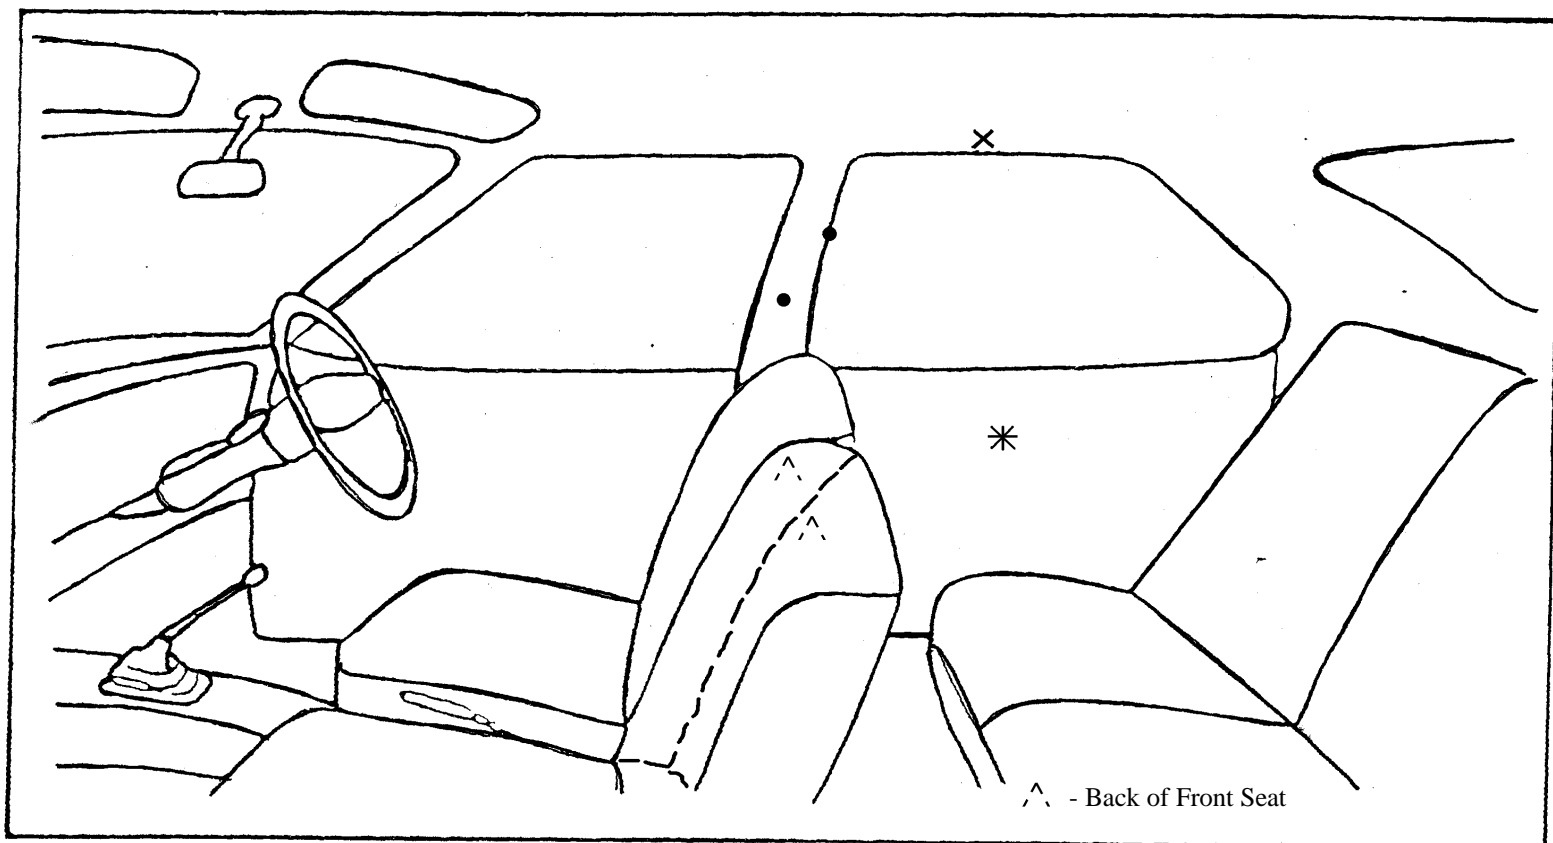
Figure 18 - Graphical Representation of Frequent Head Contact Regions, All Rear Seat Occupants - TRL Data

Key	Contact Region	Total in figure	Total no of contacts	Key	Contact Region	Total in figure	Total no of contacts
●	B Pillar	2	2	▲	Seat	2	7
	Side Other	1	1	◆	Head Restraint	0	1
	Side Roof Rail	1	3	ÿ	C Pillar	0	0

The results for all rear seat occupants are shown in Table 26. The specific points of contact on the vehicle structure are shown in figures 18-20.

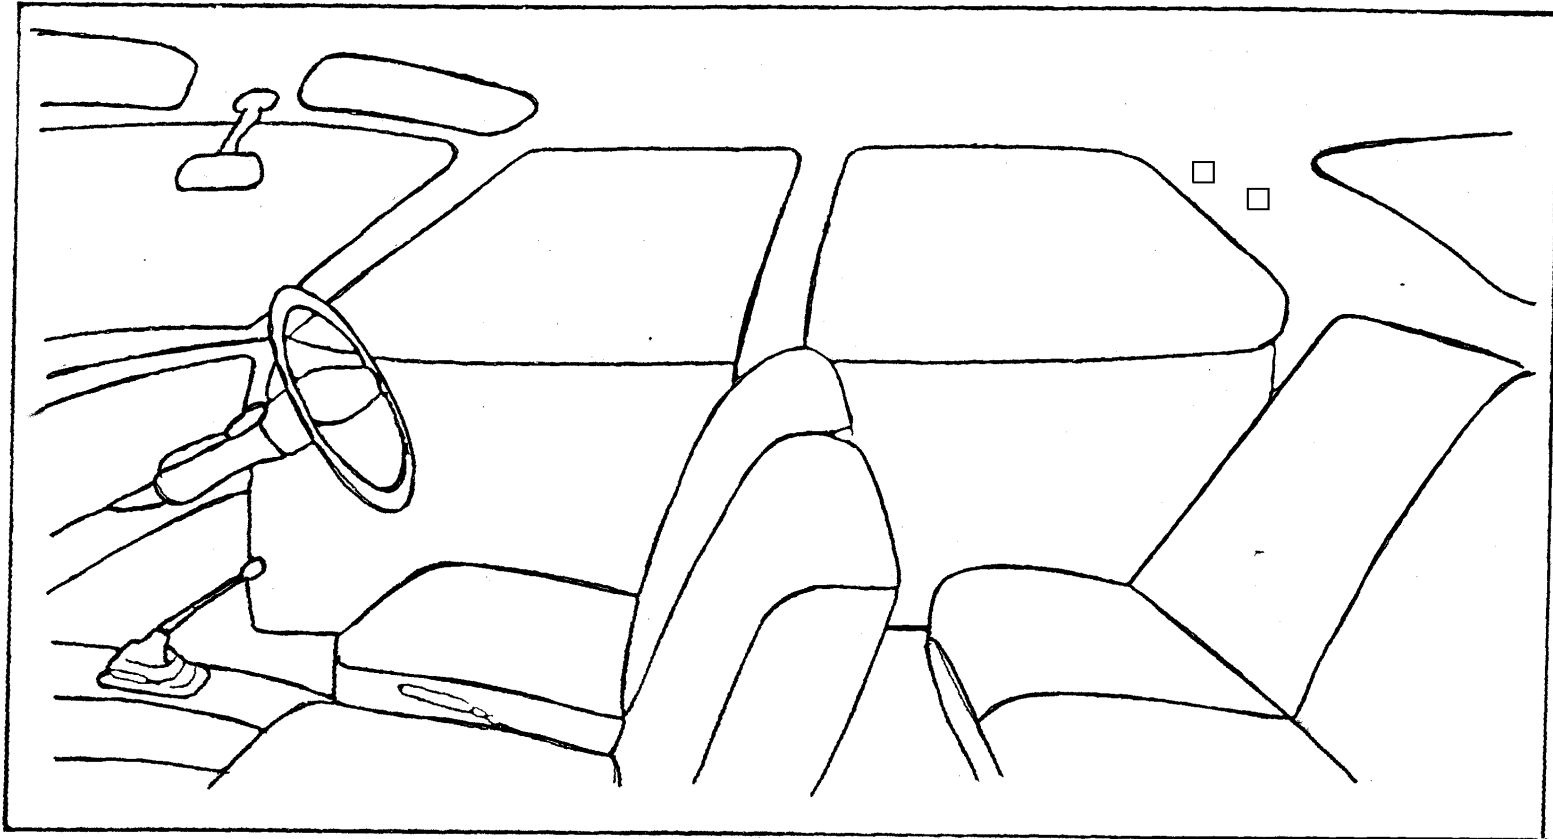
Figure 19 - Graphical Representation of Frequent Head Contact Regions, All Rear Seat Occupants - BASt Data

Key	Contact Region	Total in figure	Total no of contacts	Key	Contact Region	Total in figure	Total no of contacts
●	B Pillar	0	0	^	Seat	0	0
	Side Other	0	0	◆	Head Restraint	0	1
	Side Roof Rail	0	0	ÿ	C Pillar	2	2

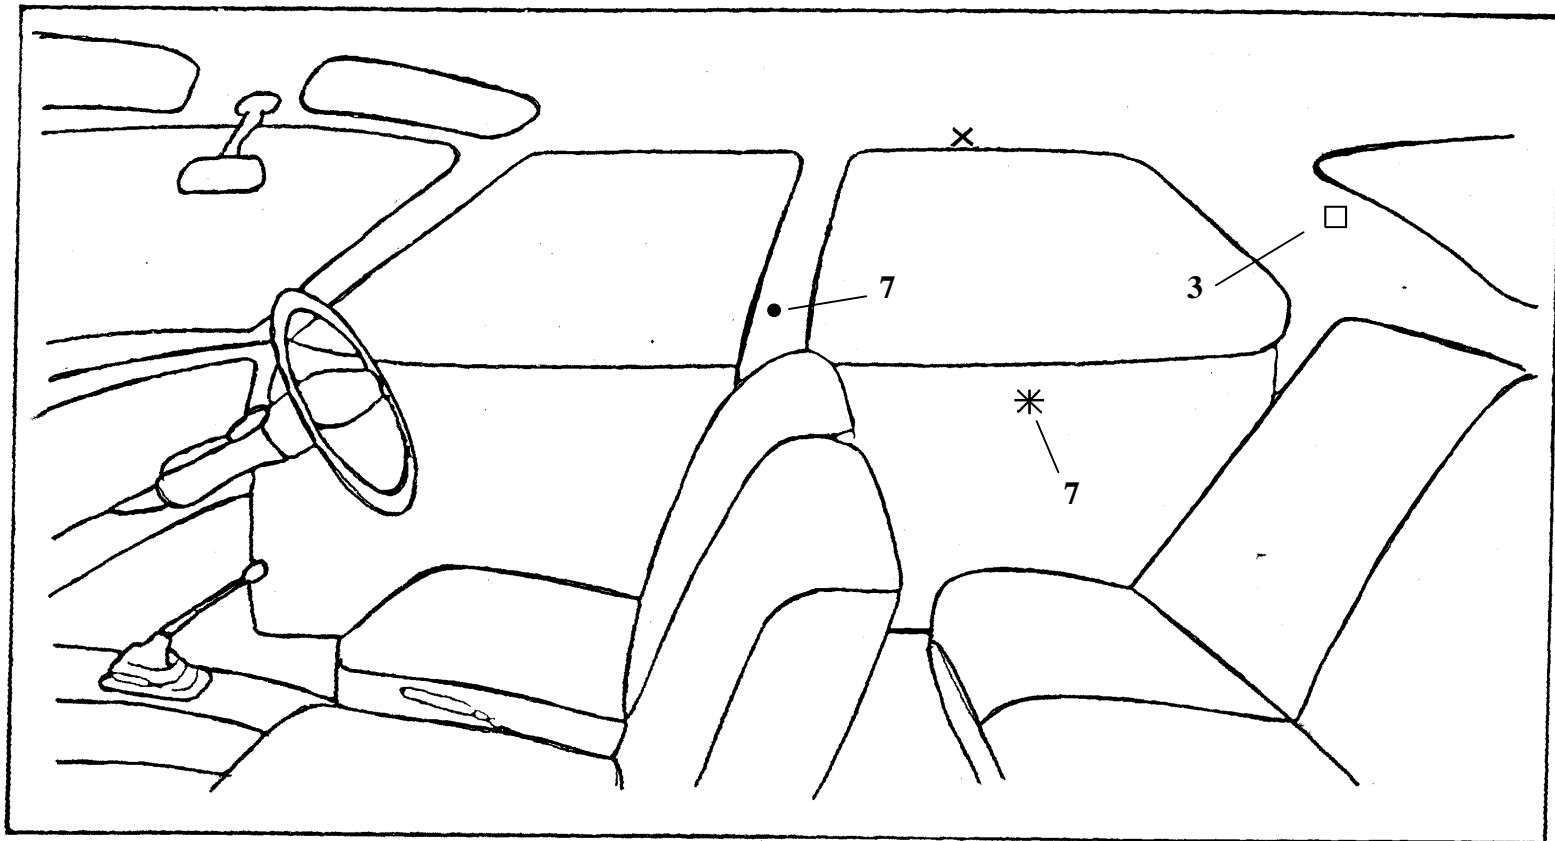
Figure 20 - Graphical Representation of Frequent Head Contact Regions, All Rear Seat Occupants - LAB Data

Key	Contact Region	Total in figure	Total no of contacts	Key	Contact Region	Total in figure	Total no of contacts
●	B Pillar	7	7	▲	Seat		
	Side Other	7	7	◆	Head Restraint		
	Side Roof Rail	1	1	ÿ	C Pillar	7	7
