A STUDY TO IMPROVE THE CRASH COMPATIBILITY BETWEEN CARS IN FRONTAL IMPACT

Final Report by

Mervyn Edwards – Consortium Manager
Transport Research Laboratory

Report to the

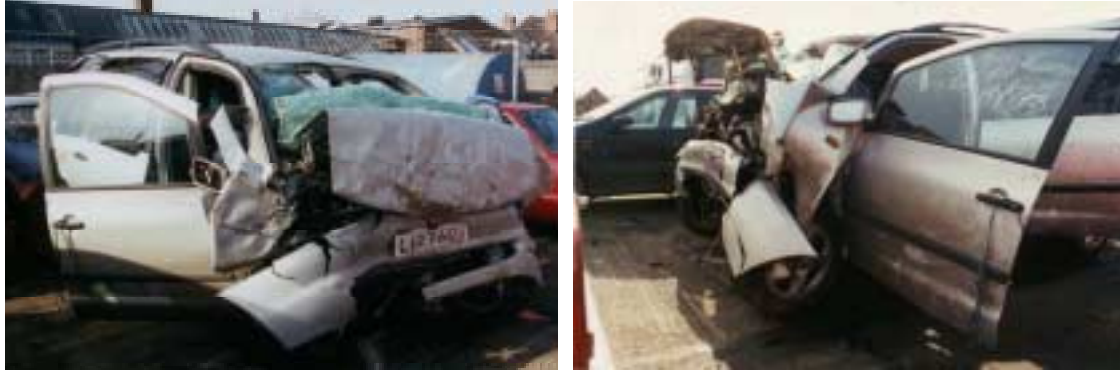
The front and side views of the vehicle (Figure 2) show that the frontal structure has deformed substantially over its entire width, thereby absorbing a significant amount of the impact energy. Good structural interaction with the solid bridge parapet has led to homogeneous deformation of the frontal structure. This, in combination with the width of the impact, has enabled the energy absorbing structures, such as the lower rails,

Figure 2: Seat Alhambra showing homogeneous deformation of frontal structure

to absorb a large proportion of the impact energy. This has ensured that less of the impact energy has been absorbed by the occupant compartment. This has resulted in a relatively small compartment intrusion for the high impact severity.

The intrusion on the offside was similar at the three recorded facia and footwell levels, with values in the region of 340mm to 430mm (Table 1). There was less intrusion on the nearside.

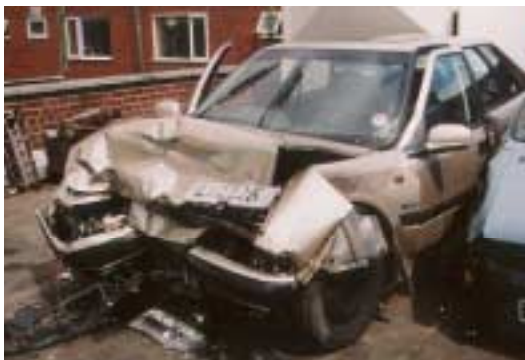
Figure 3: Daewoo Espero

The greatest deformation on the Daewoo is between the longitudinals (Figure 3). The front of the Mazda has a fairly uniform deformation over the area of direct damage on the nearside (Figure 4). The deformation of the Daewoo is a result of direct contact between the nearside longitudinal of the Mazda and the less stiff structure between the longitudinals of the Daewoo.

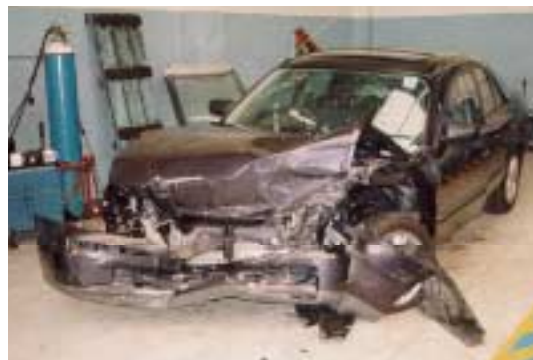
Figure 4: Mazda 626

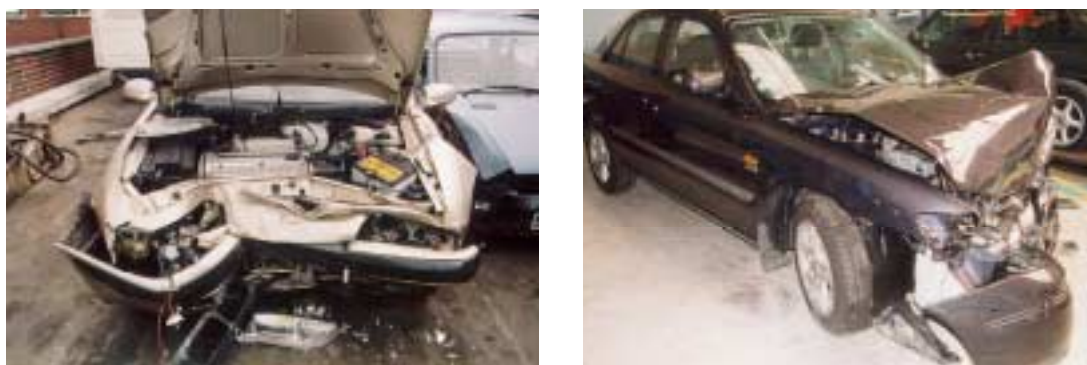
Figure 5: Comparison of the damage profiles of the Daewoo and Mazda, showing deformation of less stiff structure between longitudinals on the Daewoo

This case has been included as an example of lateral misalignment resulting in the “fork effect”. A large proportion of the injuries sustained by the occupants of both vehicles were deceleration injuries from the seat belts. These injuries may have been influenced by the deceleration pulse of this collision. There may have been an initially soft pulse that stiffened towards the end of the collision. This may have been caused by the initial deformation of the less stiff sections of the Daewoo, followed by direct contact between the engine and the Mazda longitudinal (Figure 5).

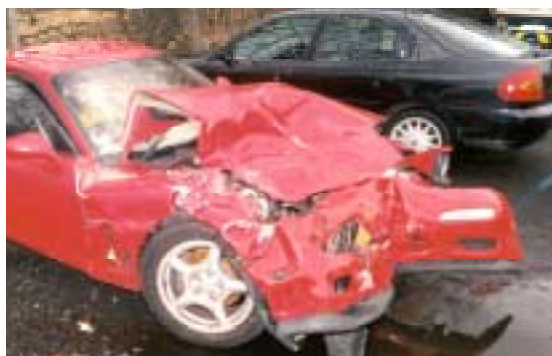
Figure 6: Mazda RX7

problems. This can be illustrated by an accident case involving a Mazda RX7 and a Land Rover Discovery (Figure 6 & Figure 7).

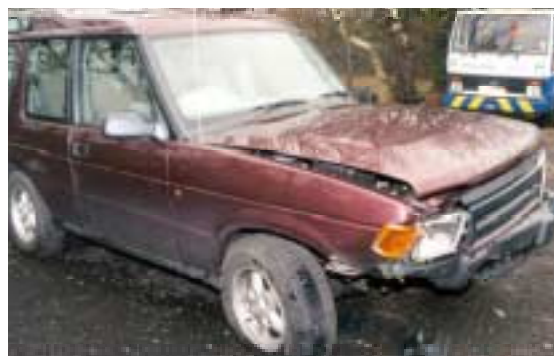
Figure 7: Land Rover Discovery

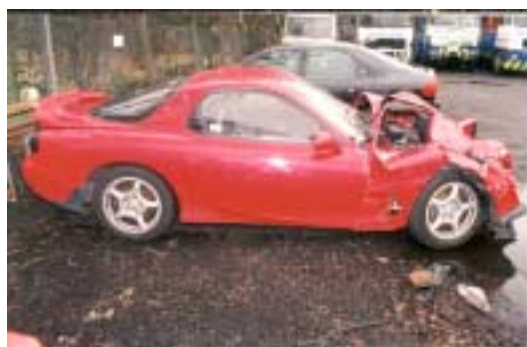
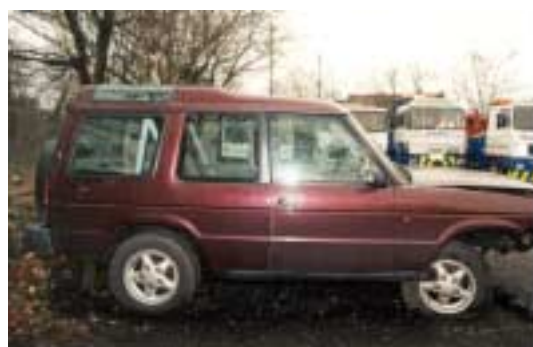
Figure 8: Comparison of the damage profiles of the Mazda and Discovery, showing the difference in the height where direct contact has occurred

There was a significant difference in the damage profiles sustained by the two vehicles (Figure 8). The Mazda has the most deformation at bonnet level, and at the top of the wing. This is significantly higher than the main frontal structure, which has been largely unaffected. The Discovery has less severe deformation, with damage to the lower levels of the front of the vehicle below the main structure. The Discovery's offside road wheel has been directly loaded and displaced rearwards. The main interaction between the vehicles has been from contact of the Discovery's offside road wheel and the Mazda's bumper beam.

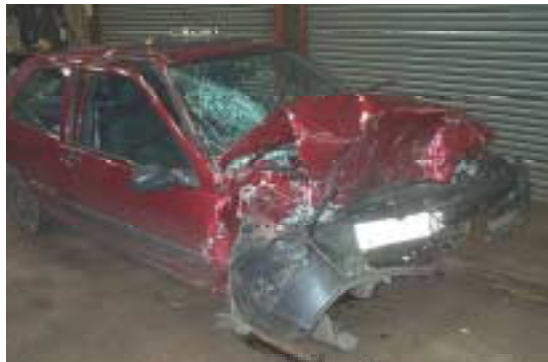
Figure 9: Renault Clio

Static vertical misalignment is not restricted to collisions between vehicles of different size, such as cars and SUVs. Slight differences in the structural height of different makes and models of cars can have a similar effect. This can be seen in the case of a head-on collision between a Renault Clio and a Ford Focus (Figure 9 & Figure 10).

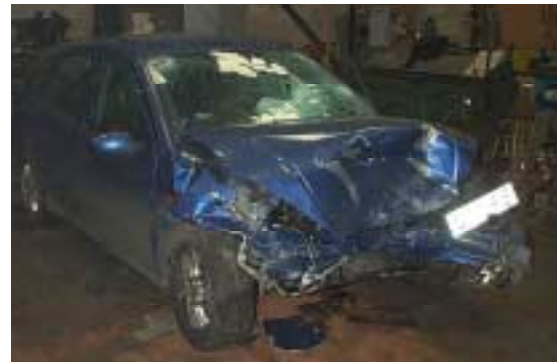
Figure 10: Ford Focus

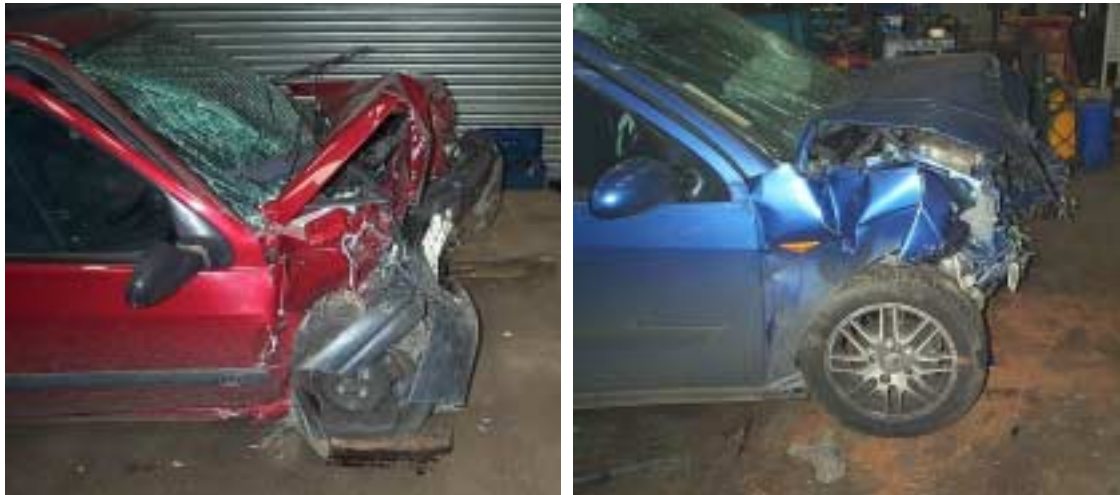
Figure 11: Comparison of the damage profiles of the Clio and Focus, showing that the Clio has been overridden

On the Focus the upper rail has not deformed so significantly. It has deformed, but not to the extent that can be seen in the Clio. The main longitudinals of the Focus have deformed more in this case. The front of the vehicle appears to have been pushed upwards. The offside road wheel has also displaced rearwards slightly.

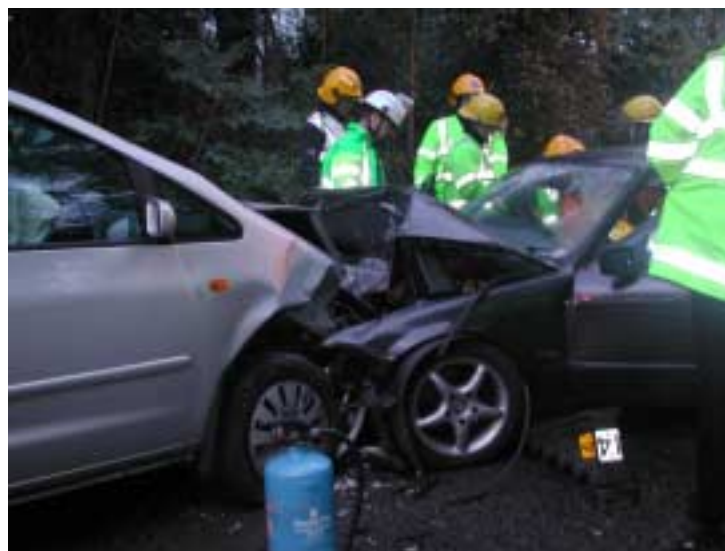
Figure 12: BMW v Sharan Accident Scene

A further example of static vertical misalignment can be seen in the collision between a BMW 3-series and a Volkswagen Sharan (Figure 12). The case was taken from a different data set, the OTS (On The Spot) accident investigation project, and does not form part of the CCIS database. The reason for including this case was that it is a particularly good example which illustrates the under/override problem caused by static vertical misalignment of the main vehicle structures.

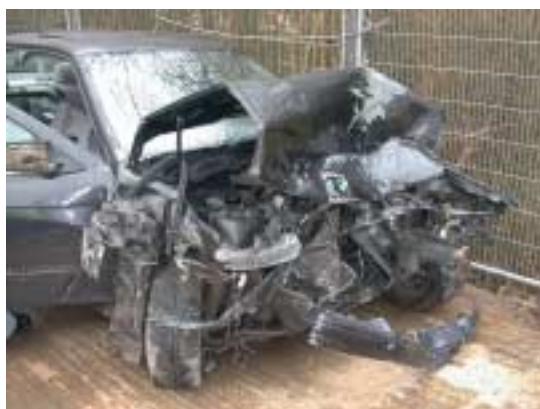
Figure 13: BMW 3-series

Comparison of the two vehicles shows that there was a significant difference in the damage sustained (Figure 13 & Figure 14). The longitudinals and bumper beam on the BMW were protruding from the front of the vehicle. The bumper beam was only attached to the offside longitudinal, having come away on the nearside. The longitudinals were mostly undamaged, although the offside had been bent downwards slightly. The rest of the front of the vehicle had been crushed back to a large extent.

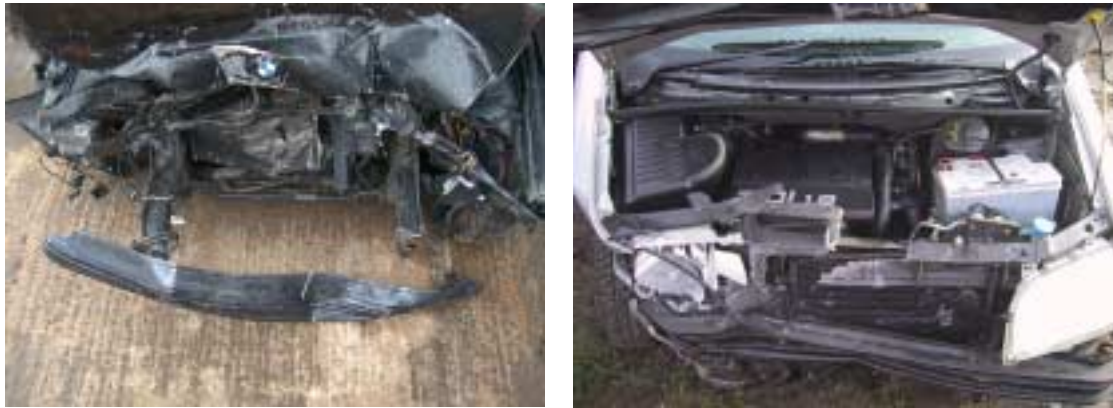
Figure 15: Comparison of damage to BMW and Sharan, showing lack of energy absorption in the frontal structures

The main structures of both vehicles have not absorbed much energy in this collision (Figure 15). The longitudinals on the BMW have been overridden by those on the Sharan. This has led to direct loading of the less stiff areas of the BMW by the stiff structure of the Sharan. The longitudinals of the BMW have gone under the Sharan, where there does not appear to be any significant part of the vehicle to contact.

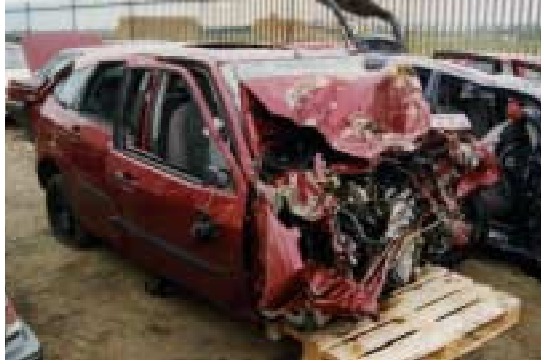
Figure 16: First Ford Focus

A Ford Focus collided head-on with another Ford Focus, the impact having an overlap of 100 percent (Figure 16 & Figure 17). As a result of the collision the first Focus spun and performed a half roll, coming to rest on its roof. The calculated values for Delta-V were 89km/h and 82km/h for the first and second Focus respectively. Both vehicles were fitted with steering wheel airbags.

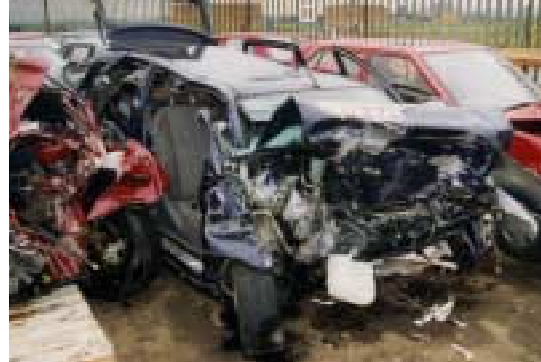
Figure 17: Second Ford Focus

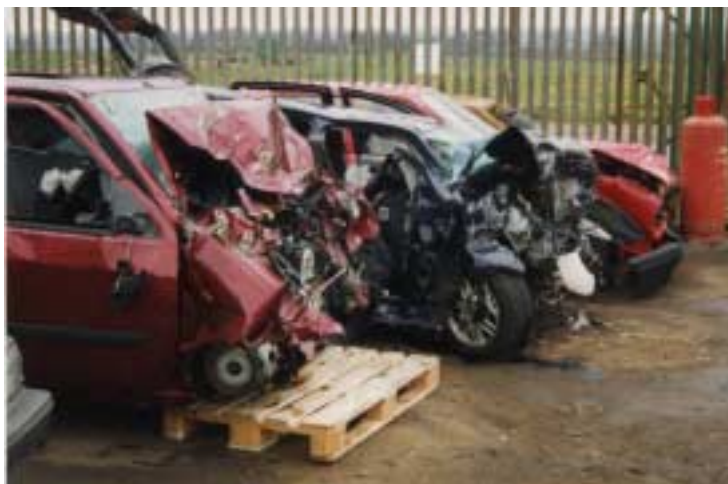
Figure 18: Comparison of front profiles of the two Focuses, showing that the first Focus (left) has been overridden

Examination of the photographic evidence reveals a difference in the damage profiles of the two vehicles (Figure 18). The bumper beam of the first Focus has been folded backwards over itself. The longitudinals appear to have been bent downwards. The bumper beam of the second Focus appears to have displaced directly rearwards, suggesting more axial deformation of the longitudinals. This difference shows the different failure mechanisms of the main structures for the two vehicles.

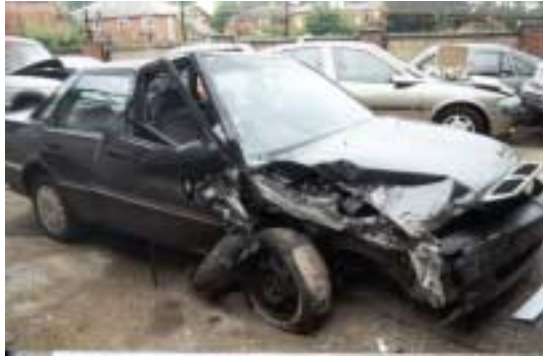
Figure 19: Rover 416

A frontal impact occurred between a Rover 416 and a Nissan Micra (Figure 19 & Figure 20). The overlap was approximately 20 percent. The collision occurred at low speed, Delta-V calculated for the Rover and Micra of 12km/h and 15km/h, respectively. The impact was severe enough for the steering wheel airbag to fire in the Rover. The Micra was not fitted with an airbag.

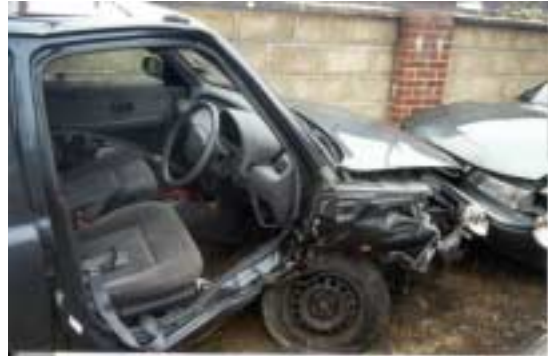
Figure 20: Nissan Micra

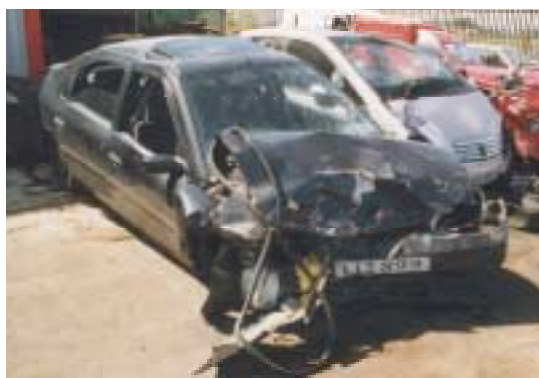
Figure 21: Ford Mondeo

A Ford Mondeo had a frontal collision with a Ford Fiesta, the vehicles impacting offside to offside with an overlap of approximately 40 percent (Figure 21 & Figure 22). As a result of the collision the Fiesta performed a half roll, coming to rest on its roof. There was a significant difference in the calculated values for Delta-V, which were 45km/h and 89km/h for the Mondeo and Fiesta respectively. There was also a large mass difference between the two vehicles. The Mondeo had a mass of 1613kg and the Fiesta had a mass of 822kg, giving a mass ratio of 1.96. The Mondeo was fitted with a steering wheel airbag. There were no airbags in the Fiesta.

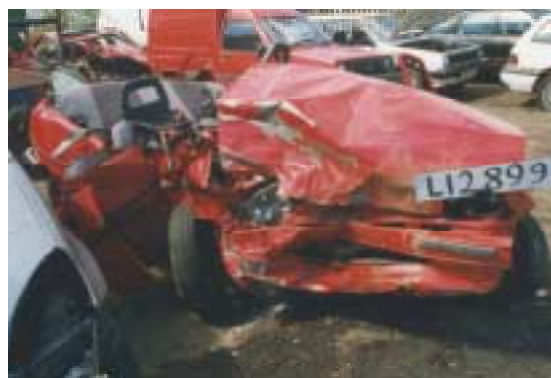
Figure 22: Ford Fiesta

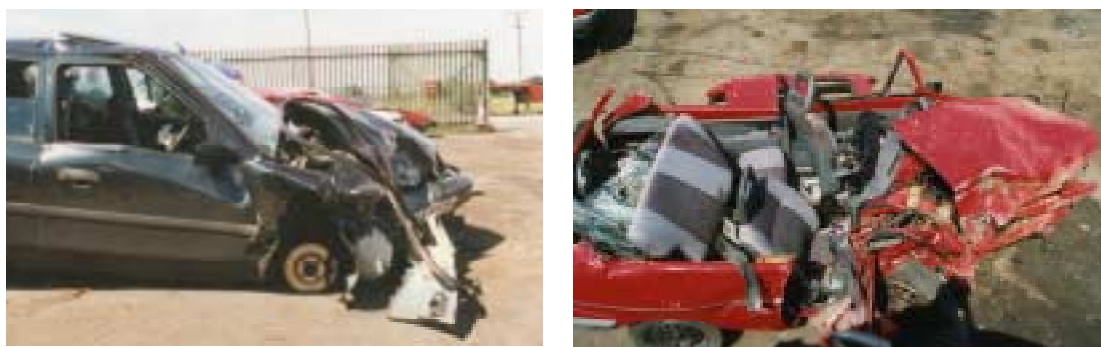
Figure 23: Comparison of vehicle damage for Mondeo and Fiesta, showing that the Fiesta has been overcrushed

The damage sustained by the two vehicles indicates that this was a very severe impact. The frontal structure of the Mondeo has crushed significantly. There is also slight deformation of the door aperture, with buckling of the roof above the B-pillar. The driver's door is slightly buckled, and appears to be jammed in compression. The damage sustained by the Fiesta is much greater than the Mondeo. The offside structure appears to have completely crushed, and the offside sill has also deformed to a large extent. The overhead view of the car shows the full extent of the crush when compared with the nearside, which was not contacted (Figure 23). Both vehicles also exhibit slightly greater deformation between the longitudinals.

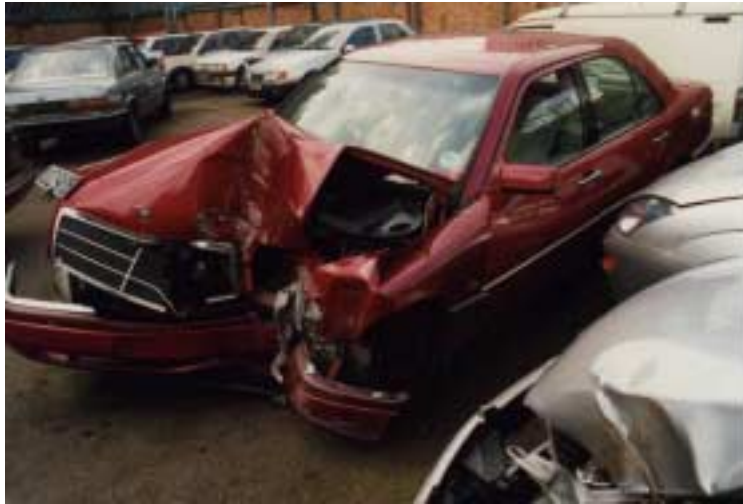
Figure 24: Mercedes C-180 showing narrow impact between longitudinals

A Mercedes C-180 had a frontal collision with a bollard and signpost (Figure 24). The main impact was between the longitudinals, on the nearside front of the car. There was a secondary impact to the nearside wing, but this appears to be minor. 27 percent of the vehicle width was directly damaged by the impact. The calculated value for ETS was 43km/h. The vehicle was fitted with a steering wheel airbag.

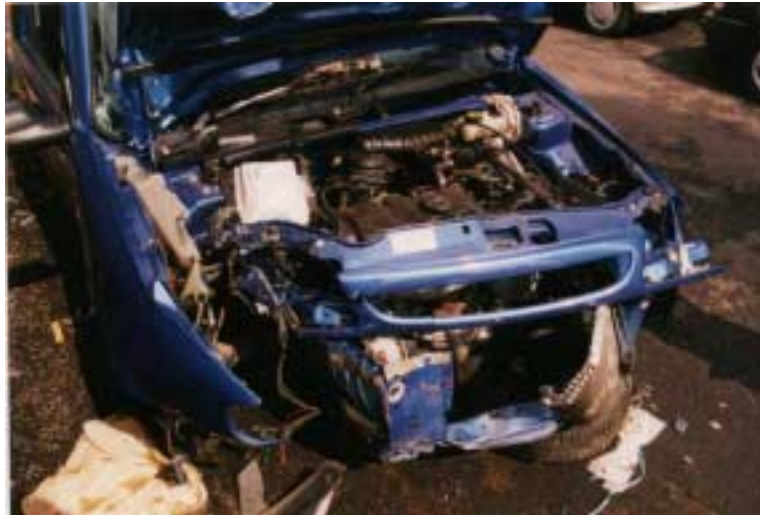
Figure 25: Citroen Saxo showing impact between upper and lower rails

A Citroen Saxo was involved in a frontal collision with a bollard and lamppost. The impact was outside the main longitudinal on the offside. The values for Delta-V and ETS were unable to be calculated. The vehicle sustained 13 percent direct damage from the impact.

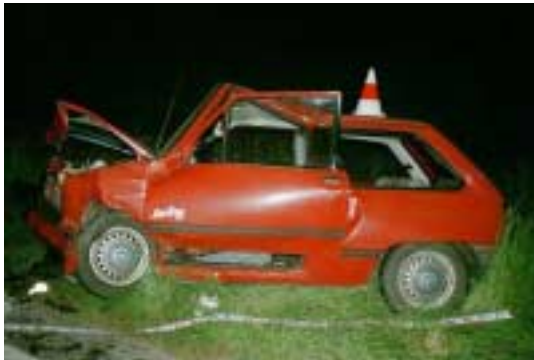
Figure 26: Opel Corsa

The accident reconstruction came to the conclusion that the collision speed was 49 km/h for the Porsche and 38 km/h for the Opel Corsa. Figure 26 and Figure 27 show the final position of the vehicles after the accident.

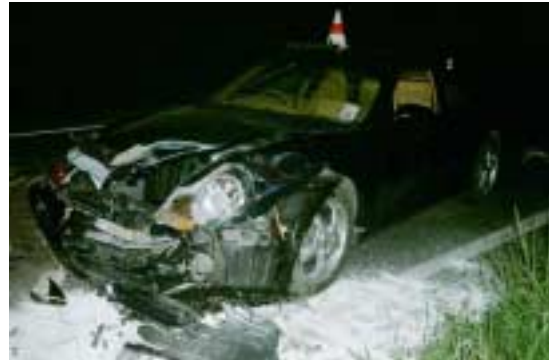
Figure 27: Porsche Carrera

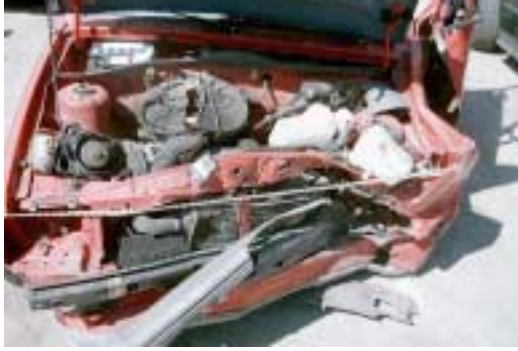
Figure 28: Front Deformation Opel

The resulting deformation of the front ends are shown in Figure 28 and Figure 29. The percentage of deformation according to the Vehicle Deformation Index VDI are 7% for the Porsche and 34% for the Corsa.

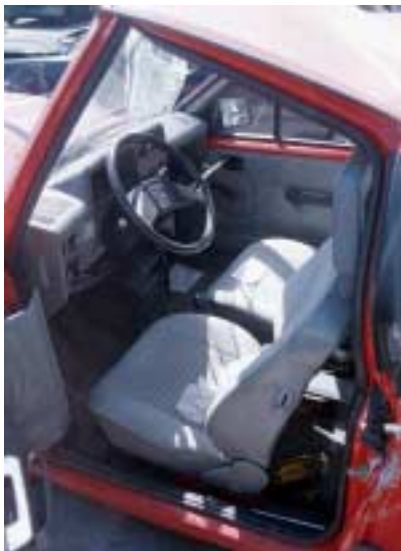
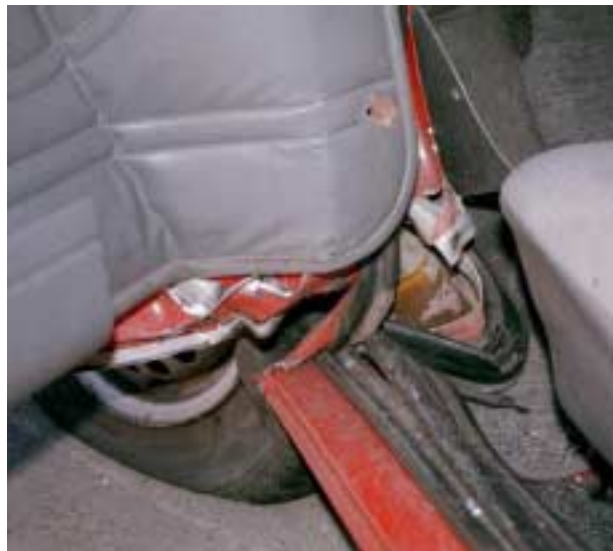
Figure 30: Deformation of the Passenger Compartment of the Corsa

Beside this other kinds of incompatibilities can be observed in this accident. Figure 5 illustrates the deformation of the passenger compartment of the Corsa. There was a footwell rupture as well as a folding of the left door sill. This is caused by vertical misalignment of the longitudinals, which leads to some overriding by the Corsa.

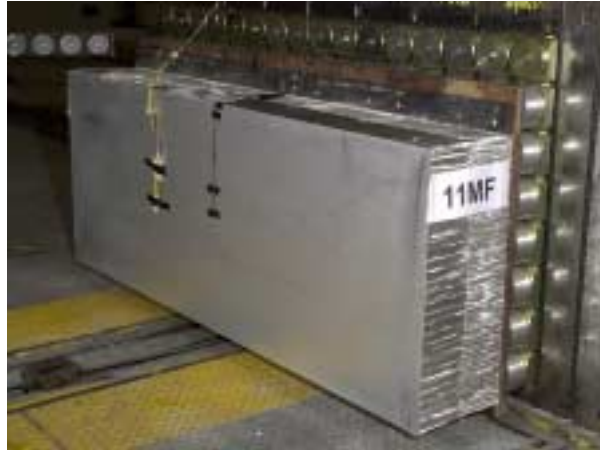
The Ford Mondeo was impacted into an aluminium honeycomb barrier of size 2m x 0.75m x 0.30m and a crush strength of 0.34MPa for the first 150mm and 1.71MPa thereafter, mounted onto a high resolution load cell wall (Figure 33).

Figure 33: Development full width test barrier mounted onto load cell wall.

The load cell wall was formed of 128 load cells of 125mm x 125mm arranged in a 16 x 8 matrix and mounted 50mm from the ground. The deformable barrier covered the lower 6 rows of the load cell wall.

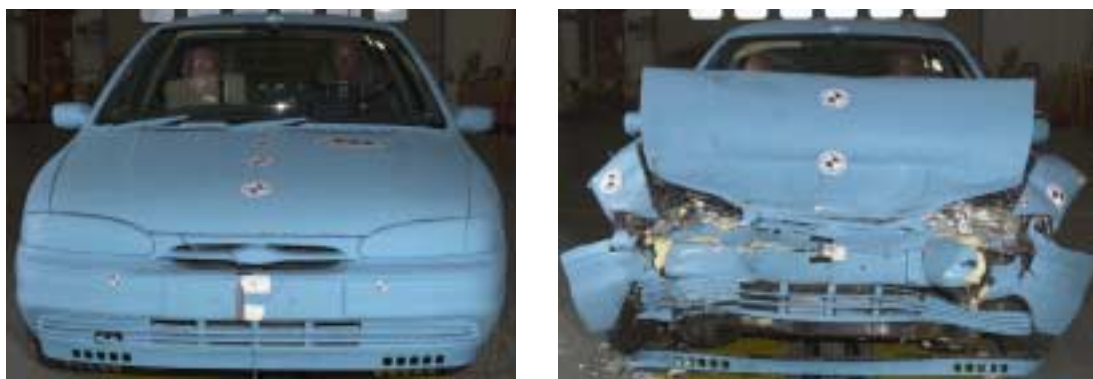
Figure 35: Pre and post test front view of test vehicle.

The test speed and overlap were within the specified tolerances. Pre and post test images of the test vehicle are shown (Figure 34 and Figure 35), along with the resultant barrier deformation (Figure 36).

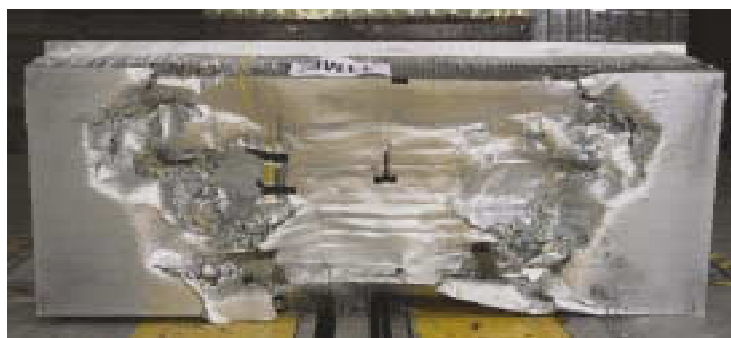
Figure 36: View of the resultant barrier deformation.

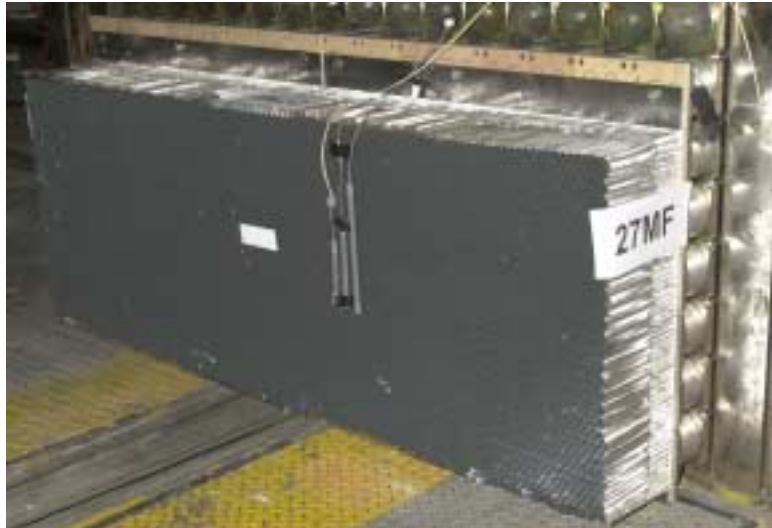
The Ford Mondeo was impacted into an aluminium honeycomb barrier of size 2m x 0.75m x 0.235m. The front layer had a depth of 150mm and a crush strength of 0.34MPa. The rear layer had a depth of 85mm and a crush strength of 1.71MPa. The stiffer rear layer of the barrier was segmented into individual blocks. The size of these blocks was 125mm by 125mm, which represented the frontal area of each load cell. The segmenting resulted in 96 individual blocks that lined up with the load cells on the wall. Due to technical difficulties with the manufacture of the barrier, the depth of the second layer was limited to 85mm, as opposed to the previously tested 150mm (11MF). In addition, the front cladding of the barrier was omitted in order to minimise any barrier deformation caused by bending.

Figure 43: Development full width test barrier mounted onto load cell wall.

The barrier was mounted onto a high resolution load cell wall (Figure 43). The load cell wall was formed of 128 load cells of 125mm x 125mm arranged in a 16 x 8 matrix. The deformable barrier covered the lower 6 rows of the load cell wall.

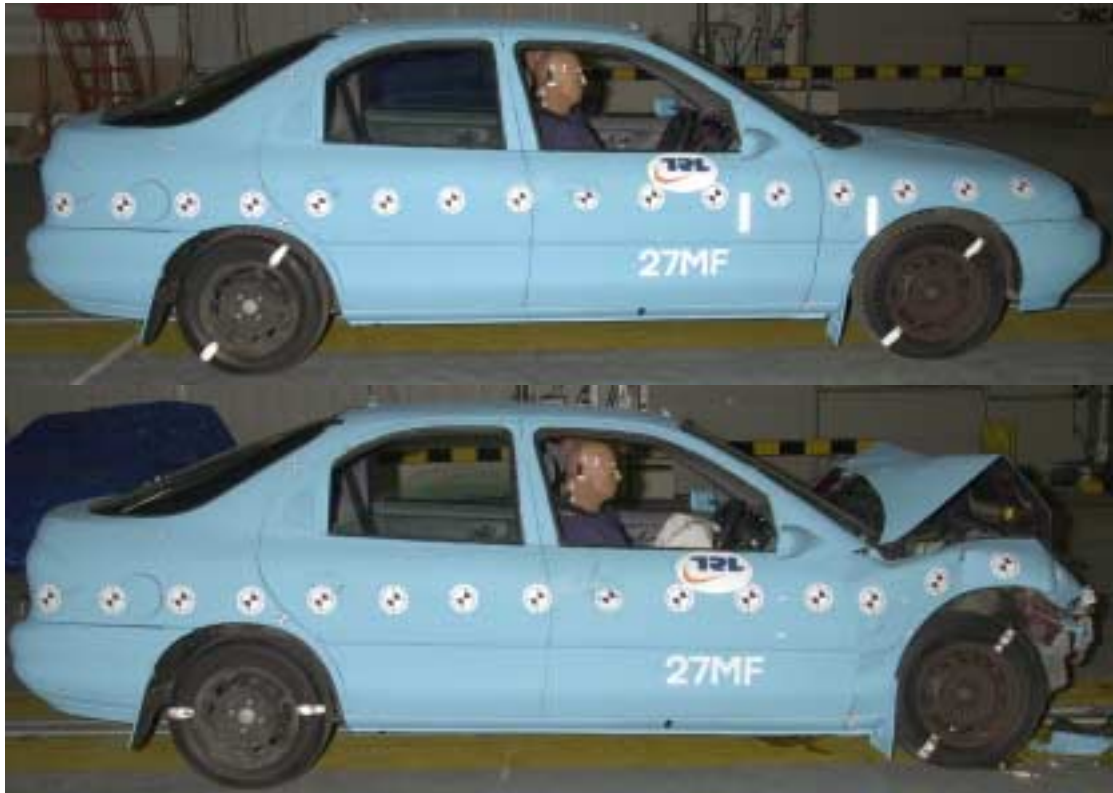
Figure 44: Pre and post test driver's side view of test vehicle.

The test speed and overlap were within the specified tolerances. Pre and post test images of the test vehicle are shown (Figure 44 and Figure 45), along with the resultant barrier deformation (Figure 46).

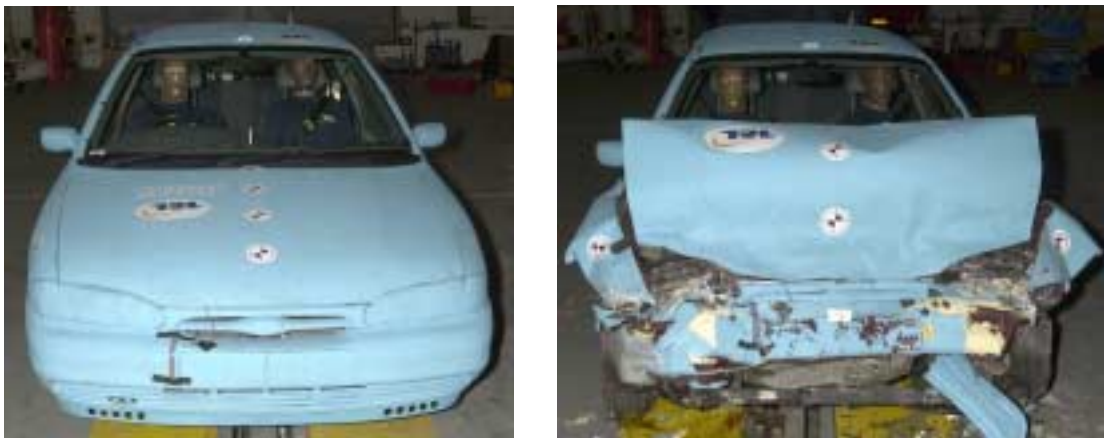
Figure 45: Pre and post test front view of test vehicle.

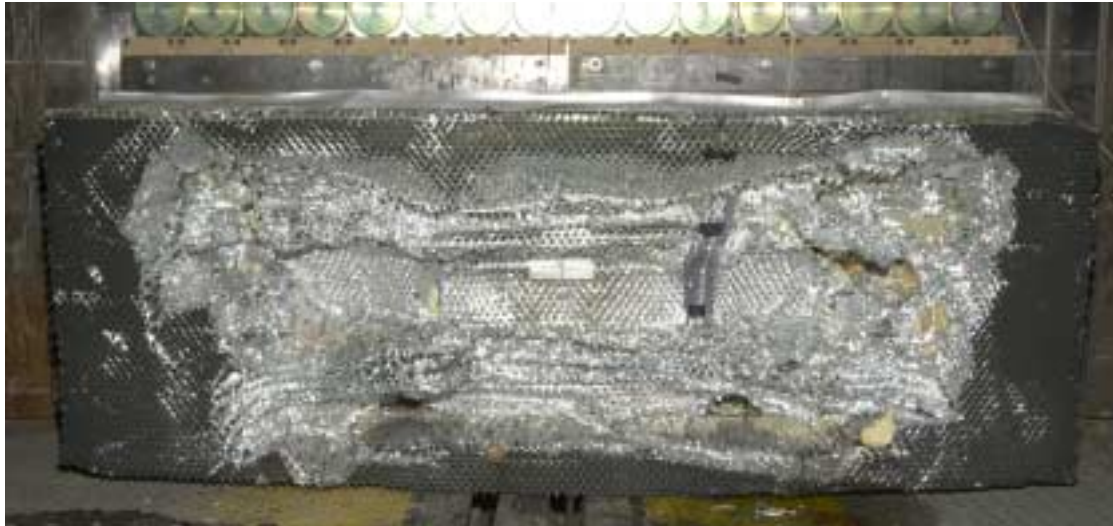
Figure 46: View of the resultant barrier deformation.

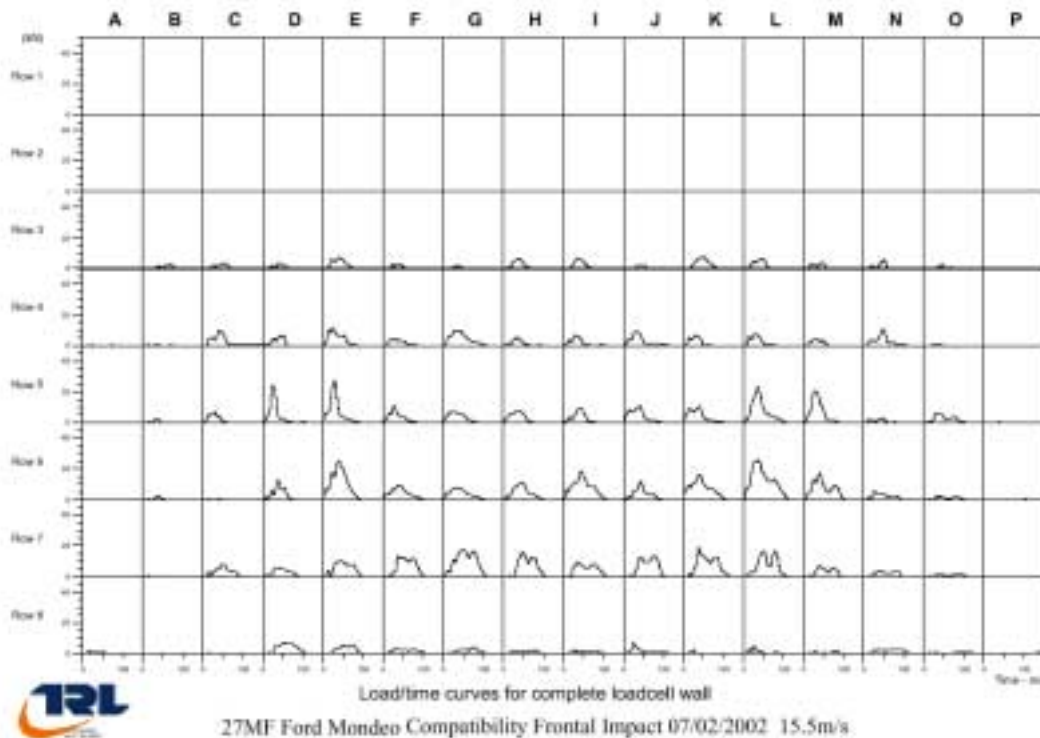
Figure 50: Load cell wall force time history showing the high loads applied by the lower rails and subframe crossbeam.

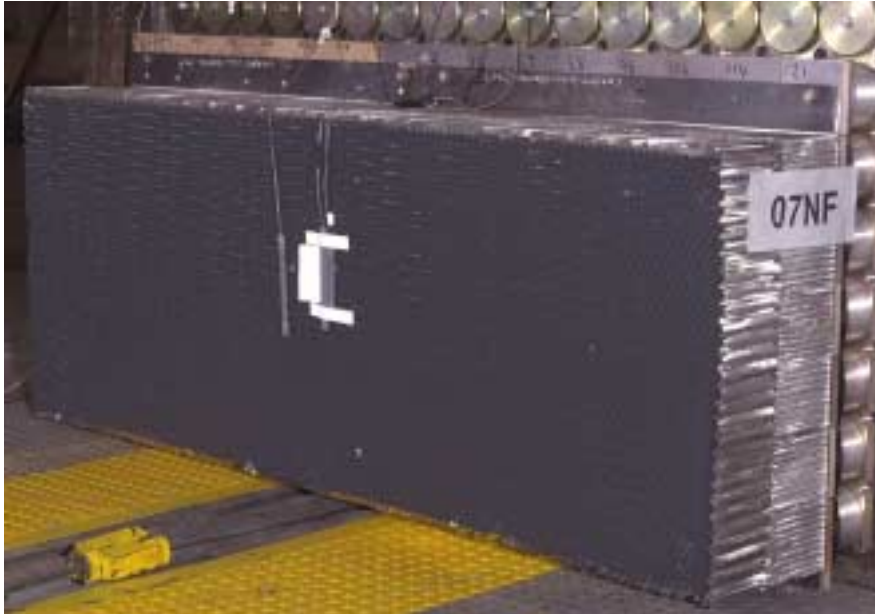
The left hand drive Renault Laguna II was impacted into an aluminium honeycomb barrier of size 2m x 0.75m x 0.3m. The front layer had a depth of 150mm and a crush strength of 0.34MPa. The rear layer had a depth of 150mm and a crush strength of 1.71MPa. The stiffer rear layer of the barrier was segmented into individual blocks. The size of these blocks was 125mm by 125mm, which represented the frontal area of each load cell. The segmenting resulted in 96 individual blocks that lined up with the load cells on the wall. In addition, the front cladding of the barrier was omitted in order to minimise any barrier deformation caused by bending.

Figure 53: Full width test barrier mounted onto load cell wall.

The barrier was mounted onto a high resolution load cell wall (Figure 54). The load cell wall was formed of 128 load cells of 125mm x 125mm arranged in a 16 x 8 matrix. The deformable barrier covered the lower 6 rows of the load cell wall.

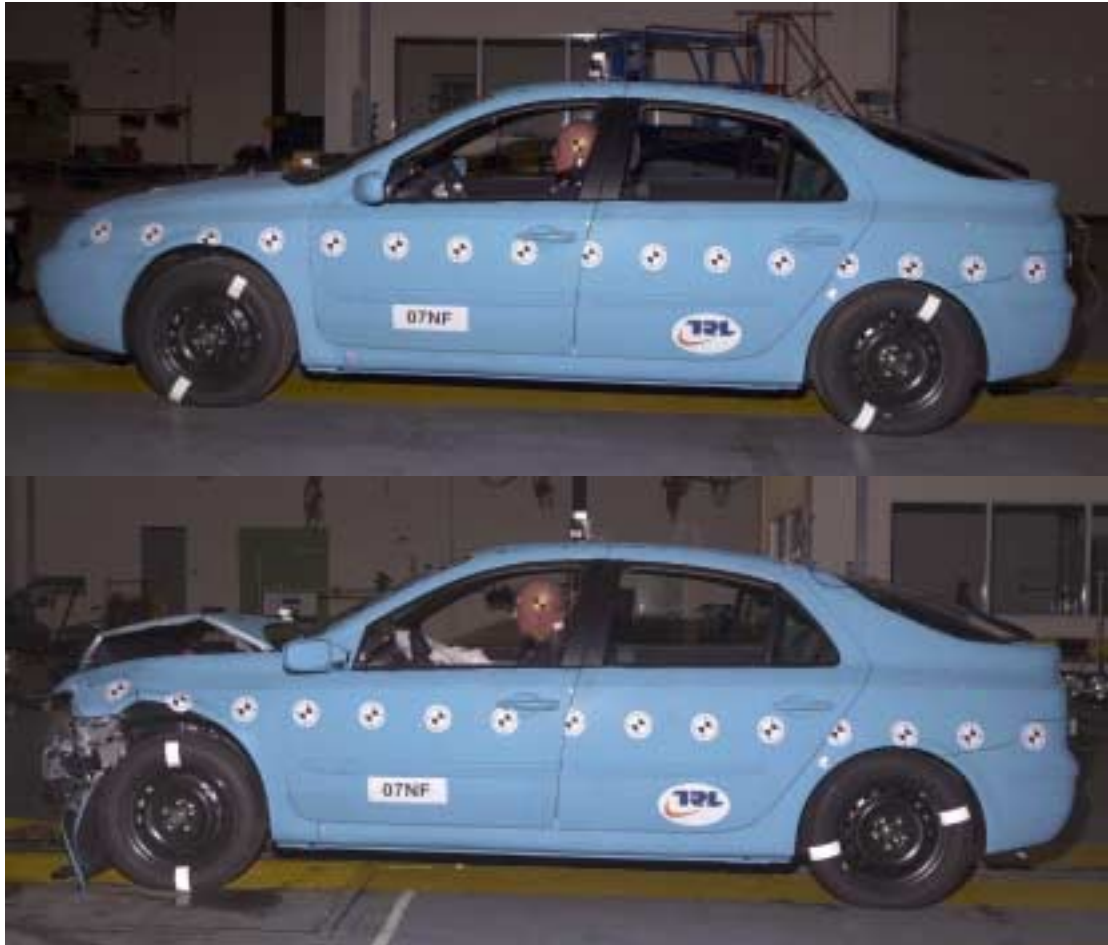
Figure 54: Pre and post test driver's side view of test vehicle.

The test speed and overlap were within the specified tolerances. Pre and post test images of the test vehicle are shown (Figure 44 and Figure 45), along with the resultant barrier deformation (Figure 46).

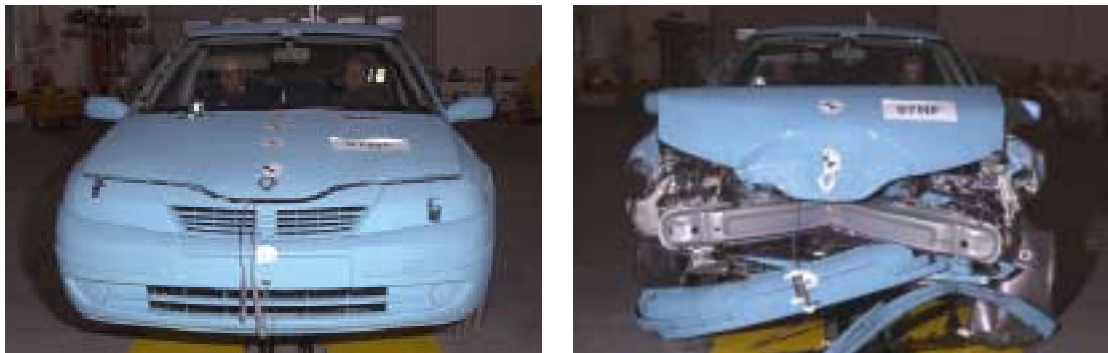
Figure 55: Pre and post test front view of test vehicle.

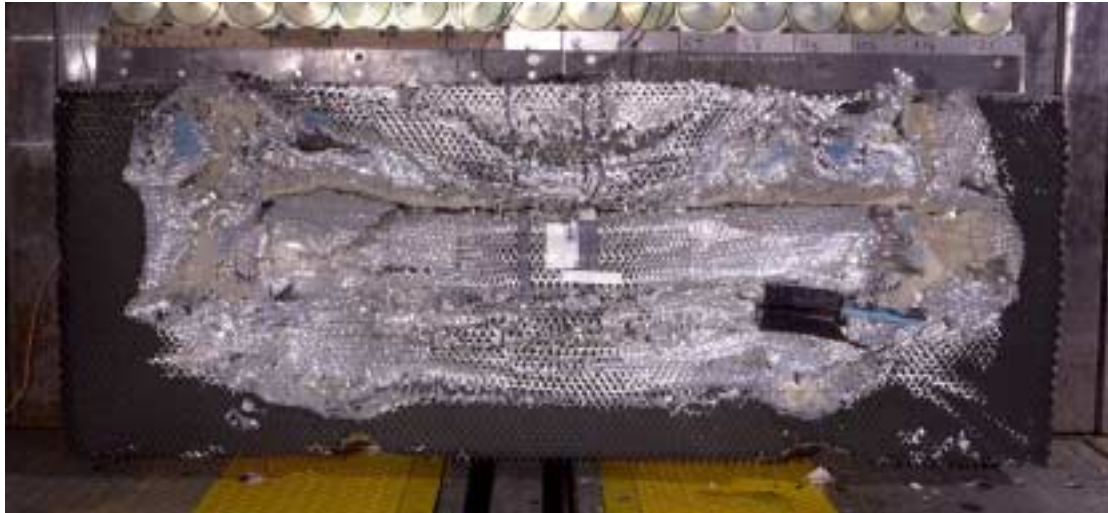
Figure 56: View of the resultant barrier deformation.

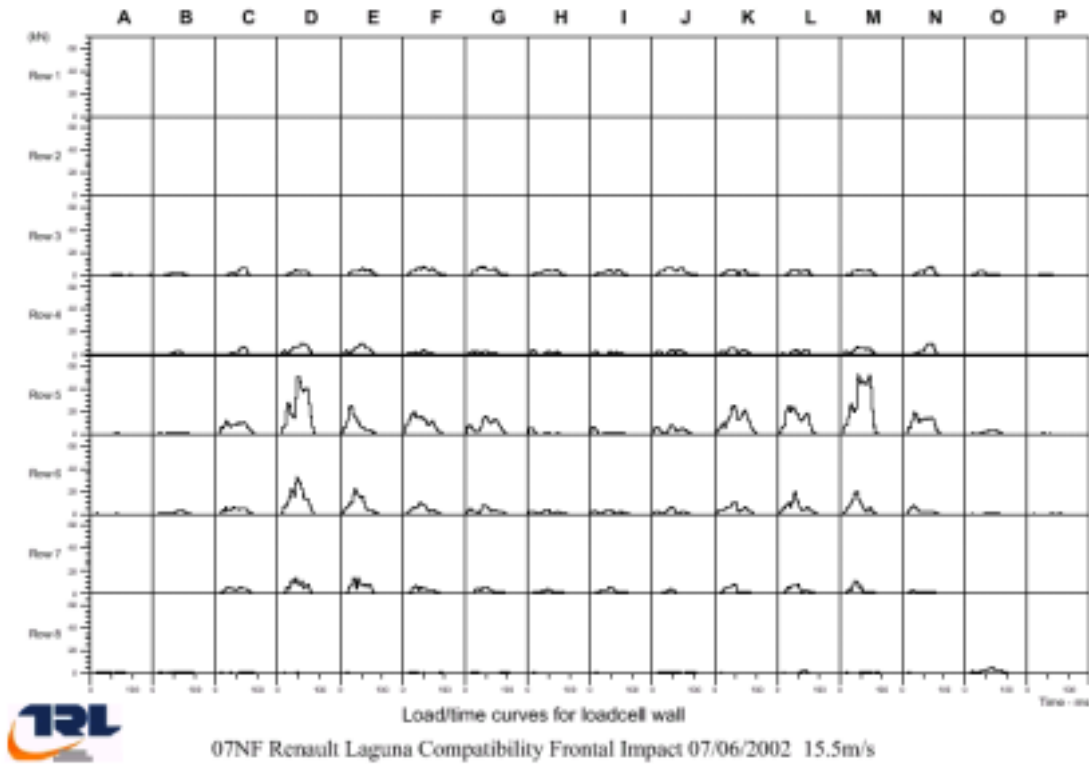
Figure 59: Load cell wall force time history showing the high loads applied by the lower rails.

The car applied high loads (~50kN) to two cells on the LCW (Row 5, columns D and M), which relate to the pre-impact location of the lower rails (Figure 59). The reason for these high loads was the bottoming out of the barrier face in front of the lower rails (Figure 60).

There was little loading of the middle of the wall (Figure 59, columns G, H, I, J). This is consistent with the failure of the subframe crossbeam and the bumper beam (Figure 61 and Figure 62).

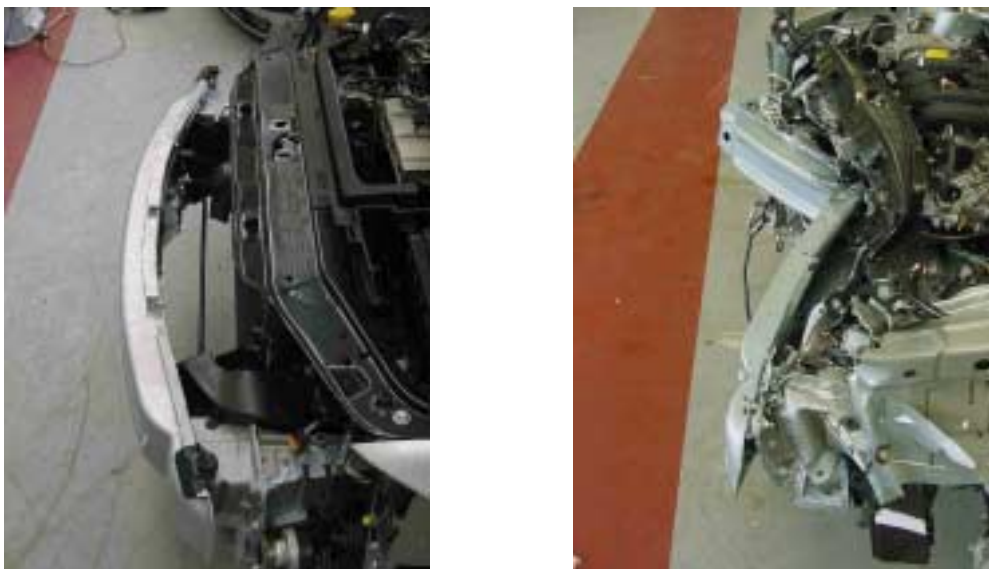
Figure 61: Comparison of bumper beam, pre and post-test, showing failure between lower rails.

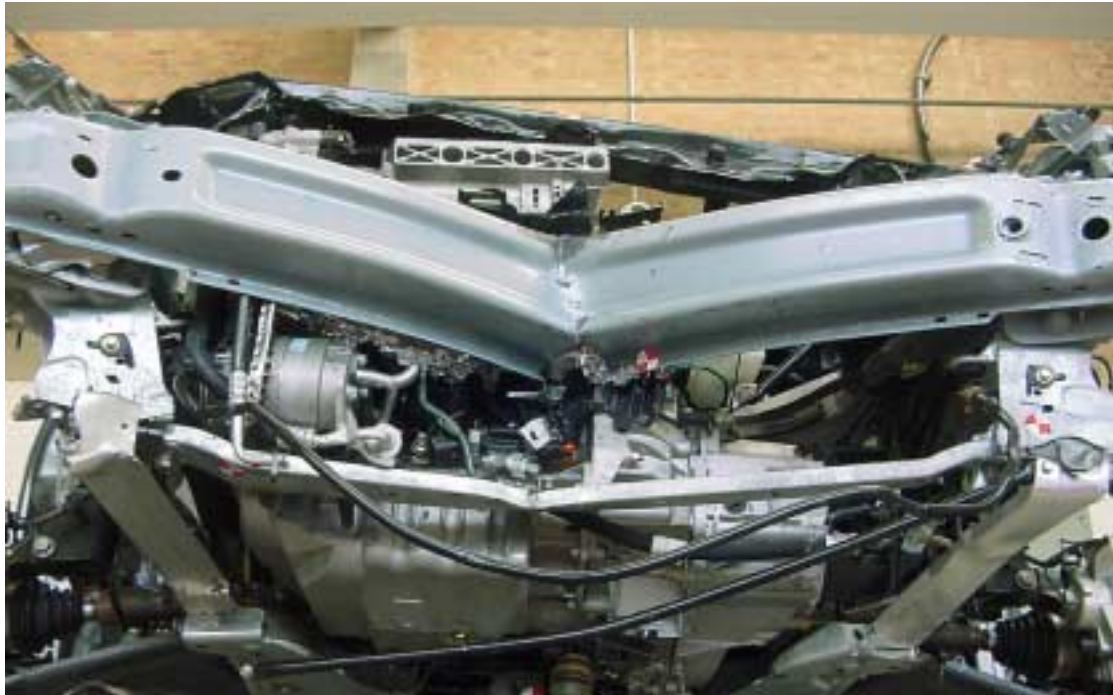
Figure 62: Centre of bumper beam and subframe crossbeam, showing bending failures.

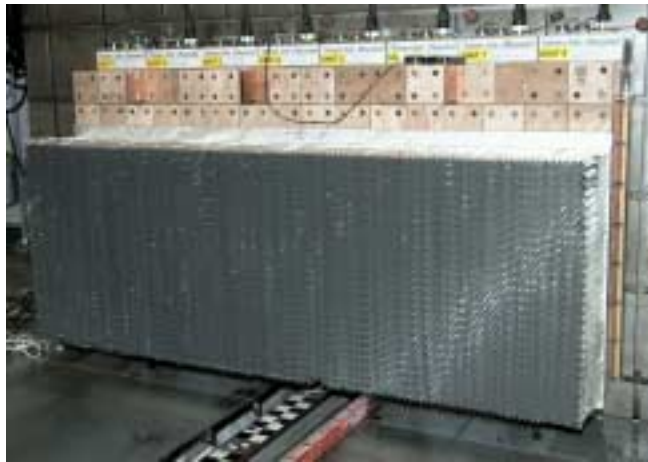
The cars were impacted into an aluminium honeycomb barrier of size 2m x 0.75m x 0.30m and a crush strength of 0.34MPa for the first 150mm and 1.71MPa thereafter, mounted onto a high resolution load cell wall (Figure 63). The stiffer rear layer of the barrier was segmented into individual blocks. The size of these blocks was 125mm by 125mm, which represented the frontal area of each load cell. The segmenting resulted in 96 individual blocks that lined up with the load cells on the wall.

Figure 63: Full Width Test Barrier and Load Cell Wall

The load cell wall was formed of 128 load cells of 125mm x 125mm arranged in a 16 x 8 matrix and mounted 165mm from the ground (TRL tests 50mm). The deformable barrier covered the lower 6 rows of the load cell wall.

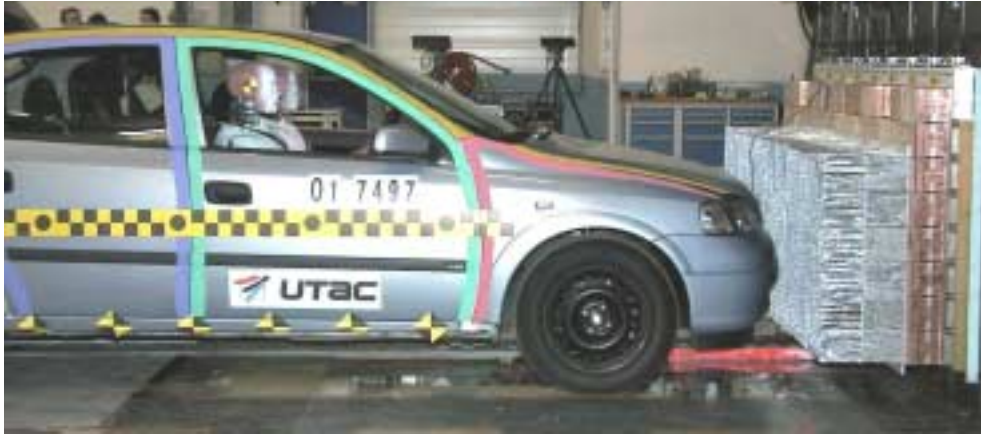
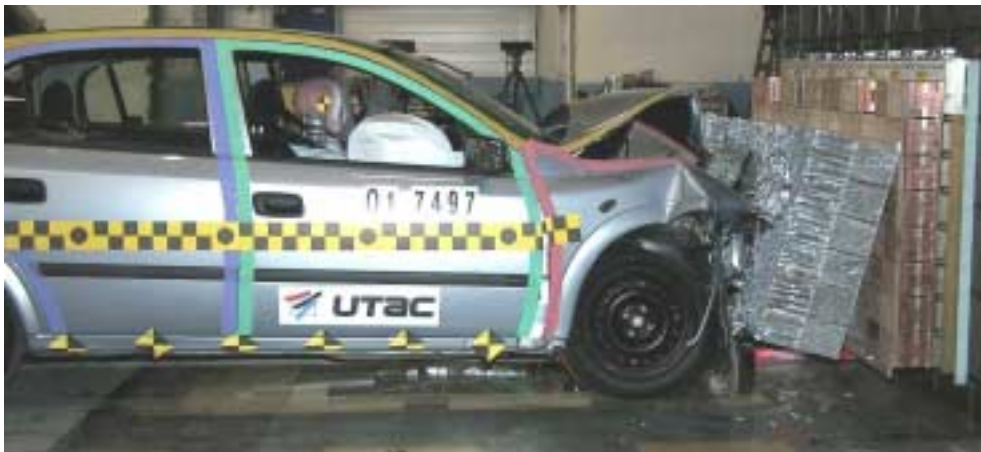
Figure 64: Pre and post test driver's side view

During the test, the bottom of the barrier became detached from the wall (Figure 64). Analysis of the video showed that it occurred during the back up of the car after the crash so there was no influence on the results.

The test speed and overlap were within the specified tolerances. Pre and post-test images of the test vehicle (Figure 64 and Figure 65), and the resultant barrier deformation (Figure 66) are shown.

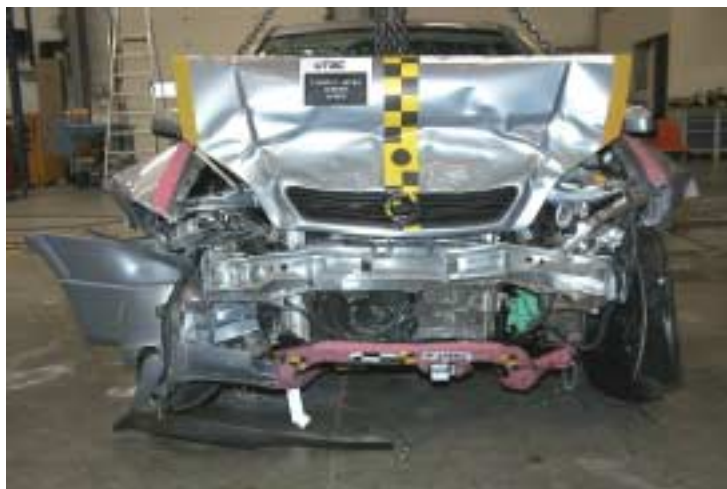
Figure 65: Post test front view

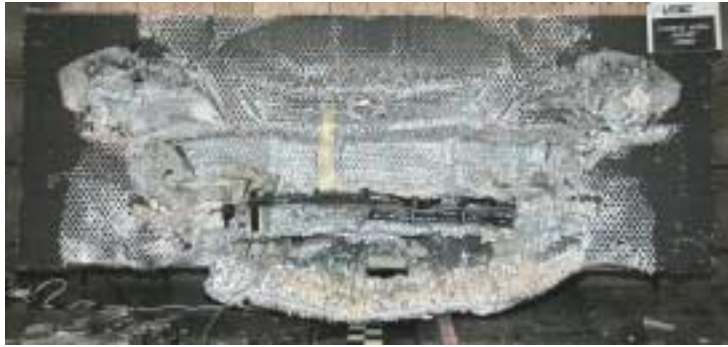
Figure 66: Resultant barrier deformation
