A STUDY TO IMPROVE THE CRASH COMPATIBILITY BETWEEN CARS IN FRONTAL IMPACT

Final Report by

Mervyn Edwards – Consortium Manager
Transport Research Laboratory

Report to the

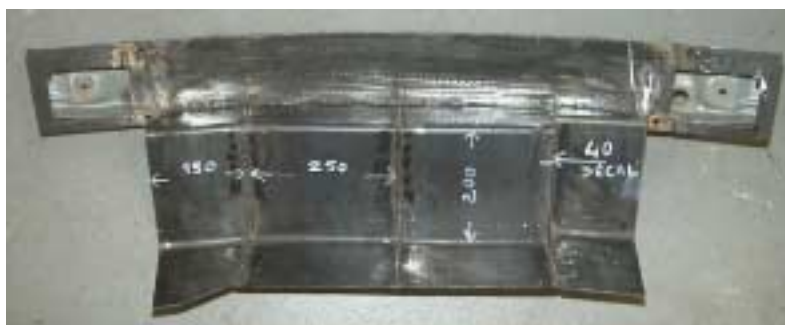
The Opel Astra has multiple load paths, which can be considered as a compatible feature. To maximise this feature, modifications were made to reinforce the cross member and the connections between load paths, and to increase the pushing surface. The purpose is to check if the test method is able to differentiate such a modification.

Figure 69: Structure of the modification

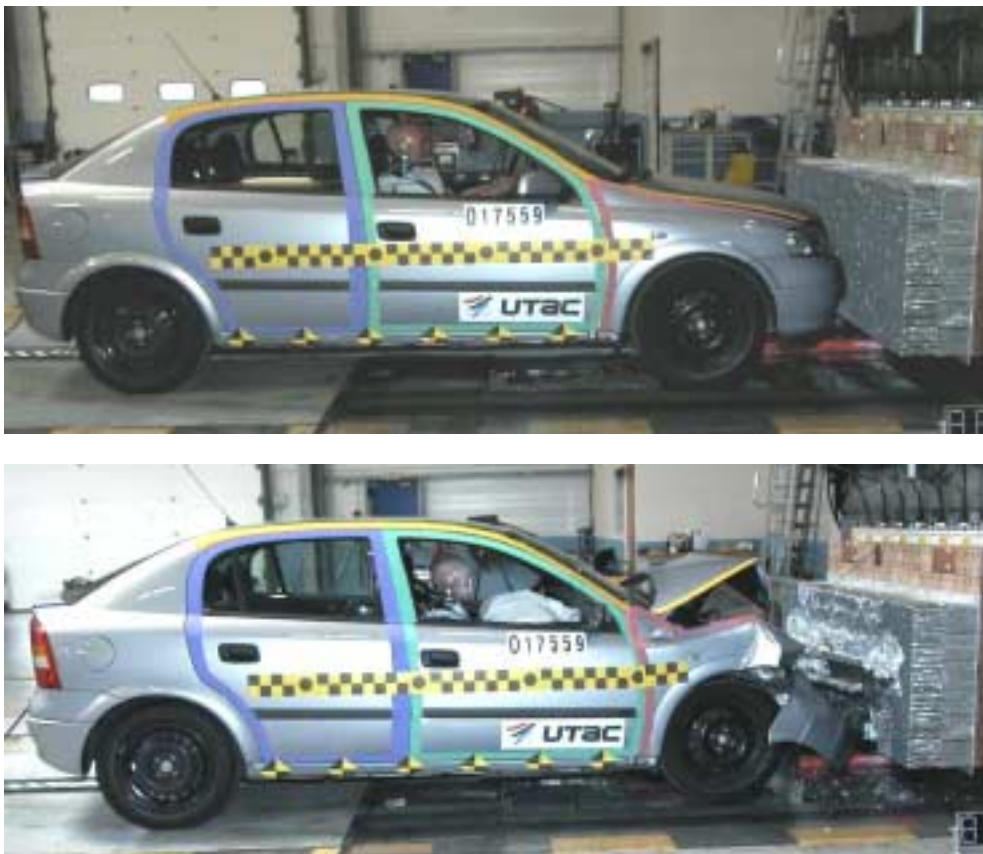
Figure 71: Pre and post test driver's side view

The test speed and overlap were within the specified tolerances. Pre and post-test images of the test vehicle (Figure 71 and Figure 72), and the resultant barrier deformation (Figure 73) are shown.

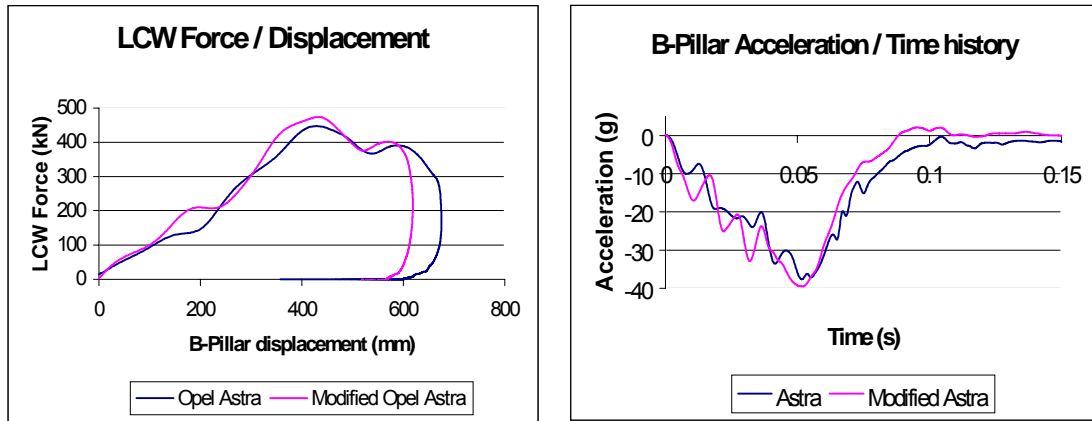
Figure 77: LCW force against displacement and B-Pillar acceleration against time

Although a slight increase in the vehicle stiffness was observed, the change in the energy absorption was mainly due to the change in the B-Pillar displacement. One probable cause for this would have been the increased interaction area due to the increased pushing surface. This increase would have resulted in less penetration into the barrier and better energy absorption by the barrier.

The compartment deceleration pulse (Figure 77), was also more severe for the modified Opel Astra. The modification seems to have increased the global stiffness of the frontal unit, this may have been due to the reinforcement of the connections between load paths resulting in slightly different failure modes of the main structure. As the deceleration pulse is more severe for the modified Opel and the energy absorbed is less, the dummy criteria are more important. The chest deflection for the driver dummy was 38.4 mm for the Astra and 45.5 mm for the modified Astra (Figure 78).

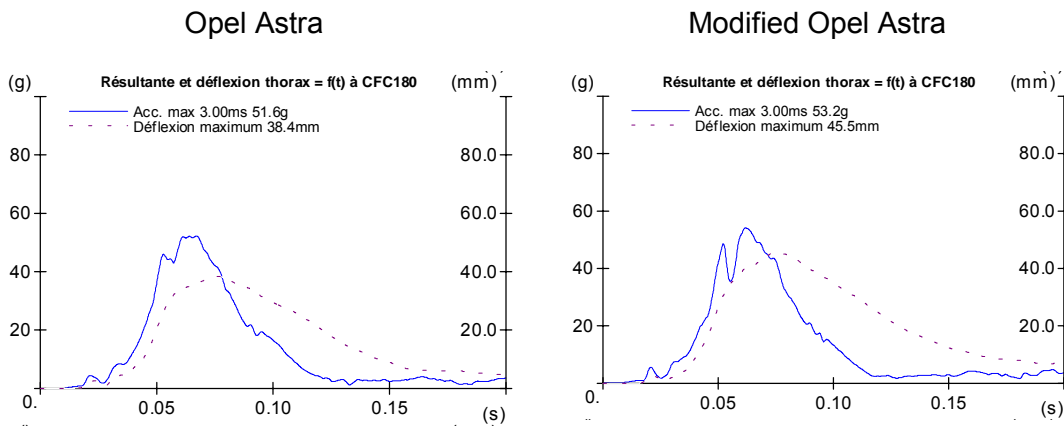
Figure 78: Dummy criteria

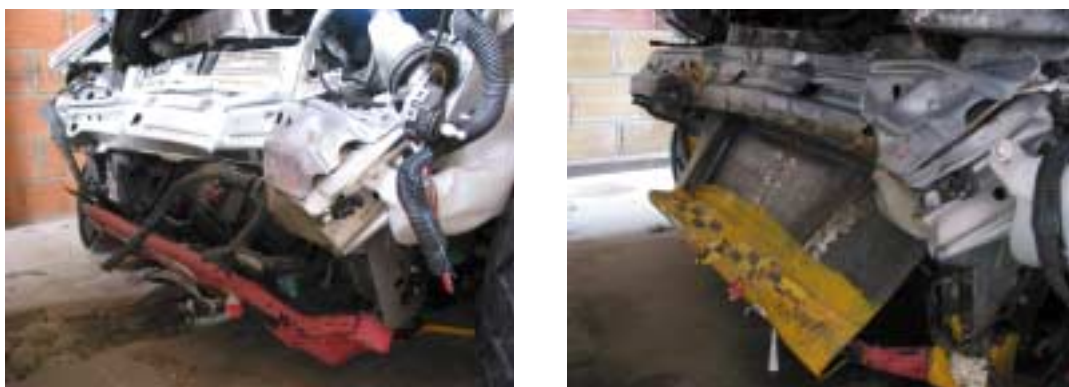
Figure 80: Subframe deformation

On these two tests, the connections between the lower rails and the subframe were not destroyed. The shear connection in the unmodified car was not used as on a car to car test. This indicates that this test did not generate the same shear forces as seen in the car to car test.

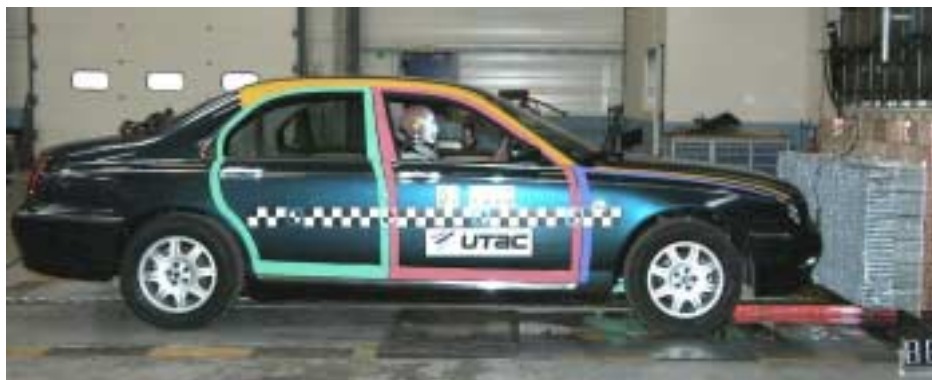
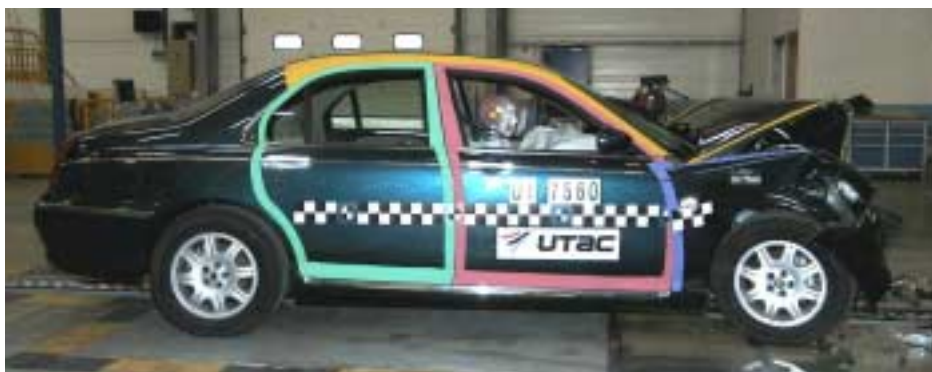
Figure 81: Pre and post test driver's side view

The test speed and overlap were within the specified tolerances. Pre and post test images of the test vehicle (Figure 81 and Figure 82), and the resultant barrier deformation (Figure 83) are shown.

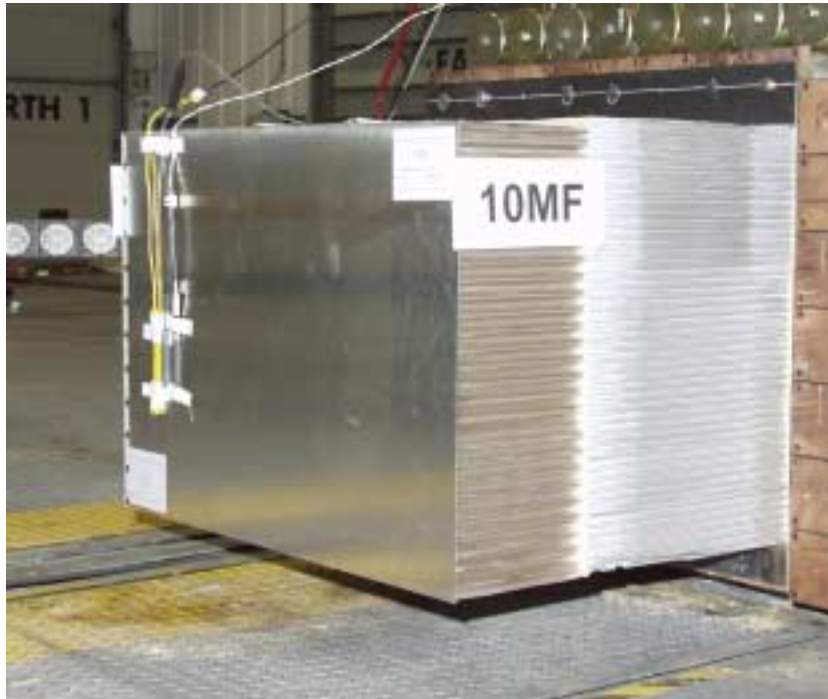
Figure 89: Progressive deformable barrier version 6 mounted on load cell wall.

The PDB was mounted on a high resolution load cell wall formed of 64 cells of 125mm by 125mm, arranged in an 8 x 8 matrix (Figure 90). The position of the load cell wall was such that the lower four rows were below the split line of the upper load and lower load areas of the barrier, whilst the remaining four rows were above the split line. Therefore, the barrier did not cover the two highest rows of the load cell wall, whilst the lowest and highest rows that were in contact with the barrier had only 64% and 92% coverage respectively.

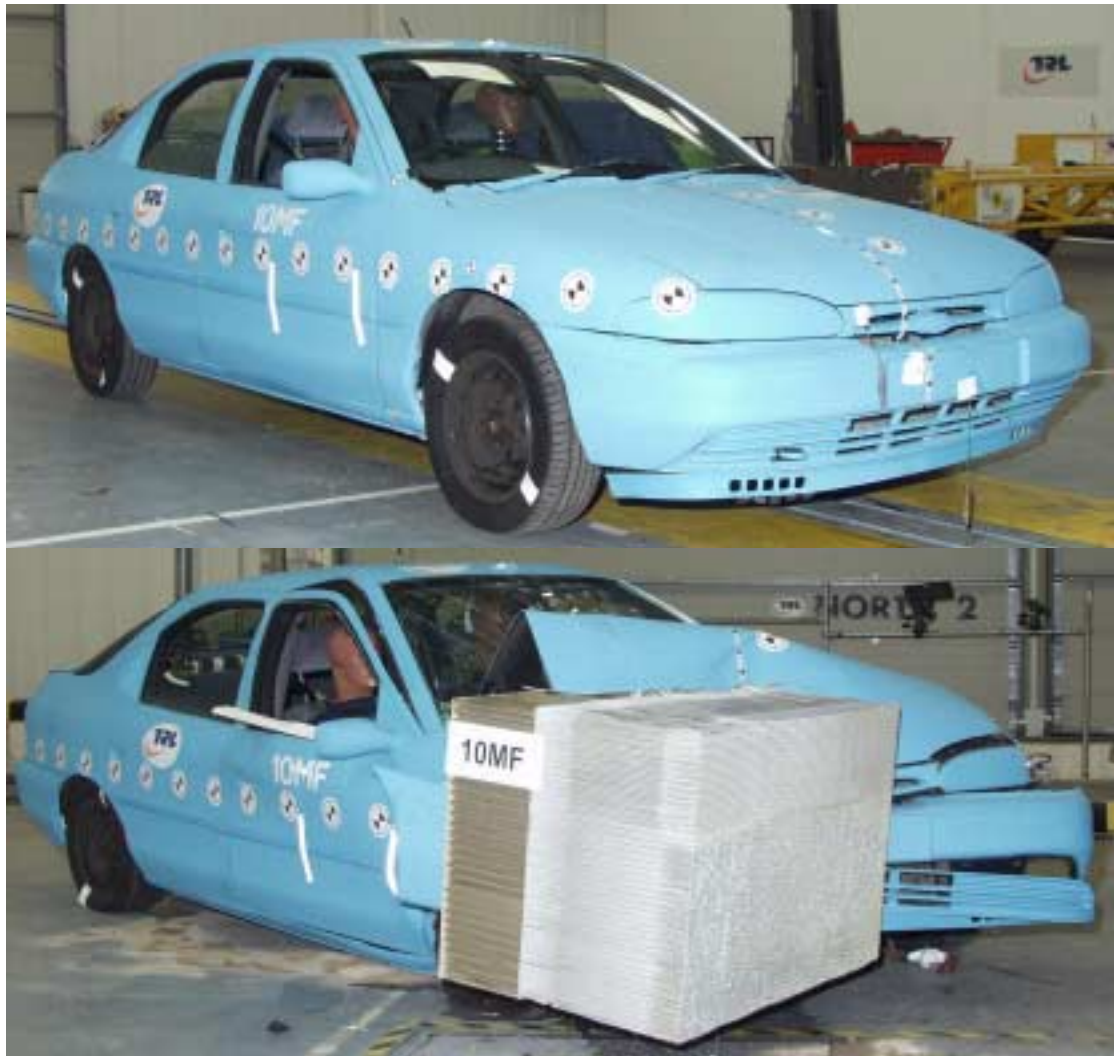
Figure 90: Vehicle pre and post test views showing the attachment of the barrier to the vehicle post impact.

The test speed and overlap were within the specified tolerances. Pre and post test images of the test vehicle are shown (Figure 90). During the impact the PDB became attached to the vehicle structure and remained attached post impact.

- During the impact, the barrier became attached to the vehicle and remained attached post impact. Removal required tools and part of the barrier became detached from the main body. For post test analysis of the barrier deformation, the separated piece was replaced approximately.
- Part of the stiffer progressive layer of the barrier failed prior to the softer front layer. This may have been due to the interaction of the aluminium plate between the two layers transferring shear forces, or the failure in bending of the aluminium honeycomb. The failure of the aluminium honeycomb in bending would require less force than for failure in axial crush and would have therefore resulted in different levels of barrier deformation.

- In the Mondeo test a part of the barrier remained attached to the car after the test. This would cause severe difficulties in measuring the barrier final deformation profile objectively, which the PDB approach is completely reliant upon. For this test the version 6 of PDB was used. Version 7 of the barrier has a thicker front sheet, which may reduce or solve this problem. The lack of penetration of the barrier front sheet in the test with the Volvo S80 indicates the improved performance of version 7 of the barrier in this respect.

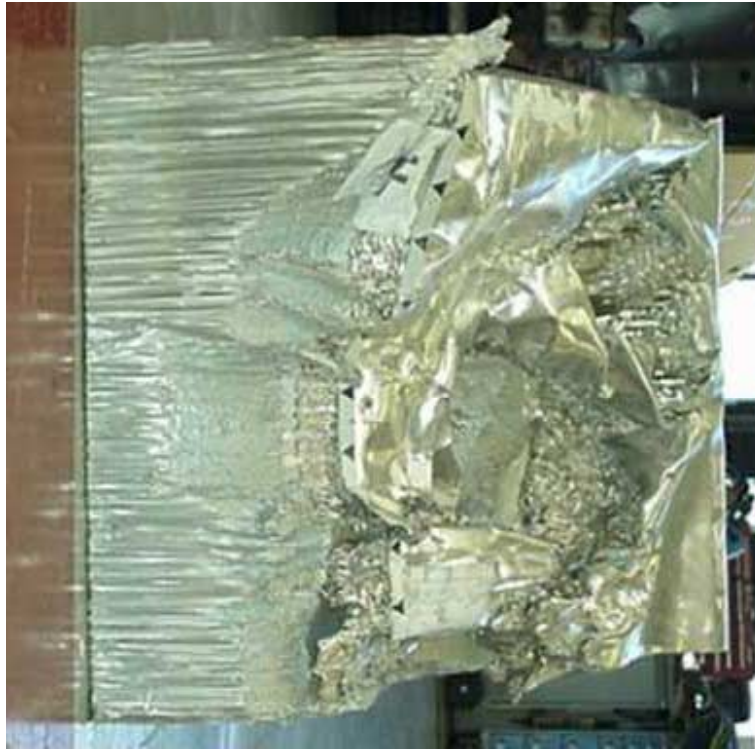
Figure 93: Progressive deformable barrier post impact after removal of all sections from the test vehicle.

After removal of the separated part of the barrier from the vehicle, the two sections of the barrier were joined together (Figure 92 and Figure 93).

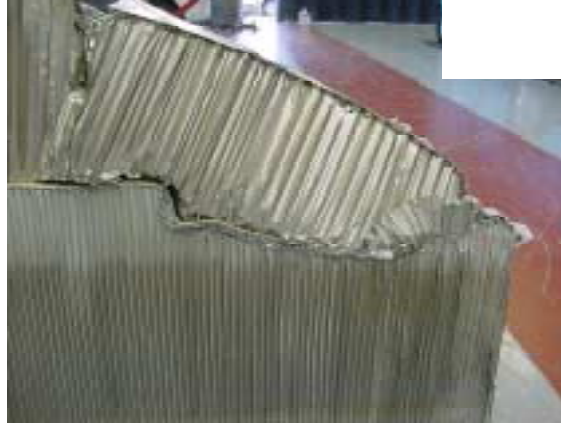
Figure 102: Barrier deformation showing the failure of the stiffer progressive layer prior to the softer front layer.

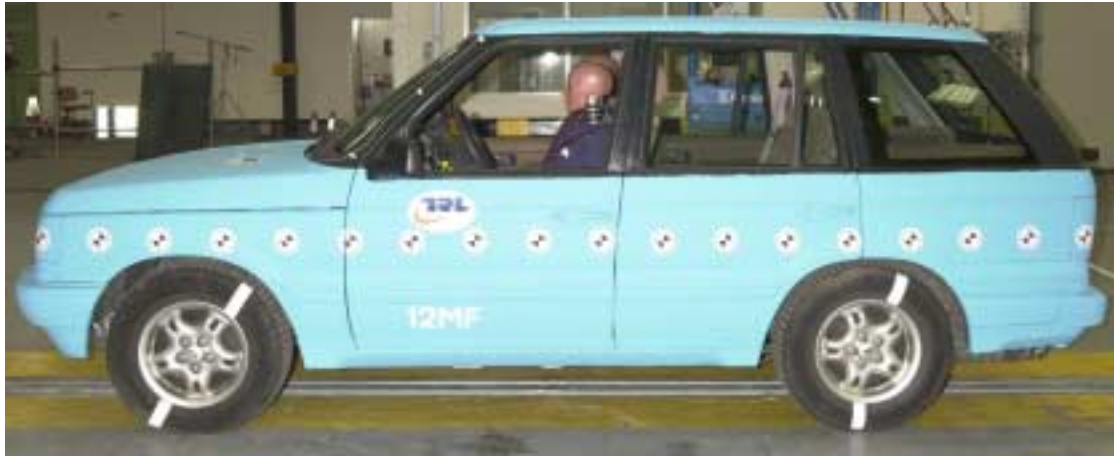
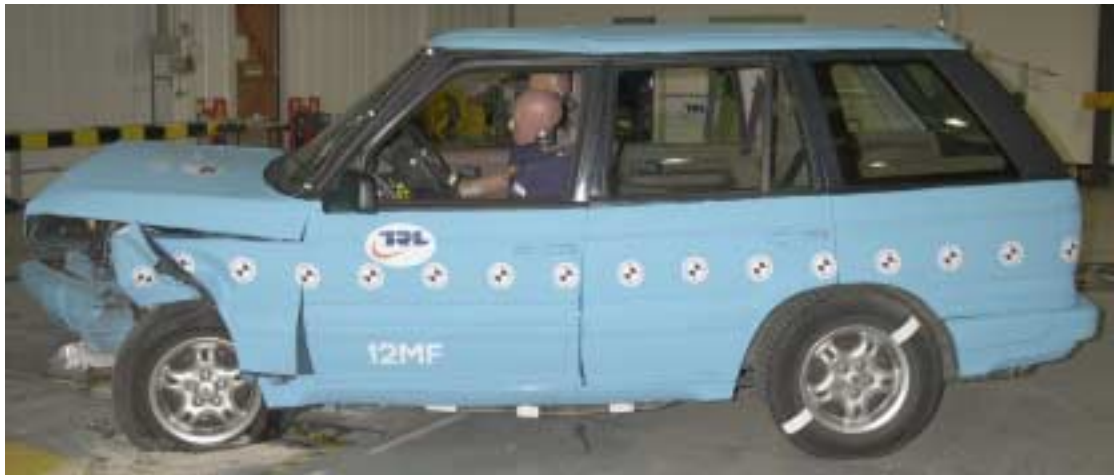
Figure 103: Vehicle pre and post test driver's side view of Range Rover.

The test speed and overlap were within the specified tolerances. Pre and post test images of the test vehicle are shown (Figure 103 and Figure 104).

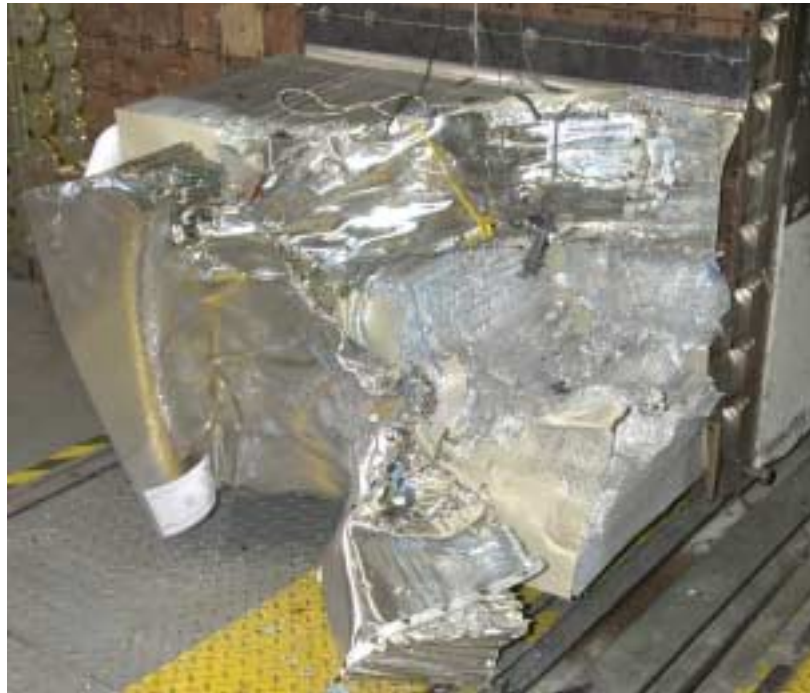
Figure 105: Progressive deformable barrier post impact showing bottoming out of barrier.

The post test images of the barrier are shown (Figure 105 and Figure 106). These images show that the test vehicle bottomed out the barrier over a significant area in front of the main chassis member, the latch platform, the LHS body structure along with the LHS front wheel. During the impact, the barrier became attached to the vehicle and began to pull away from the load cell wall. Although the attachment of the barrier to the load cell wall held, the action of the vehicle pulling against the load cell

wall attachment resulted in additional deformation of the barrier and its mounting plate.

- The vehicle's main chassis rail, LHS body structure and latch platform bottomed out the barrier over a large area. The extensive contact induced significant damage to the honeycomb not directly impacted, mainly through the transfer of shear forces.

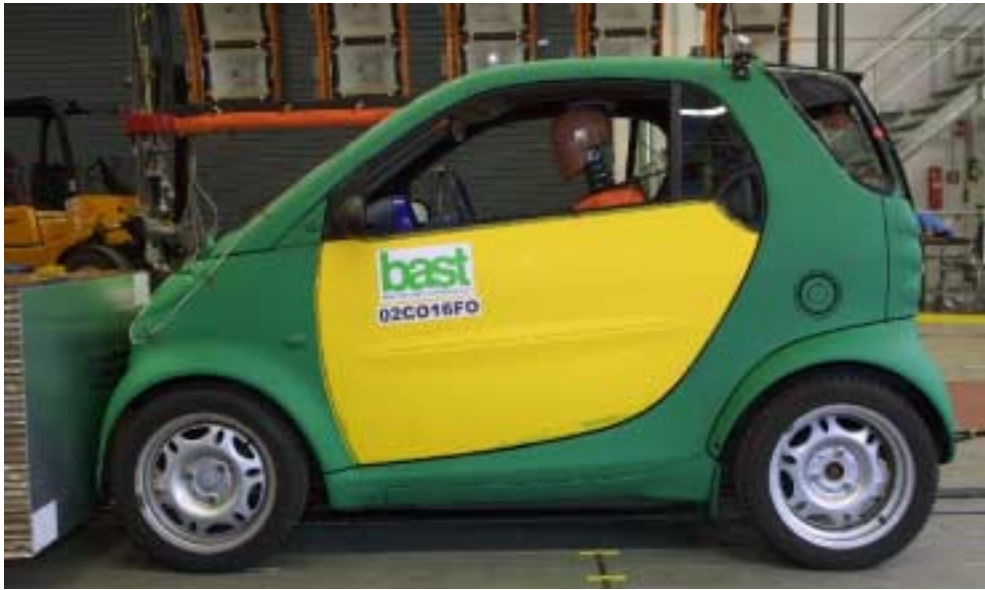
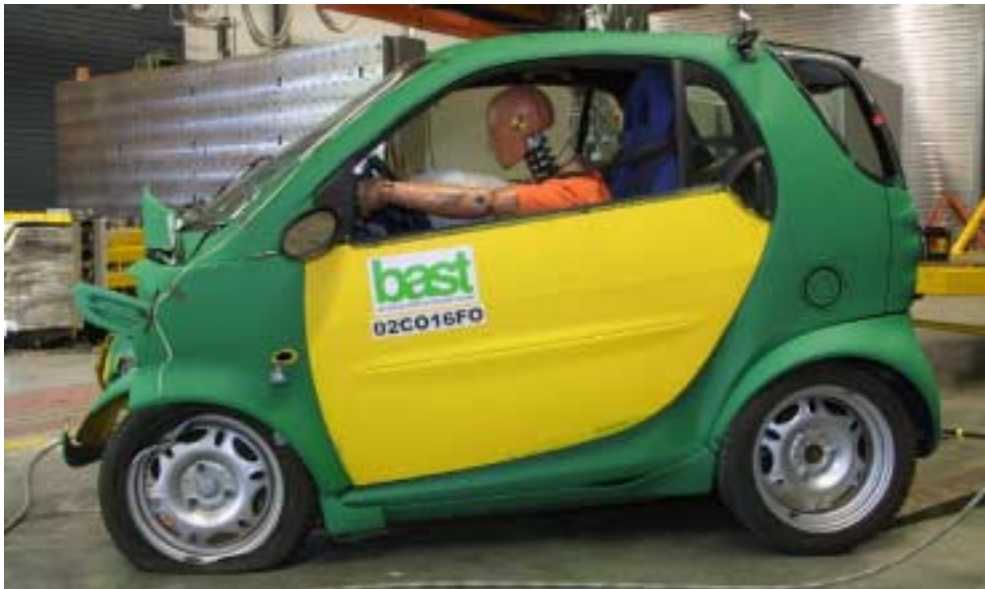
Figure 115: Vehicle pre and post Test Driver's Side View, Test 02CO16FO

The test speed and overlap were within the specified tolerances. Pre and post test images of the test vehicle are shown in Figure 115 and Figure 116.

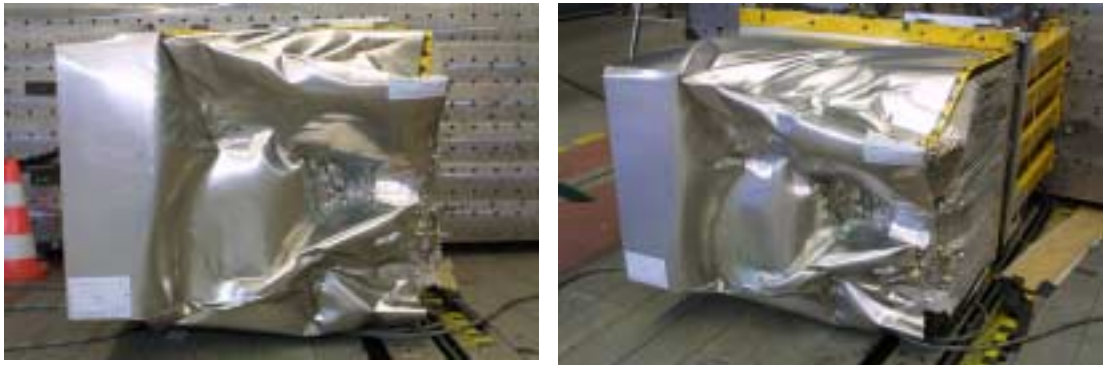
Figure 117: Progressive Deformable Barrier Post Impact, Test 02CO16FO

The post test images of the deformed barrier are shown in Figure 117. These images show that the SMART deformed the PDB relatively homogeneously over the full contact area between SMART front and the PDB face. Only the extreme stiff left longitudinal penetrated locally the PDB element version 7 with the thicker aluminium cover sheet. The overlap of 750 mm covers about two thirds of the SMART front, additionally the longitudinals are located closer to the middle of this car in comparison to other car models; these two facts are the reason for very little lateral deformation of the PDB caused by rotation of the vehicle during impact.

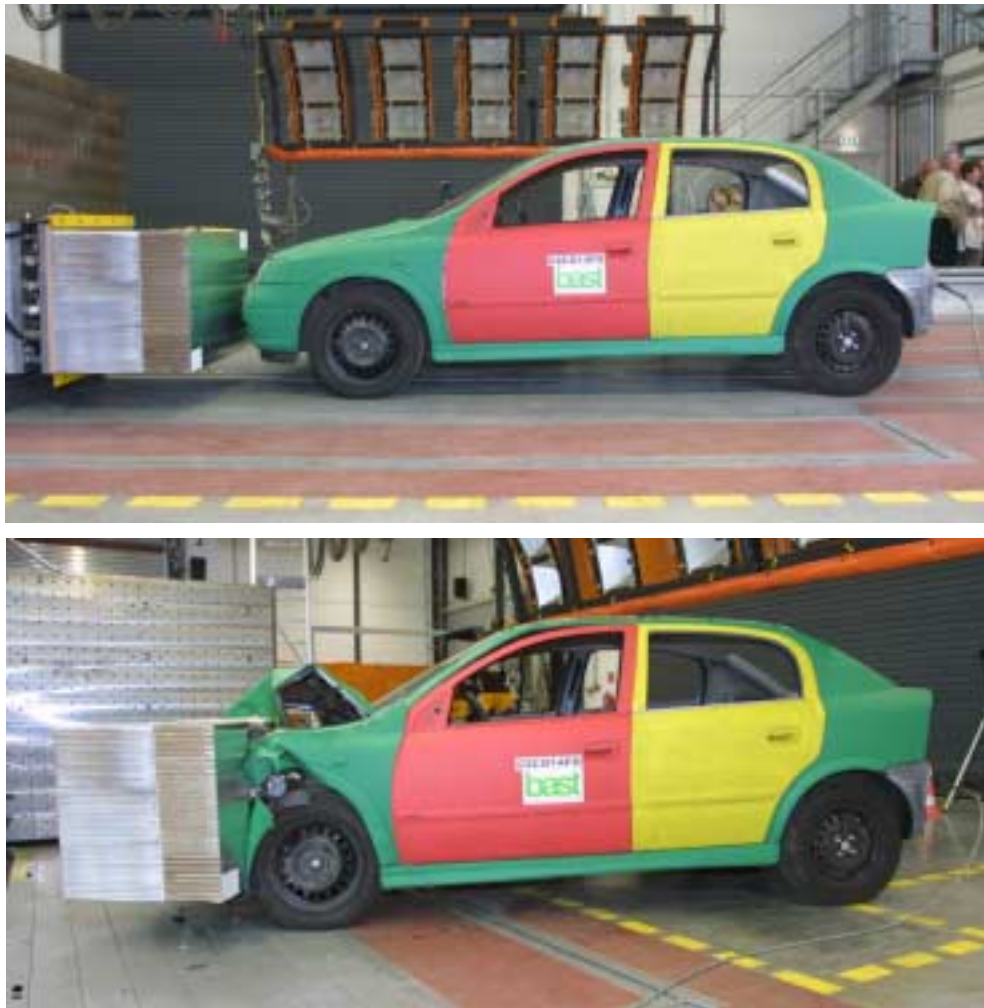
Figure 123: Vehicle pre and post Test Driver's Side View, Test 02CO14FO

The test speed was within the specified tolerances. Pre and post test images of the test vehicle are shown in Figure 123 and Figure 124. The PDB-element was trapped by the front structure of the ASTRA and torn off from the back plate during the vehicle rebound. Figure 125 shows the deformed car front after removal of the PDB and destroyed plastic front covers.

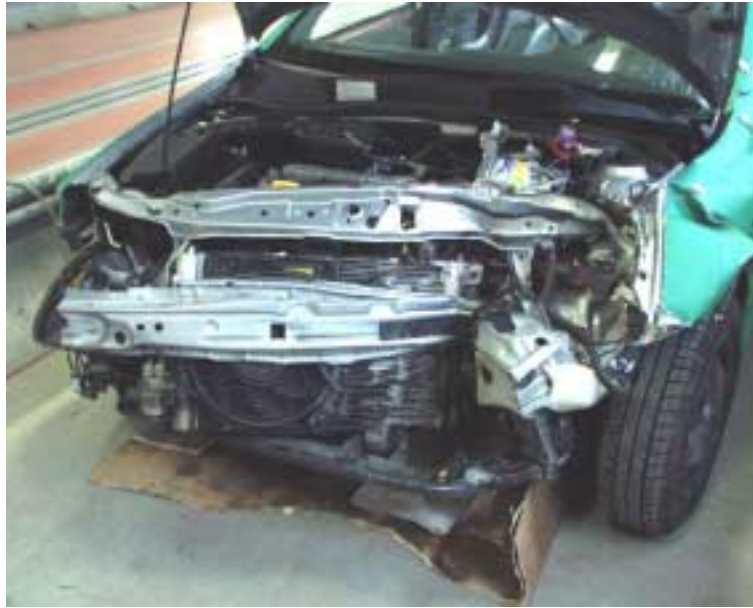
Figure 125: Vehicle Post Test Front View, Test 02CO14FO

The significant deformation characteristic of the vehicle front is the deep deformation of the front lateral beam close to the left longitudinal. This shows that the PDB clearly generates shear when weaker structures are contacted and loaded. The stiffer second layer apparently does not reduce this effect as a rigid block would do.

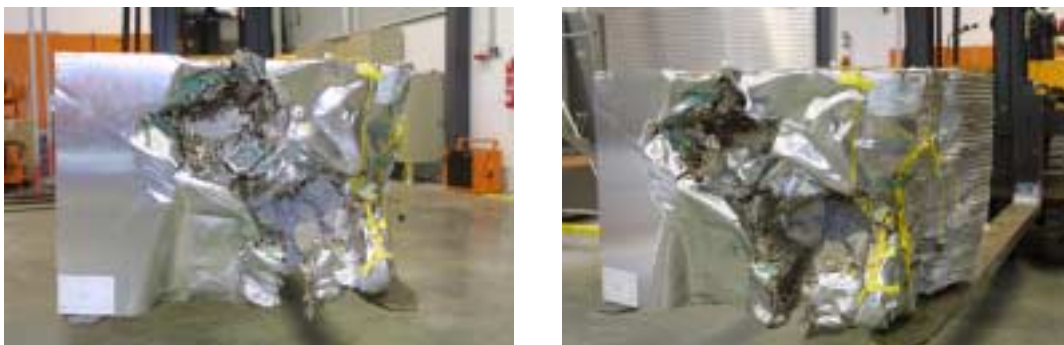
Figure 126: Progressive Deformable Barrier Post Impact, Test 02CO14FO

The post test images of the deformed barrier are shown in Figure 126. These images illustrate that the ASTRA deeply deformed the PDB at different locations of the contact area. The stiff left longitudinal penetrated locally the PDB element. Apparently when it reached the second stiffer honeycomb layer the foremost end of the longitudinal was bent nearly 90° upwards and as a consequence of this the lateral beam was twisted to the same degree. The support of the cooler was also bent upwards so that a sharp wedge was generated. This wedge easily cut deeply into the PDB-element. A stiffer front cover would probably have avoided this effect caused by a part of the front structure, which does not significantly contribute to the vehicle's frontal stiffness distribution.

Although the ASTRA is only about 140 kg heavier than the SMART it deeply deforms the PDB. The different structures of the ASTRA tear up the softer front honeycombs

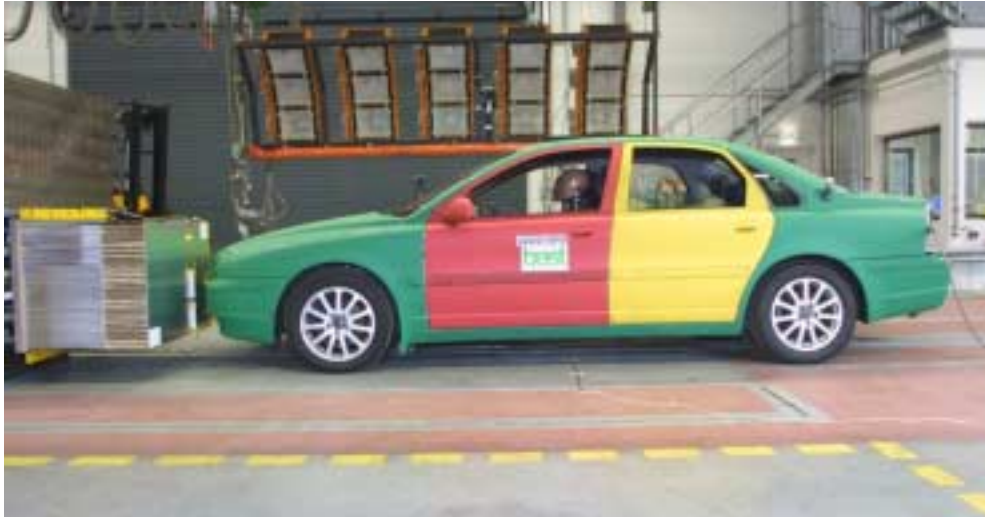
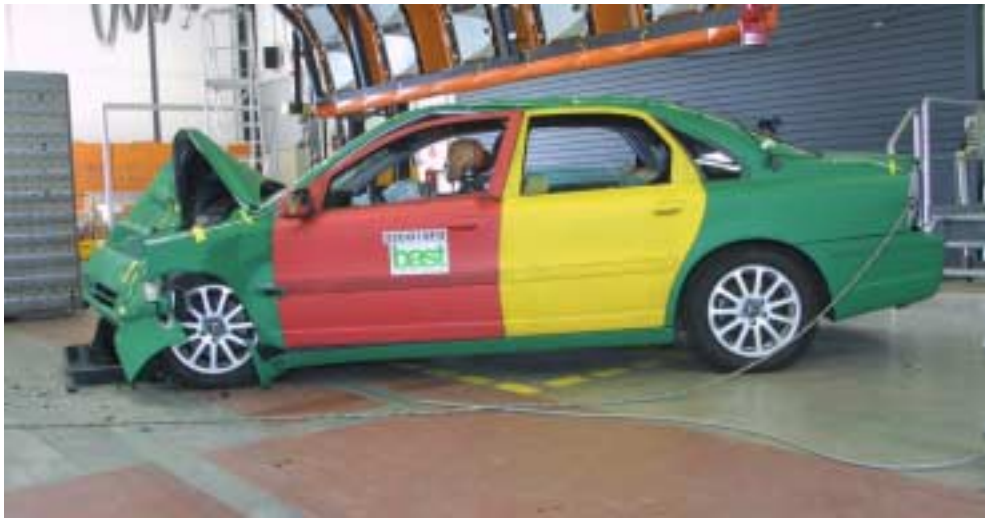
Figure 132: Vehicle pre and post Test Driver's Side Views, Test 02CO15FO

The test speed was within the specified tolerance. Pre and post test images of the test vehicle are shown in Figure 132 and Figure 133.

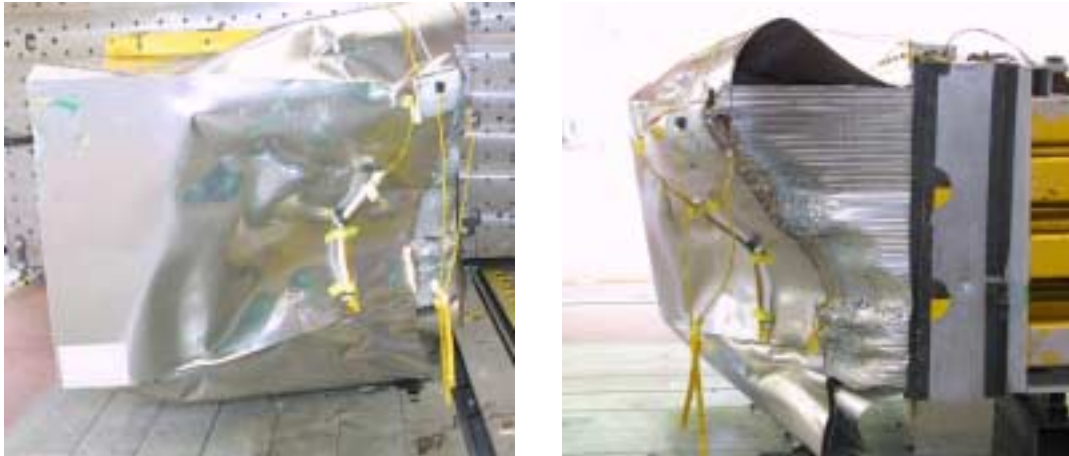
Figure 134: Progressive Deformable Barrier Post Impact, Test 02CO15FO

The post test images of the deformed barrier are shown in Figure 134. These images show that the Volvo S 80 deformed the PDB very homogeneously over the full contact area. There was no local penetration found on the PDB element version 7

with the thicker aluminium cover sheet. The deep deformation of the lower row of the PDB shows that the main stiff load paths of this vehicle are placed also relatively deep. In contrast to this the upper load paths of the Volvo seem to be relatively weak. This might result in a susceptibility to being overridden by other vehicles. As the Volvo is a very heavy vehicle the deformation depth of the PDB is substantial. Due to the rotation of the test vehicle at the end of the impact the inner honeycomb material is pressed sideways.

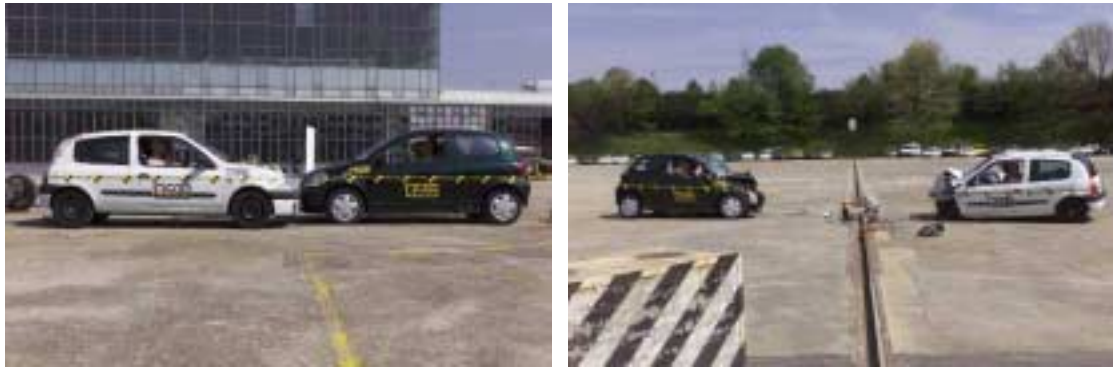
Figure 140: Initial and final position of crashed cars

The test was performed at 118 kph (59 kph for each car) due to a problem at the logical control of external engine of the laboratory. After the crash, both cars had a rotation of about 90° from the initial position (Figure 140).

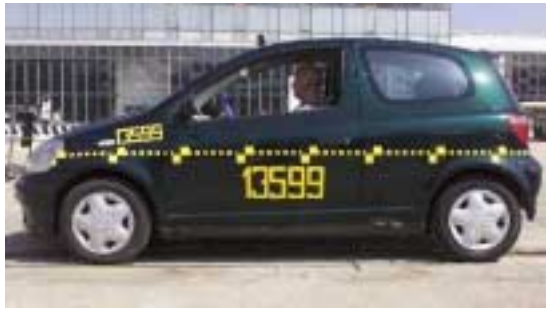
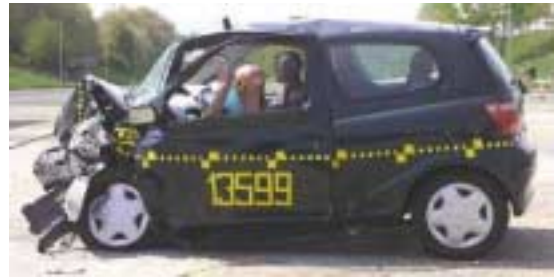
Figure 146: Toyota Yaris: pre and post test driver's side view

Pre and post test images of the Toyota Yaris are shown (Figure 146 and Figure 147). In these photographs there is evidence of insufficient stability of the occupant compartment in a crash of this severity.

Analysing the TOYOTA YARIS front-end, it is evident that the longitudinal did not collapse as designed; in fact, it moved upwards and this caused a fold of the rear part of the rail. The height of the longitudinal extremity was measured after the crash and it was verified an upwards movement of 90 mm; this measure was not the whole movement because, after the crash, the front tyre was deflated while, before the crash, it was at the correct pressure.

- The Toyota Yaris has a design consisting of one main load path, the lower rails. The Renault Clio has a multi-level load path design. Examination of the cars prior to the test showed that there was good structural alignment between them, which indicated that good structural interaction between the lower rails might be expected. However, poor structural interaction was seen in the test caused by dynamic effects. When the Toyota Yaris lower rail impacted against the Renault Clio one, the Yaris lower rail bent upwards resulting in poor interaction with the Clio structure. As a result of this the Yaris occupant compartment intruded significantly and became unstable. The Clio compartment performed well without significant intrusion.

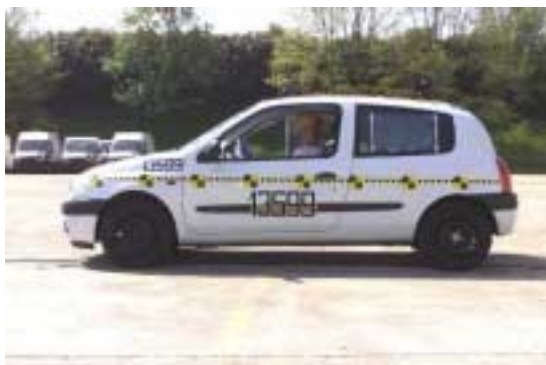
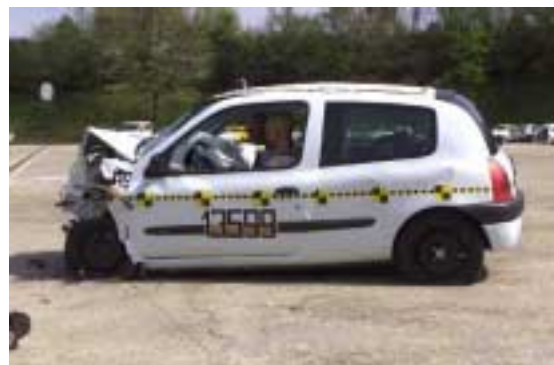
Figure 148: Renault Clio: pre and post test driver's side view

Pre and post test images of the Renault Clio are shown (Figure 148 and Figure 149). The images show the good stability of the Clio occupant compartment that received very low intrusion in the front part (it is possible to observe a deformation below the rear left wheel).

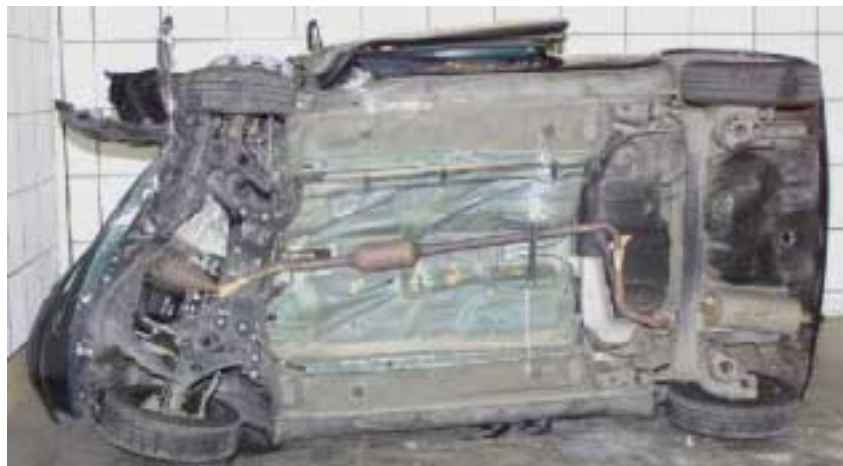
Figure 154: Toyota Yaris, bottom view

The deformation of the floor pan for both cars is shown (Figure 154 and Figure 155). It is possible to observe that the Toyota Yaris floor pan was totally deformed, not only in the left front part but also in the rear and the right part. Instead, the Renault Clio floor pan was not considerably deformed, considering the violence of crash.

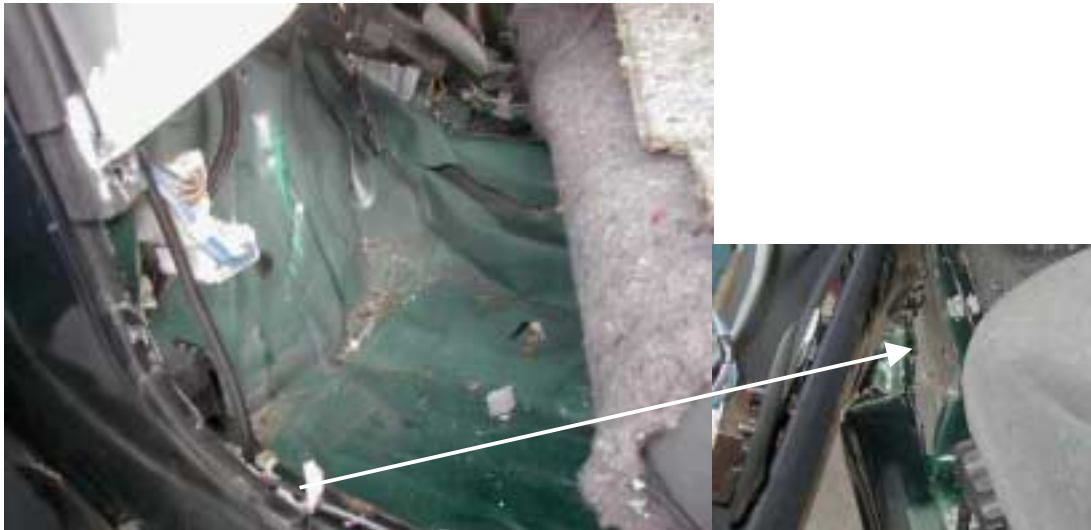
Figure 157: Toyota Yaris: Intrusions at low level of occupant compartment

There is the evidence of greater low level intrusions in the Toyota Yaris occupant compartment compared to the Clio, due to the crush of the lateral sill at the height of the front door (Figure 157 and Figure 158).

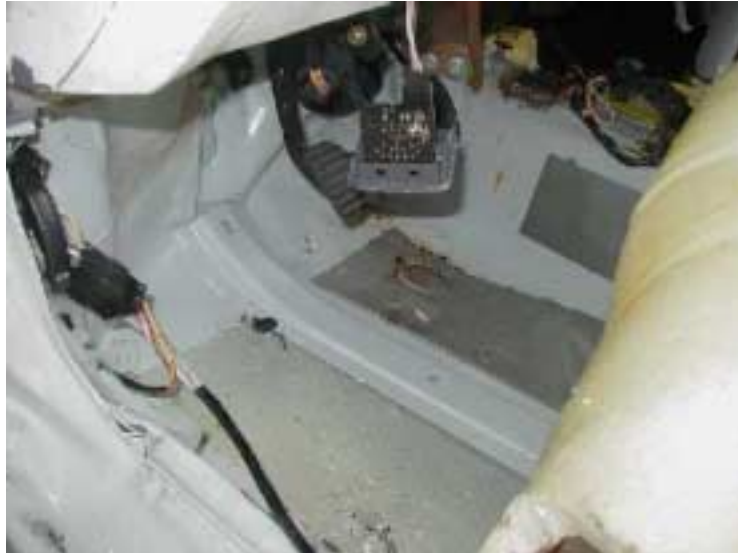
Figure 158: Renault Clio: Intrusions at low level of occupant compartment

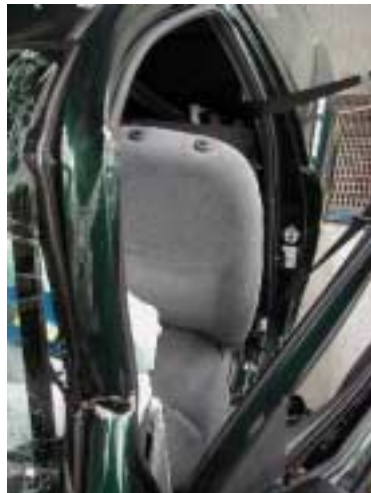
Figure 159: Toyota Yaris: driver seat rotation

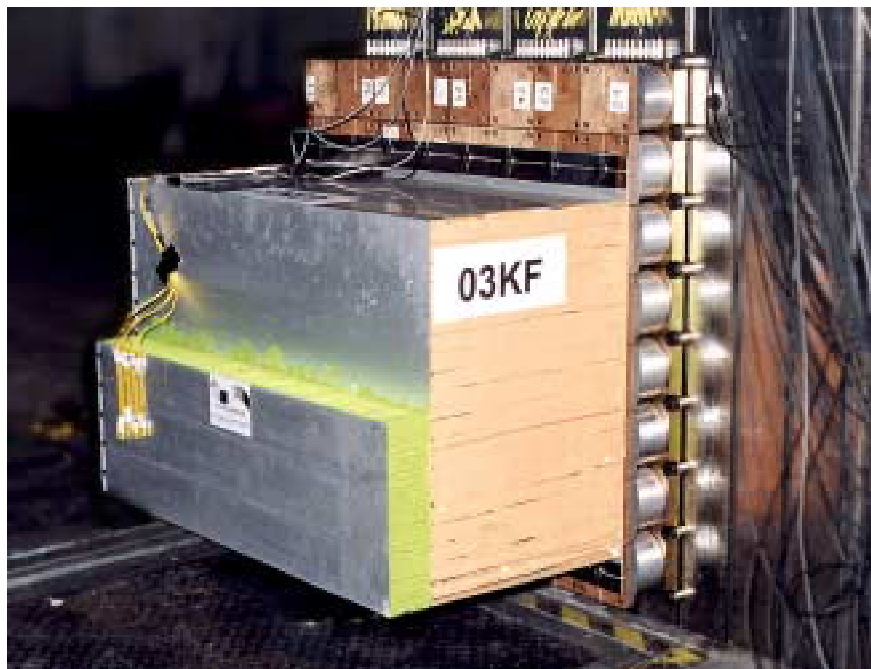
Figure 161: Offset deformable barrier (ODB) mounted onto high resolution load cell wall.

The respective vehicles were impacted into an EEVC frontal impact barrier with a 40% overlap. The barrier was mounted onto a high resolution load cell wall formed of 64 load cells of 125mm x 125mm arranged in an 8x8 matrix. The position of the load cell wall was such that 5 of the eight rows of load cells are centred behind the deformable element. Of the three remaining rows, two were above the barrier and one below (Figure 161).

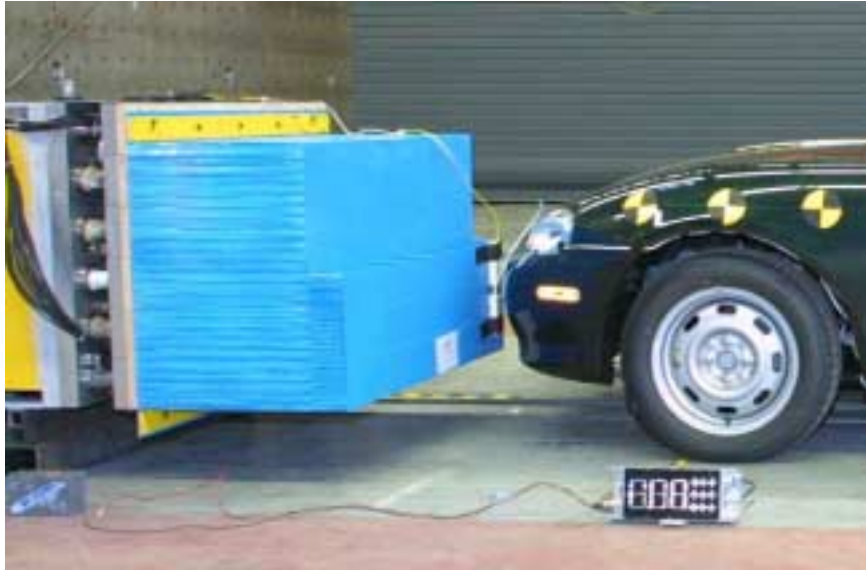
Figure 177: Euro NCAP Frontal Impact Barrier mounted to the Load Cell Wall

The deformable element mounted to force measuring wall is shown (Figure 177). The lowest row of the force transducers fits to the lower edge of the deformable element.
